# Opel Astra H - Koudemiddelverlies | HELLA

Opel

Astra H

Koudemiddelverlies

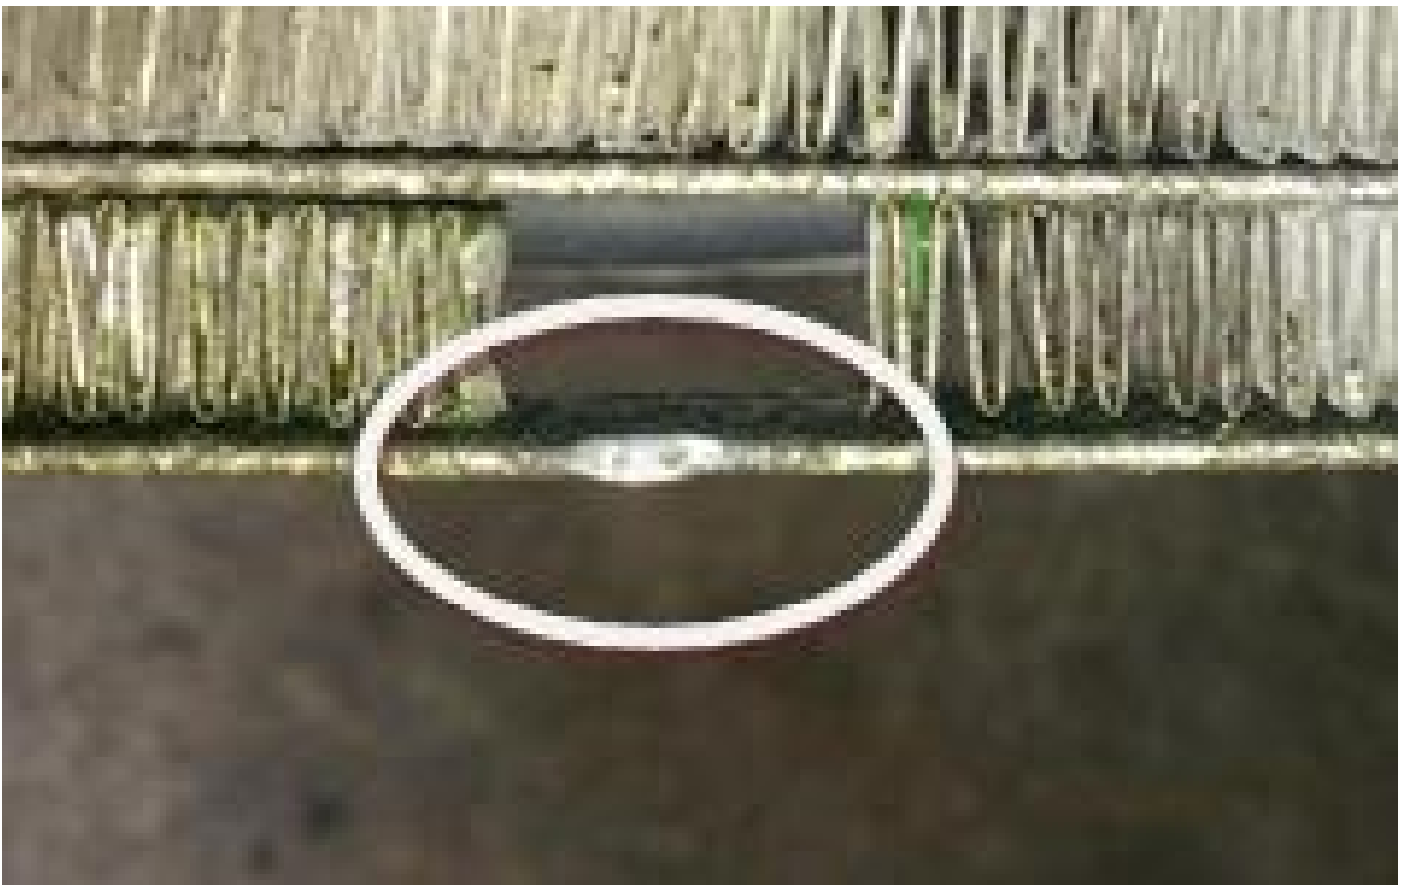
Door uitgevallen lamellen treedt er instabiliteit in het condensornet op. De trillingen kunnen vervolgens tot contact met andere onderdelen leiden. Hierdoor wordt de condensor beschadigd (afbeelding 1) en kan deze lek raken.

Als bij bovengenoemde voertuigen een koudemiddelverlies wordt vastgesteld, moet speciale aandacht aan de condensor worden geschonken.

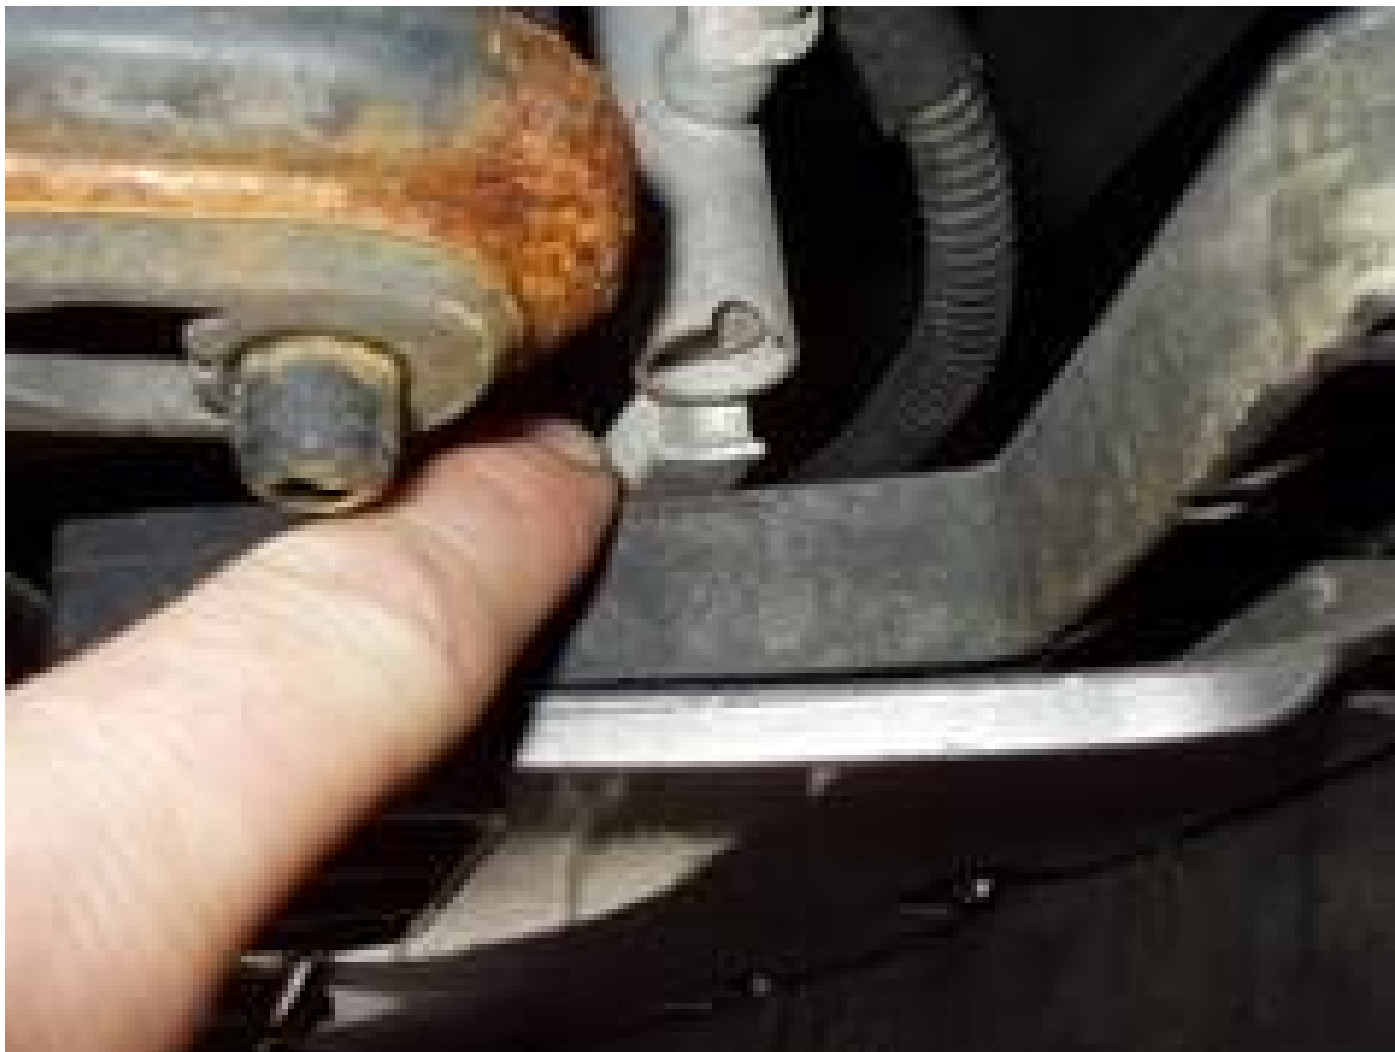
Figure 2

Verder is het mogelijk dat de condensor uit zijn bevestiging losraakt en tegen de drager komt te liggen (afbeelding 2). Dit kan eveneens tot lekkage leiden.
