# Skoda Fabia II - Functiestoring; zijknipperlicht | HELLA

**Skoda Fabia II**

Bouwjaar: 2007 - 2014

## Functiestoring; zijknipperlicht

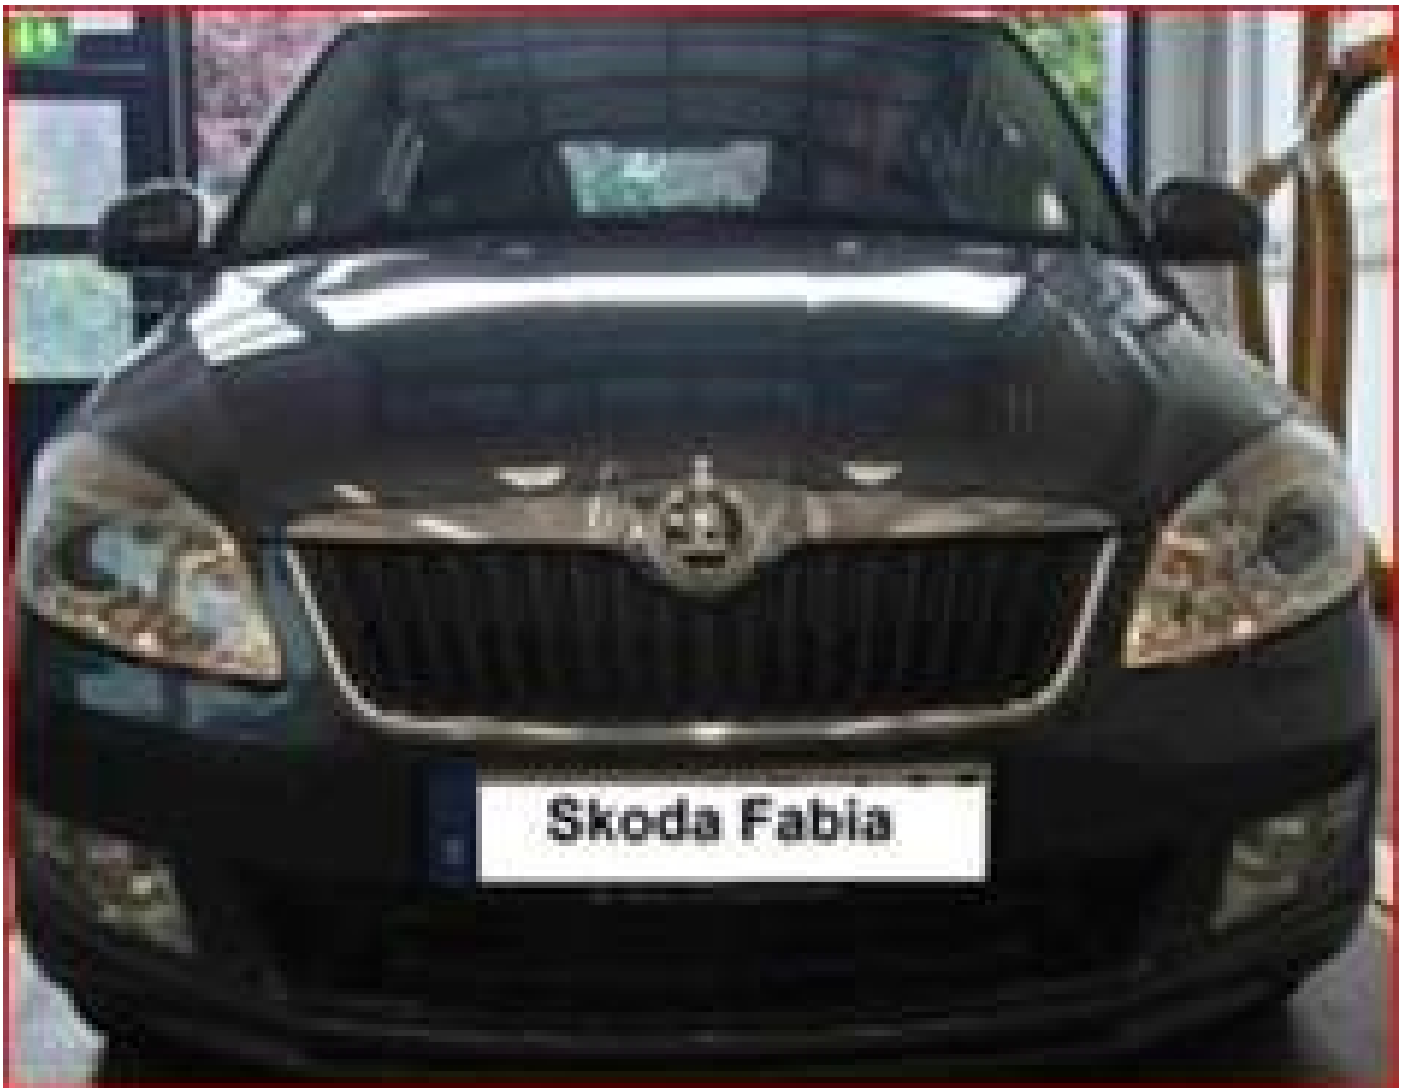
Afb. 1

Als bij het bovengenoemde voertuig (afb. 1) een functiestoring optreedt aan het zijknipperlicht (afb. 2), kan dit worden veroorzaakt door een defecte aansluitkabel.
