# **Toyota Auris, Corolla - Geklapper bij de wielrem van de vooras | HELLA**

**Toyota**

**Auris, Corolla**

## **Geklapper bij de wielrem van de vooras**

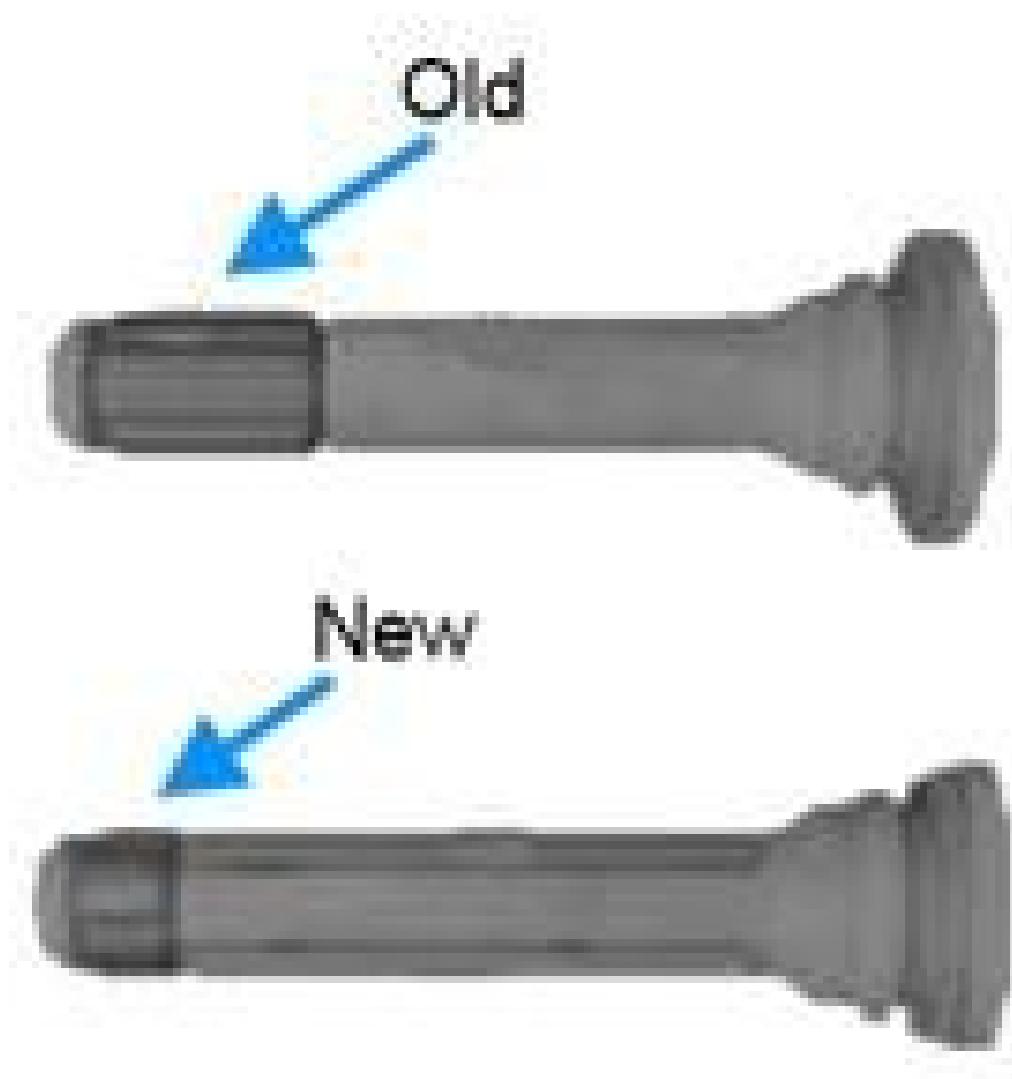
De ombouw is herkenbaar aan de gewijzigde geleidepen met bus. (Afbeelding)

Visuele controle uitvoeren. Remsysteem van de vooras op beschadigingen, correcte werking, overmatige vervuiling of slijtage controleren. De wielrem zo nodig voor een verdere controle deels demonteren. Als er geen gebreken kunnen worden vastgesteld, moeten de remklauwhouders worden gecontroleerd en zo nodig door de gewijzigde onderdelensets worden vervangen.

To remedy the defect, the following OE spare parts have been offered by the vehicle manufacturer as part of a corrective measure:

- Brake calliper carrier 47721-09560
