# Coolant pumps | HELLA

## General

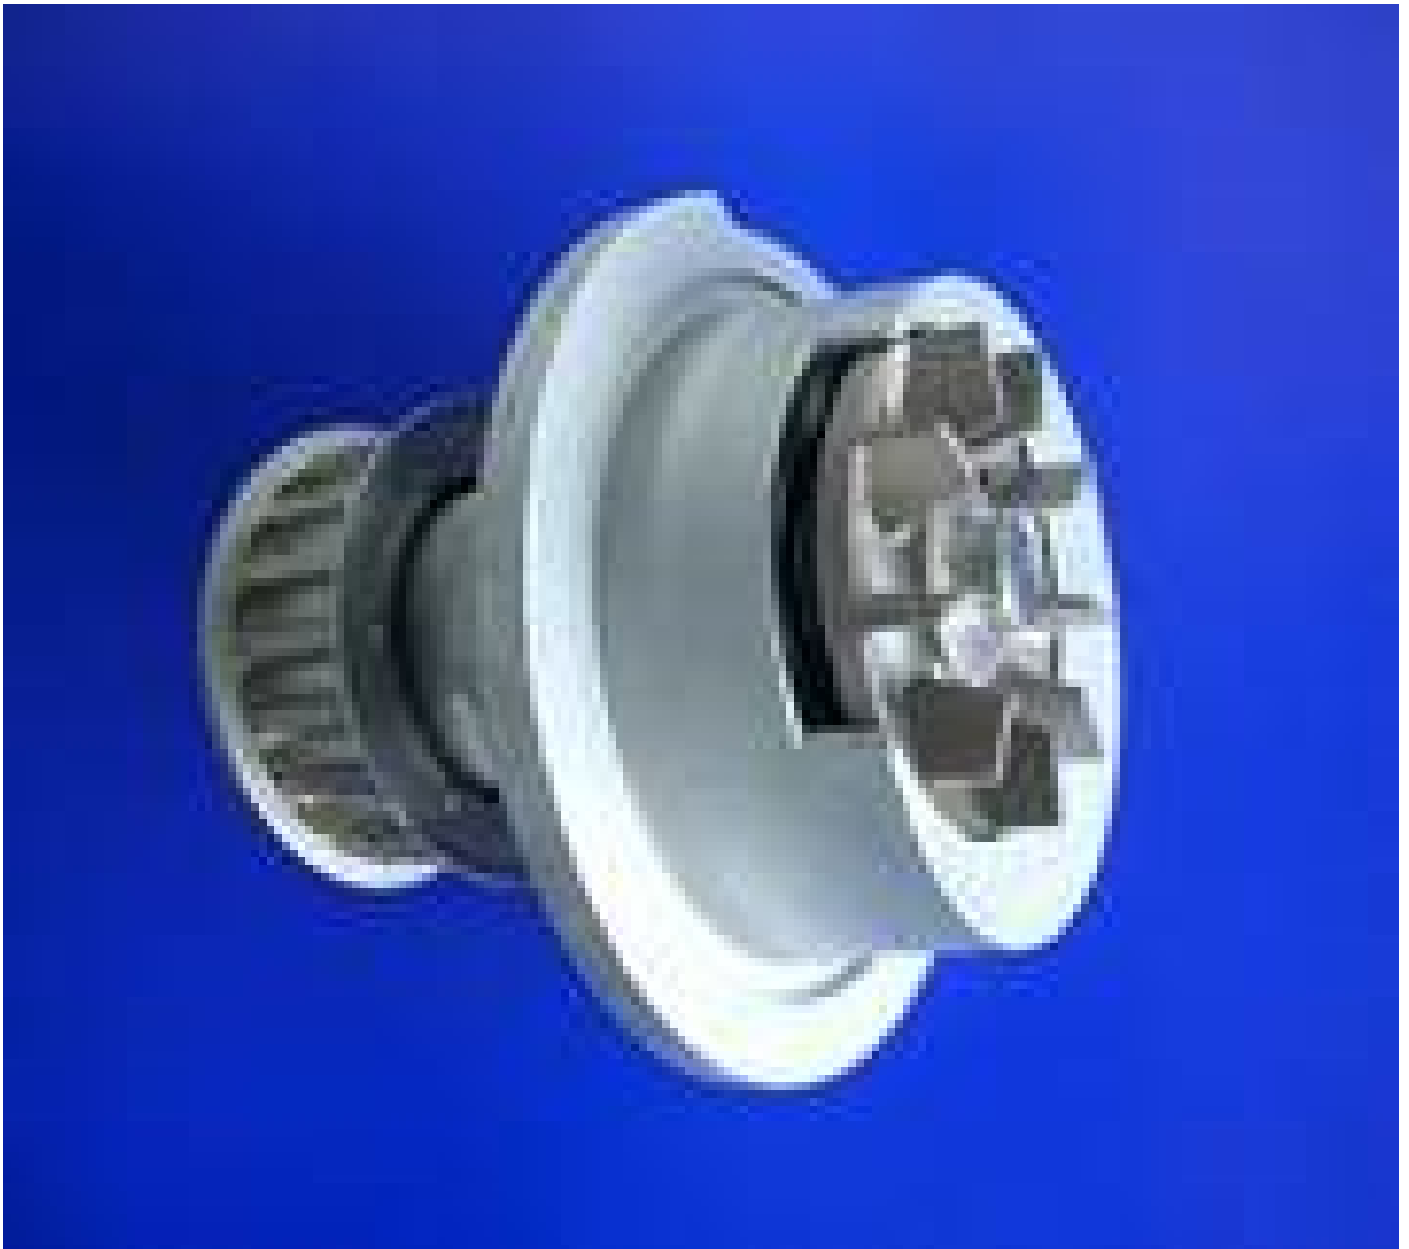
Figure 1

Coolant pumps (Figure 1) are mostly driven mechanically, by a toothed belt or V-ribbed belt, and transport the coolant through the engine's coolant circuit. The pumps can be flanged directly to the engine or also installed away from it. The designs are quite different. Coolant pumps must withstand huge variations in temperature ( $-40\text{ }^{\circ}\text{C}$  to approx.  $+120\text{ }^{\circ}\text{C}$ ). Changing speeds (500 - 8000 rpm) and pressures of up to 3 bar require high stability of bearings and seals.
