# **Volvo V60 - Replacement of direction indicator bulbs | HELLA**

### **Volvo V60**

**Model year: 2010 - 2013**

## **Replacement of direction indicator bulbs**

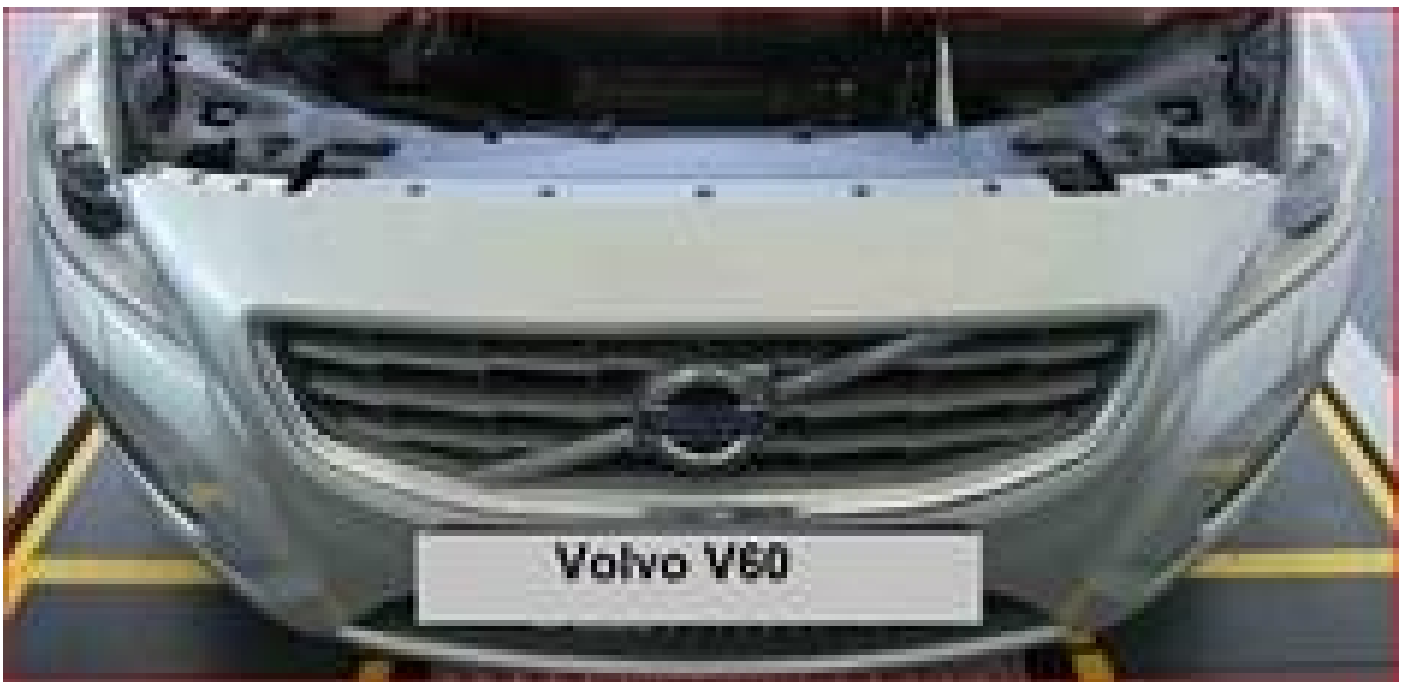
Fig.1

Figure 1 shows the front view of a Volvo V60.

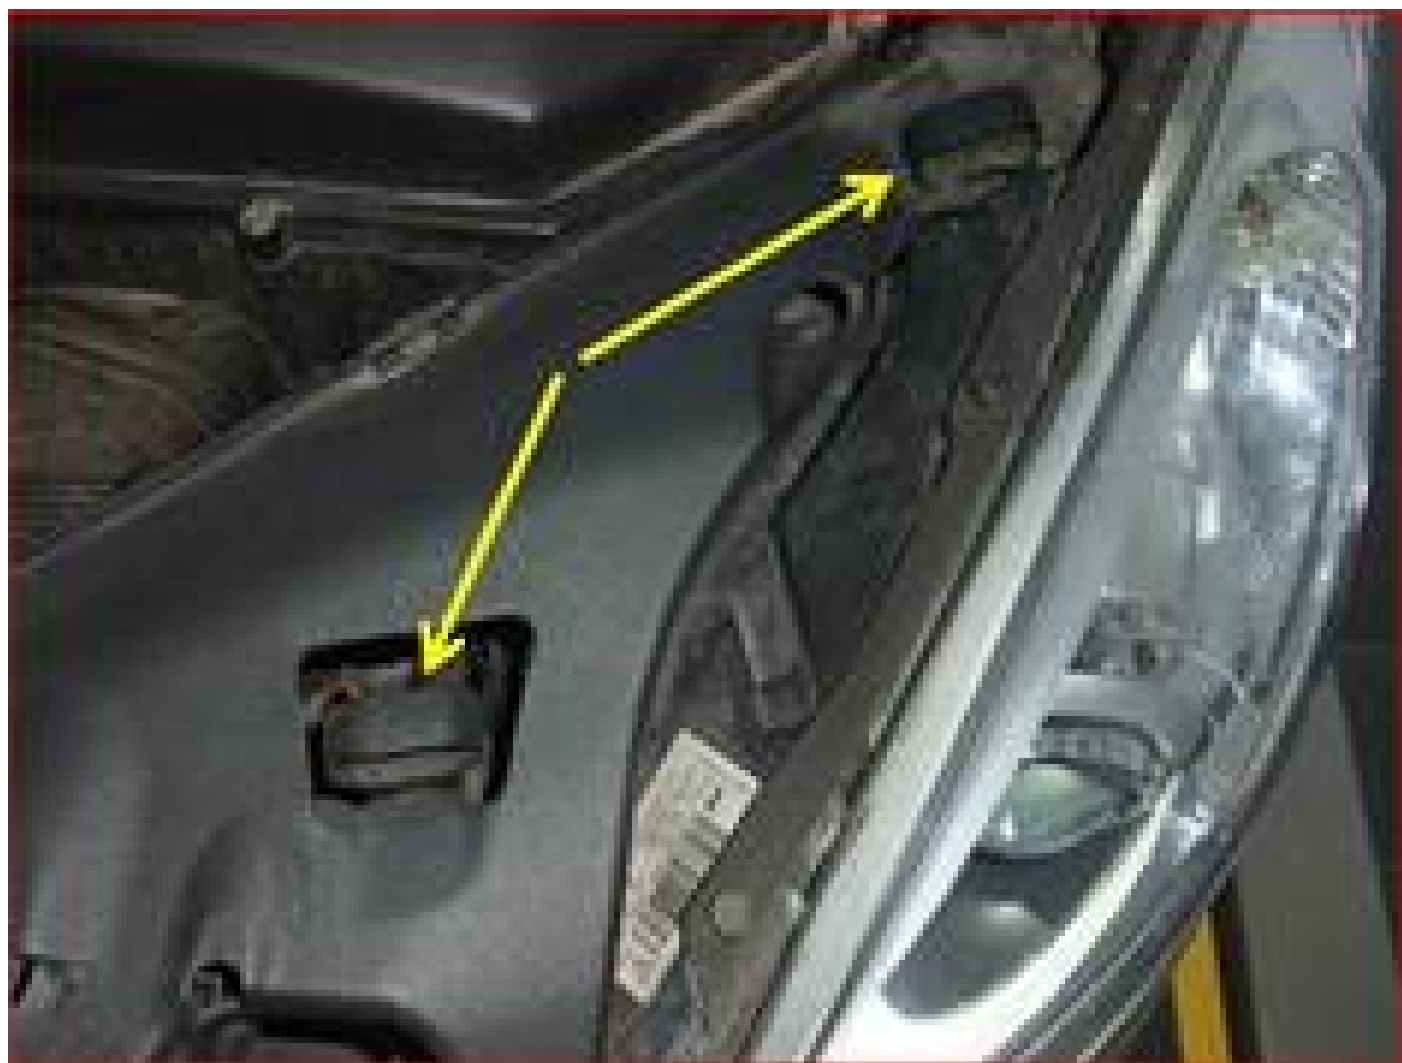
Fig. 2

So as to release the headlamp from the engine compartment, pull out the locking pins (Fig.2) upwards and carefully pull the headlamp forwards out of the body (Fig.3).
