# Informação do produto — Calços de travão Toyota | HELLA

**Toyota brake linings**

8DB 355 014-881 replaces 8DB 355 013-741

### New allocation of the brake pads

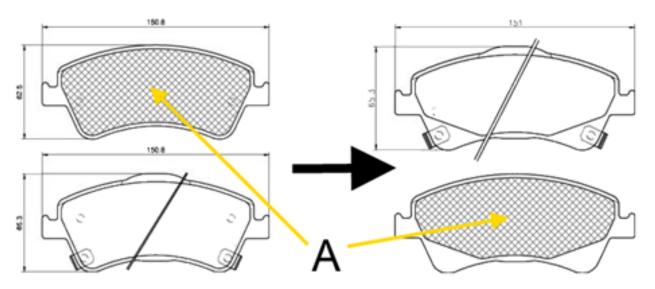
The visible difference between both brake linings is the changed shape of the friction pad (A).

## 8DB 355 013-741 / T1747 (old)

# 8DB 355 014-881 / T1905 (new)

Brake pad 8DB 355 013-741 / T1747 will be replaced by brake pad 8DB 355 014-881 / T1905.
