# Opel Insignia — Ajuste em altura do banco com defeito | HELLA

## Insignia

**Model year: 2009**

## Height adjustment system for seating defective

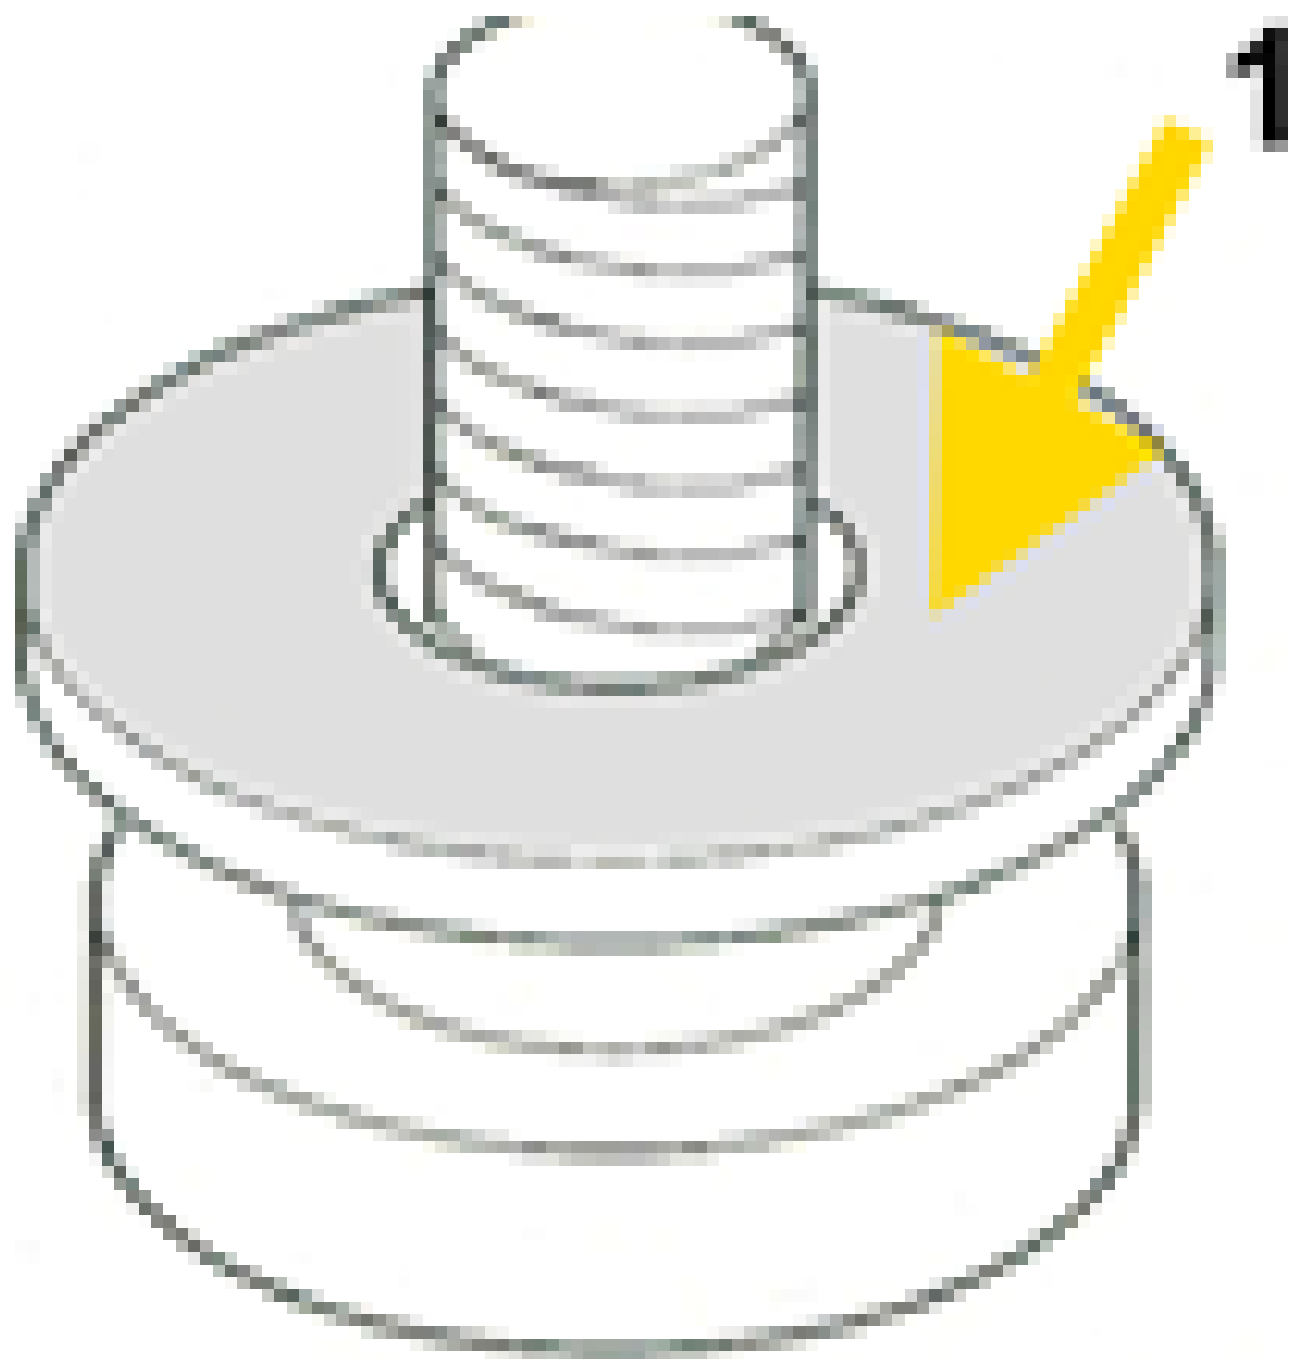
If the height adjustment system for the seating in the vehicle mentioned above no longer functions, it can be the fault of a blocked adjustment spindle.

The motor responsible for the adjusting of the seat height can jam between the spindle and the plastic stopper.

The problem can be solved with the help of an additional washer (1).

- Dismantle seat
- Loosen screw (2) and dismount
- Place washer (1) with the measurements 6.4 x 18 x 1.6 in position (OE No. 11035613)
- Lubricate with special grease (OE No. 13329237)
- Replace screw (2) and tighten with 10 Nm torque
- Remount seat
