Opel Insignia — Perda de líquido de refrigeração no radiador RGE | HELLA

Opel Insignia Ano de modelo: 2009 - Motor: A20DT/A20DTH/A20DTJ/A20DTR/A20DTC

Perda de líquido de refrigeração no radiador RGE

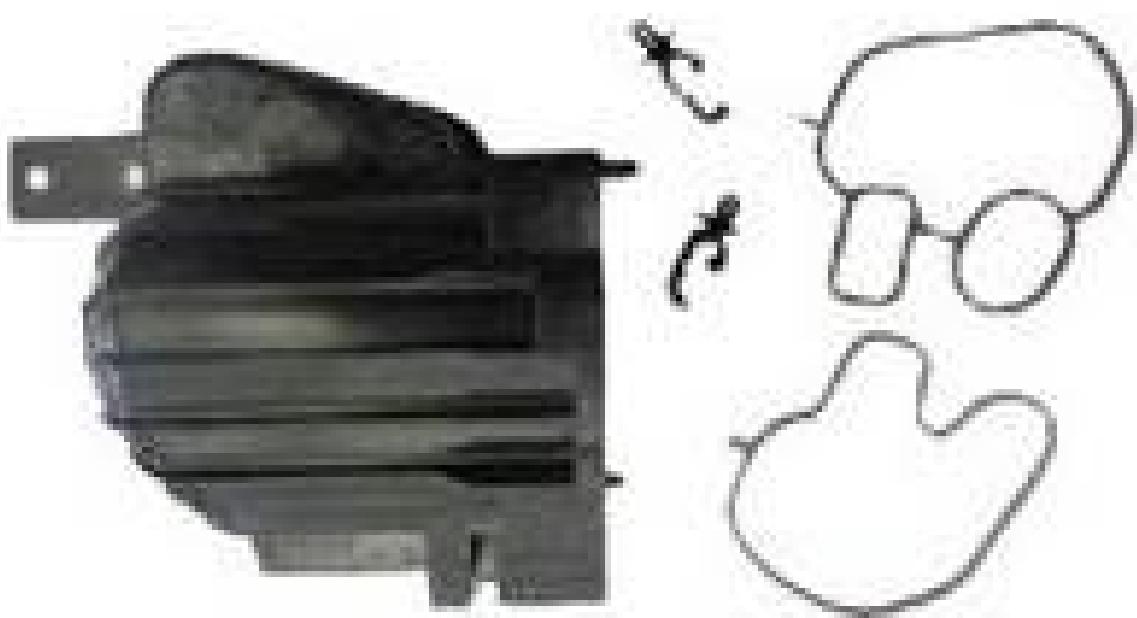
Para resolver a situação, deve-se proceder da seguinte forma e utilizar um kit de reparação (Figura) constituído por uma carcaça, 2 vedantes e 2 clipe:

Utilizar o kit de reparação (ref.: 55590953):

Deixar arrefecer o motor

Desmontar a carcaça do radiador RGE (recolher o líquido de refrigeração)

Desmontar o radiador RGE da carcaça

Limpar as superfícies vedantes

Montar o radiador RGE na nova carcaça

Montar a carcaça do radiador utilizando os novos vedantes

Encher o líquido de refrigeração

Purgar o ar do sistema de refrigeração

Realizar um teste de estanqueidade
