Skoda Fabia II - Functional failure; side direction indicator | HELLA

Skoda Fabia II

Model year: 2007 - 2014

Functional failure; side direction indicator

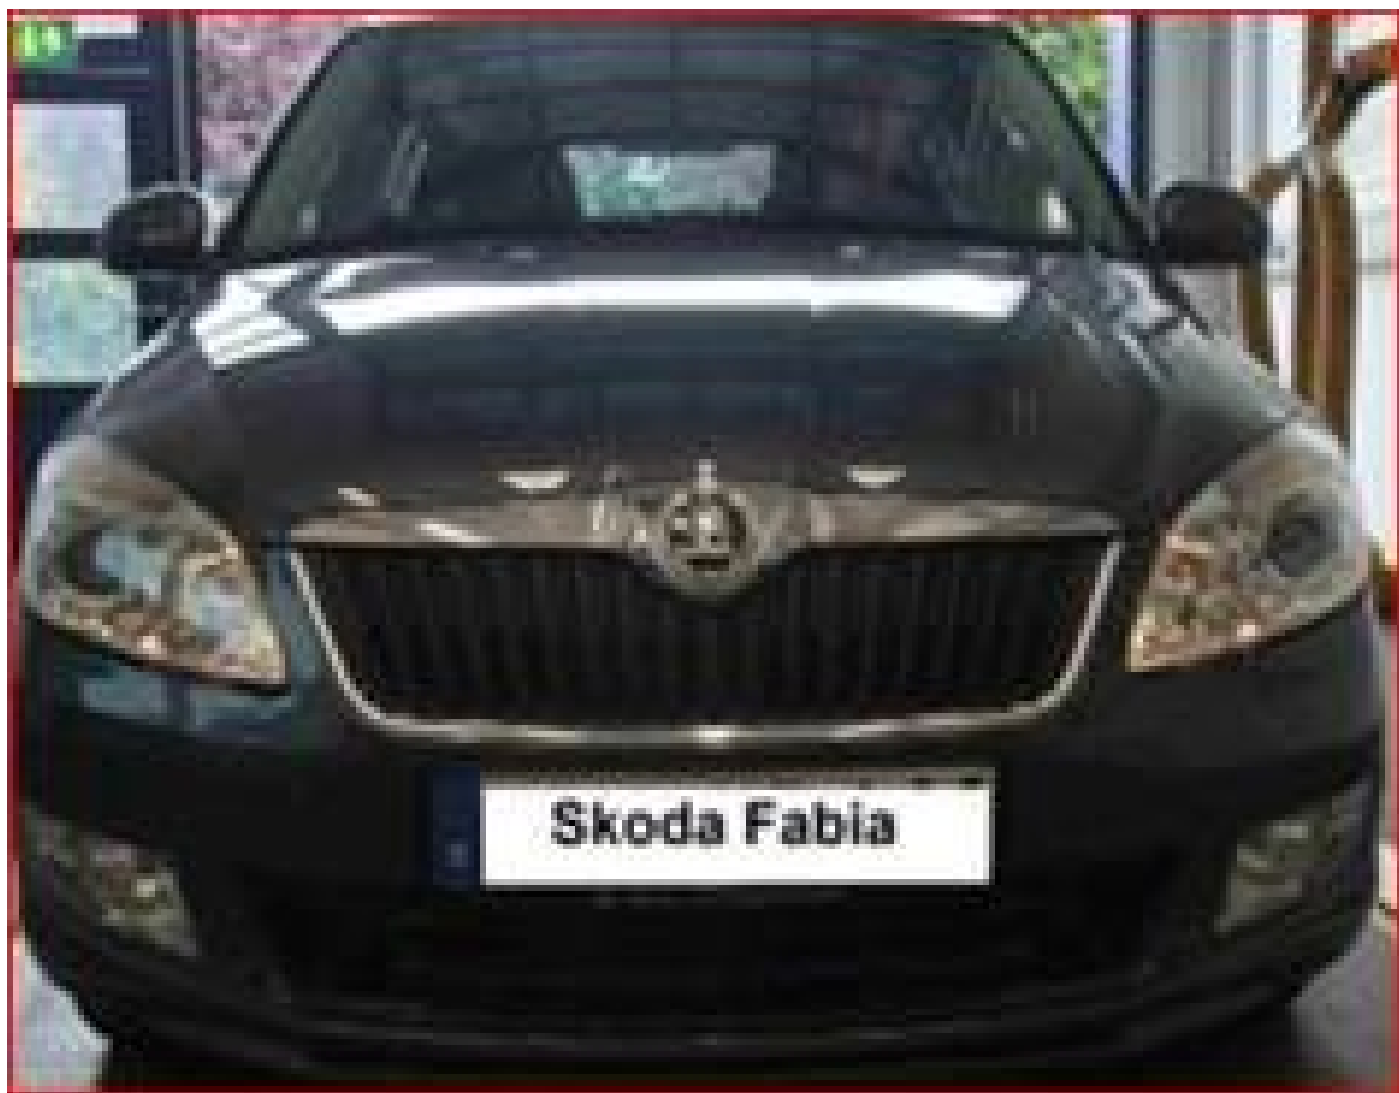
Fig. 1

If the above-mentioned vehicle (Fig.1) is found to have a malfunctioning side direction indicator (Fig.2), this may be caused by a defective connection cable.
