# Coolant pumps | HELLA

## General

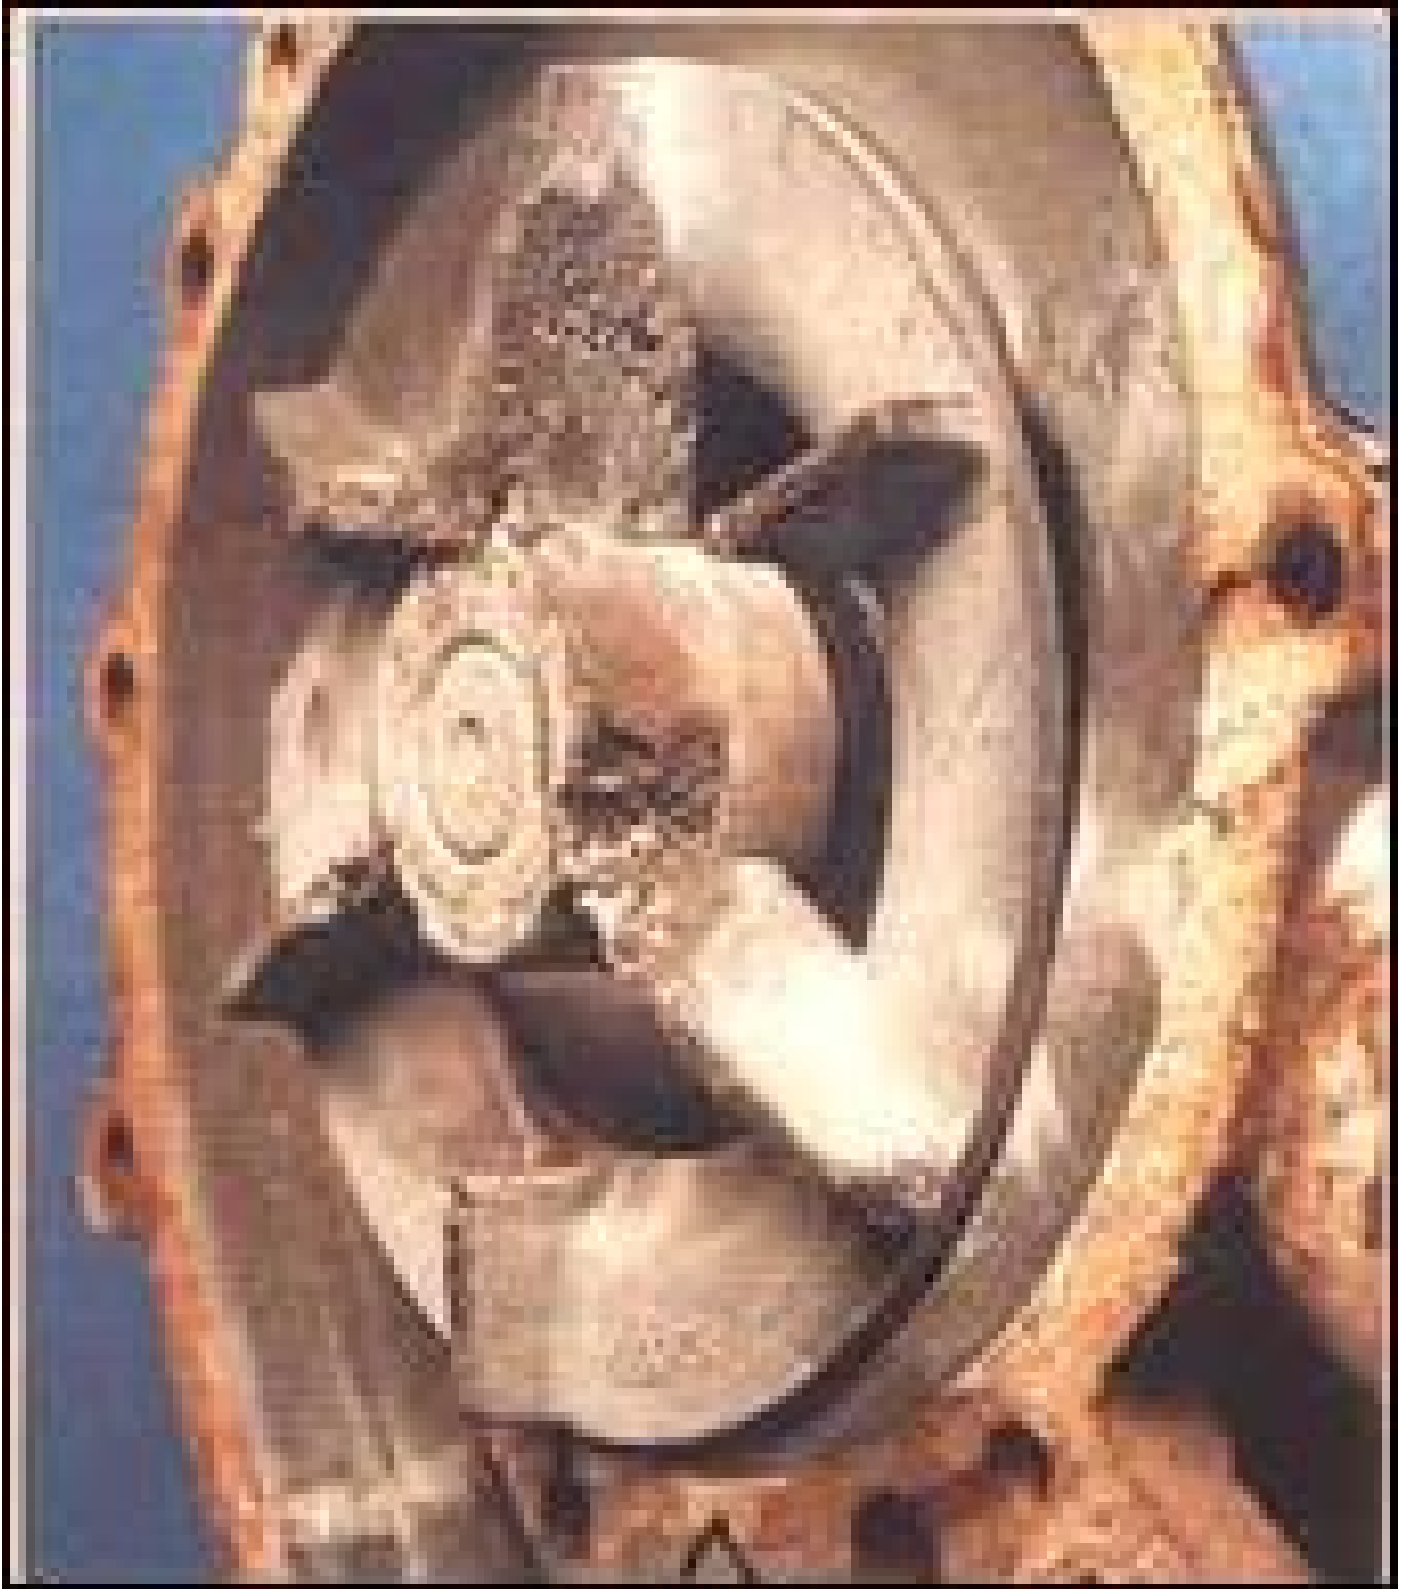
Figure 3

- Mechanical damage: Loose/broken vane  
Bearing or seal broken  
Drive gear damaged
- Cross-section constricted by corrosion or sealant
- Cavitation: Damage to the vane by the forming and collapsing of vapour bubbles in the coolant (Figure 3)
- Electrical fault (short-circuit/interruption)
