# AIXAM UV53 - replacing the cabin air filter

## Data sheet

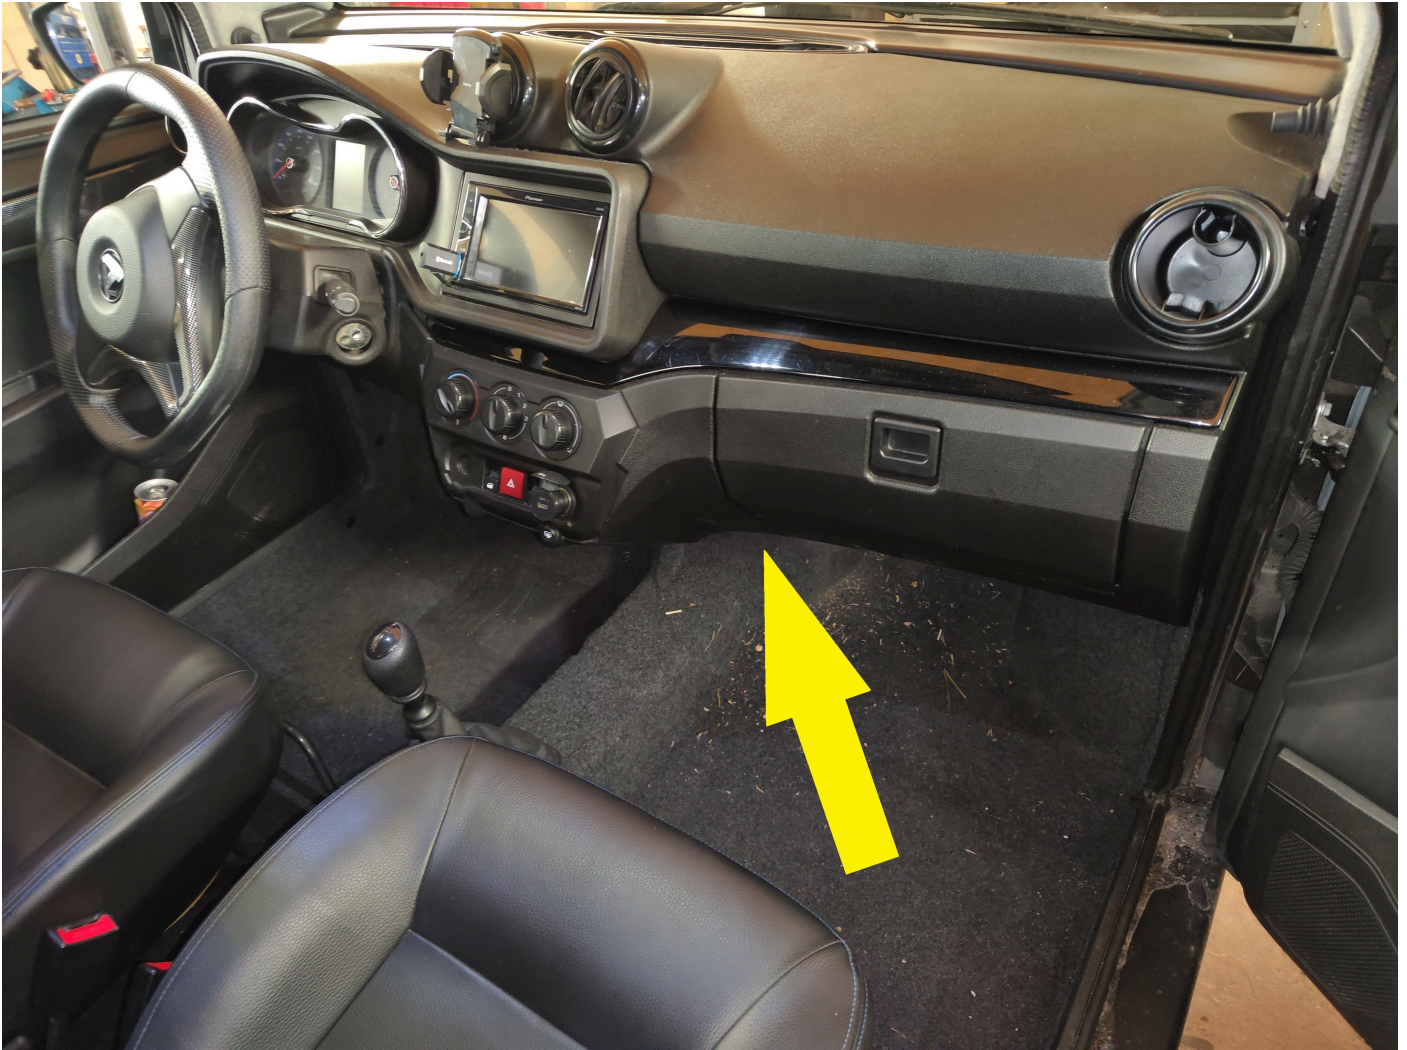
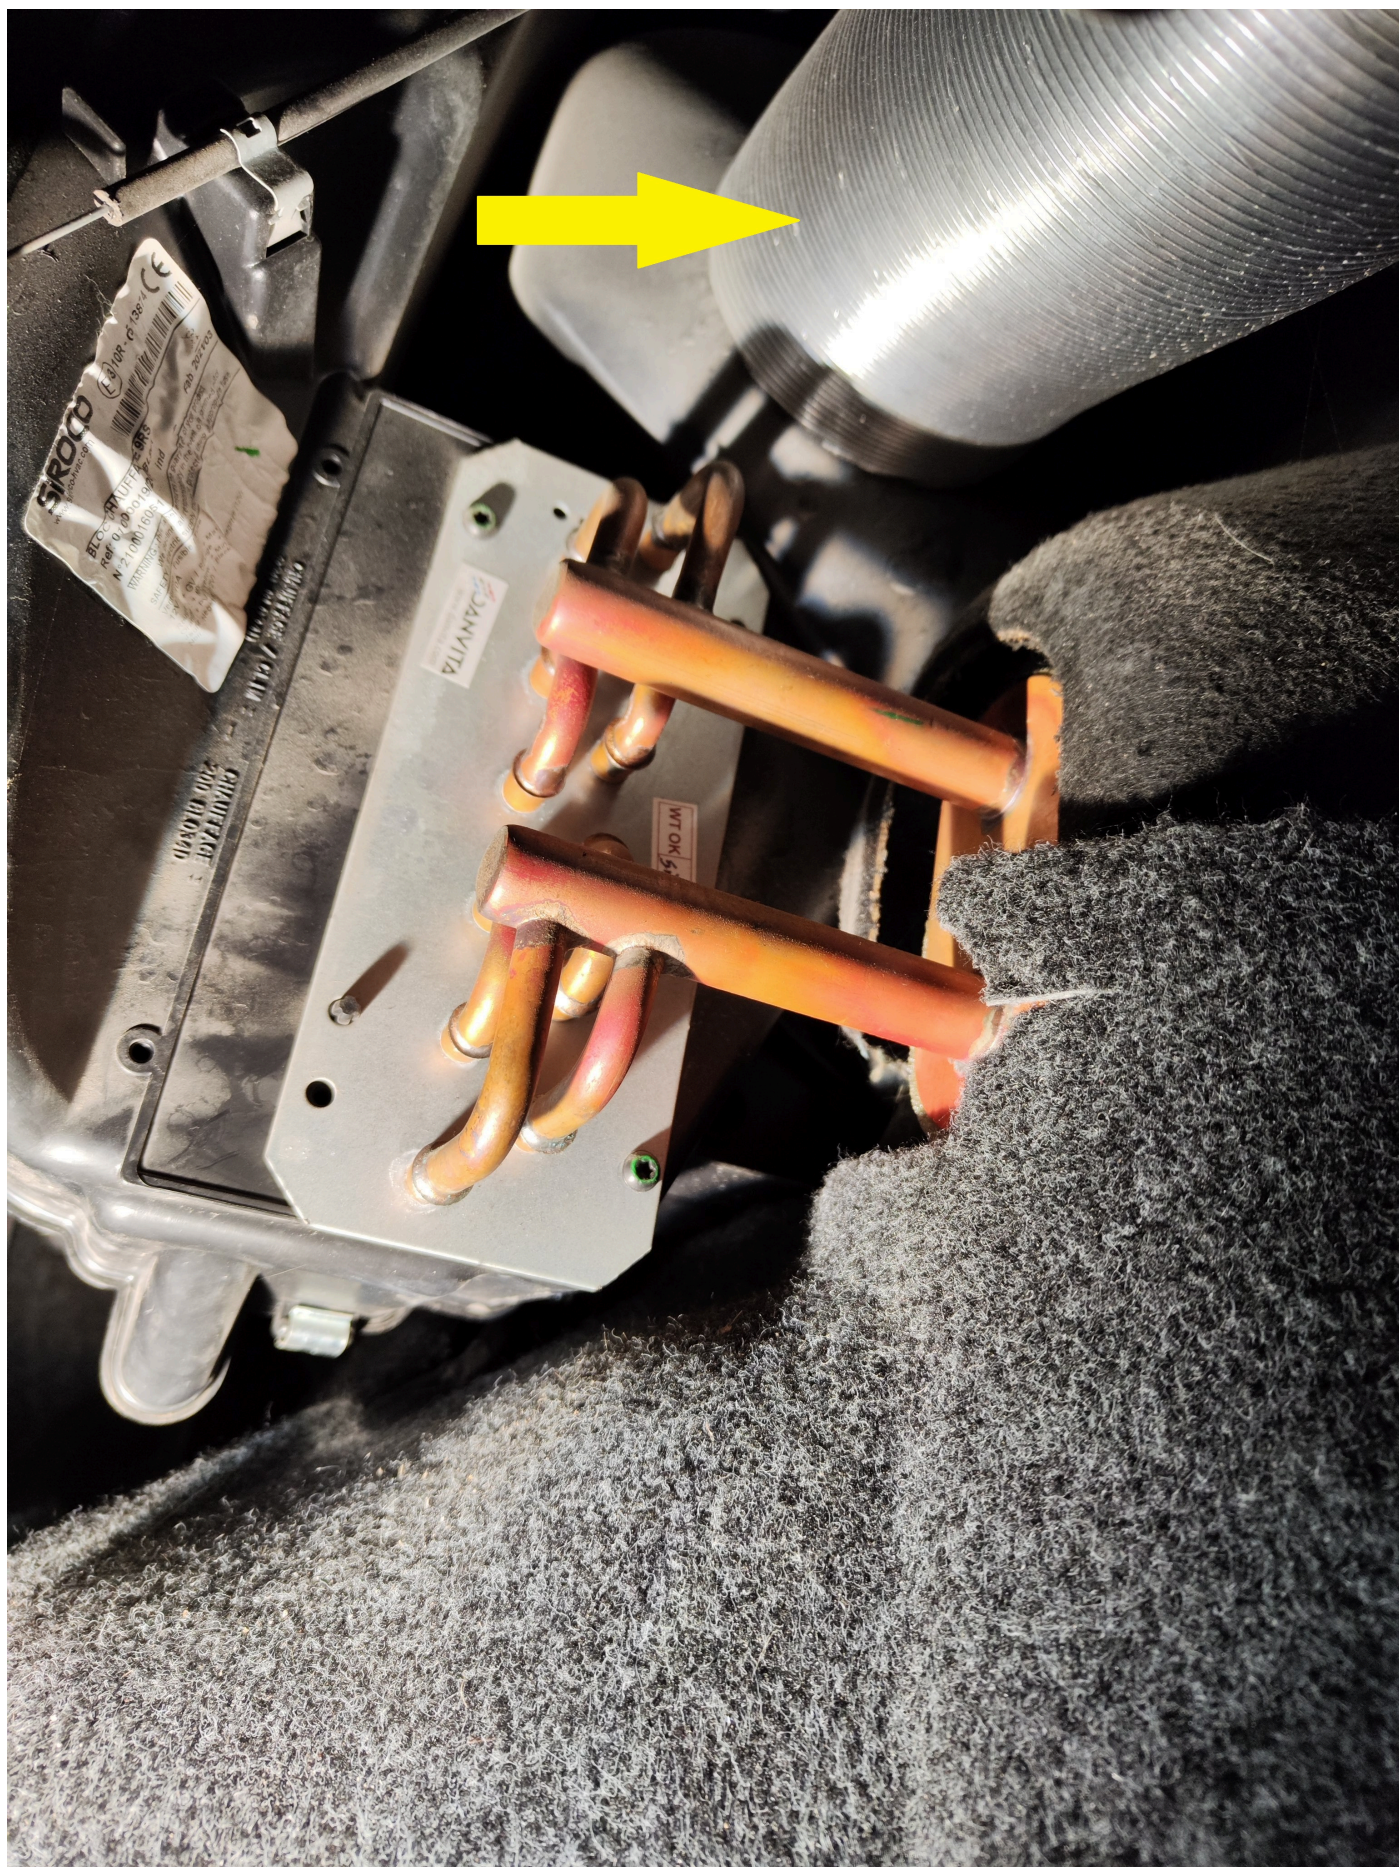
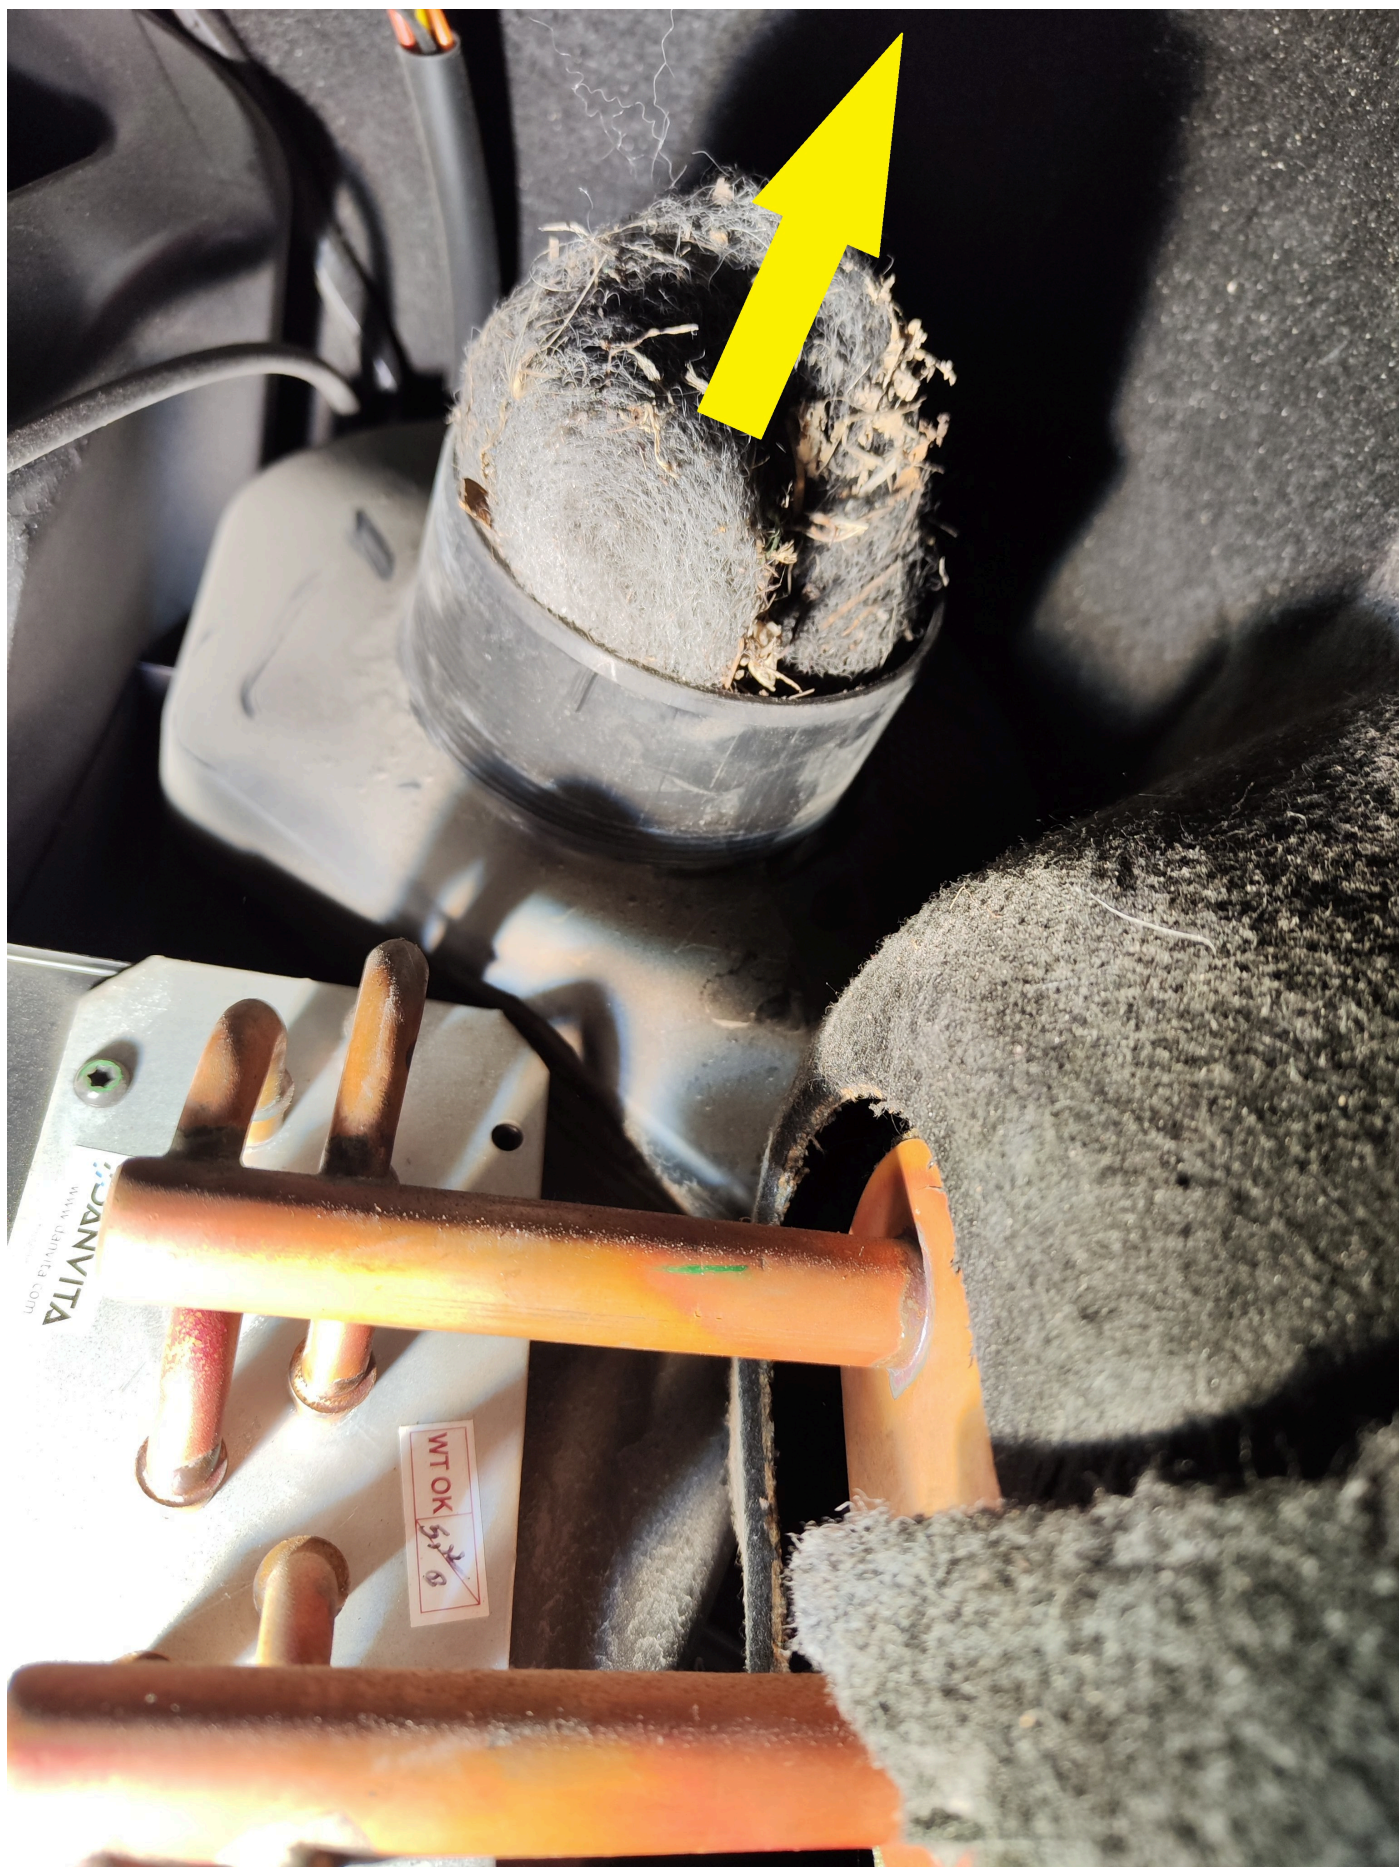
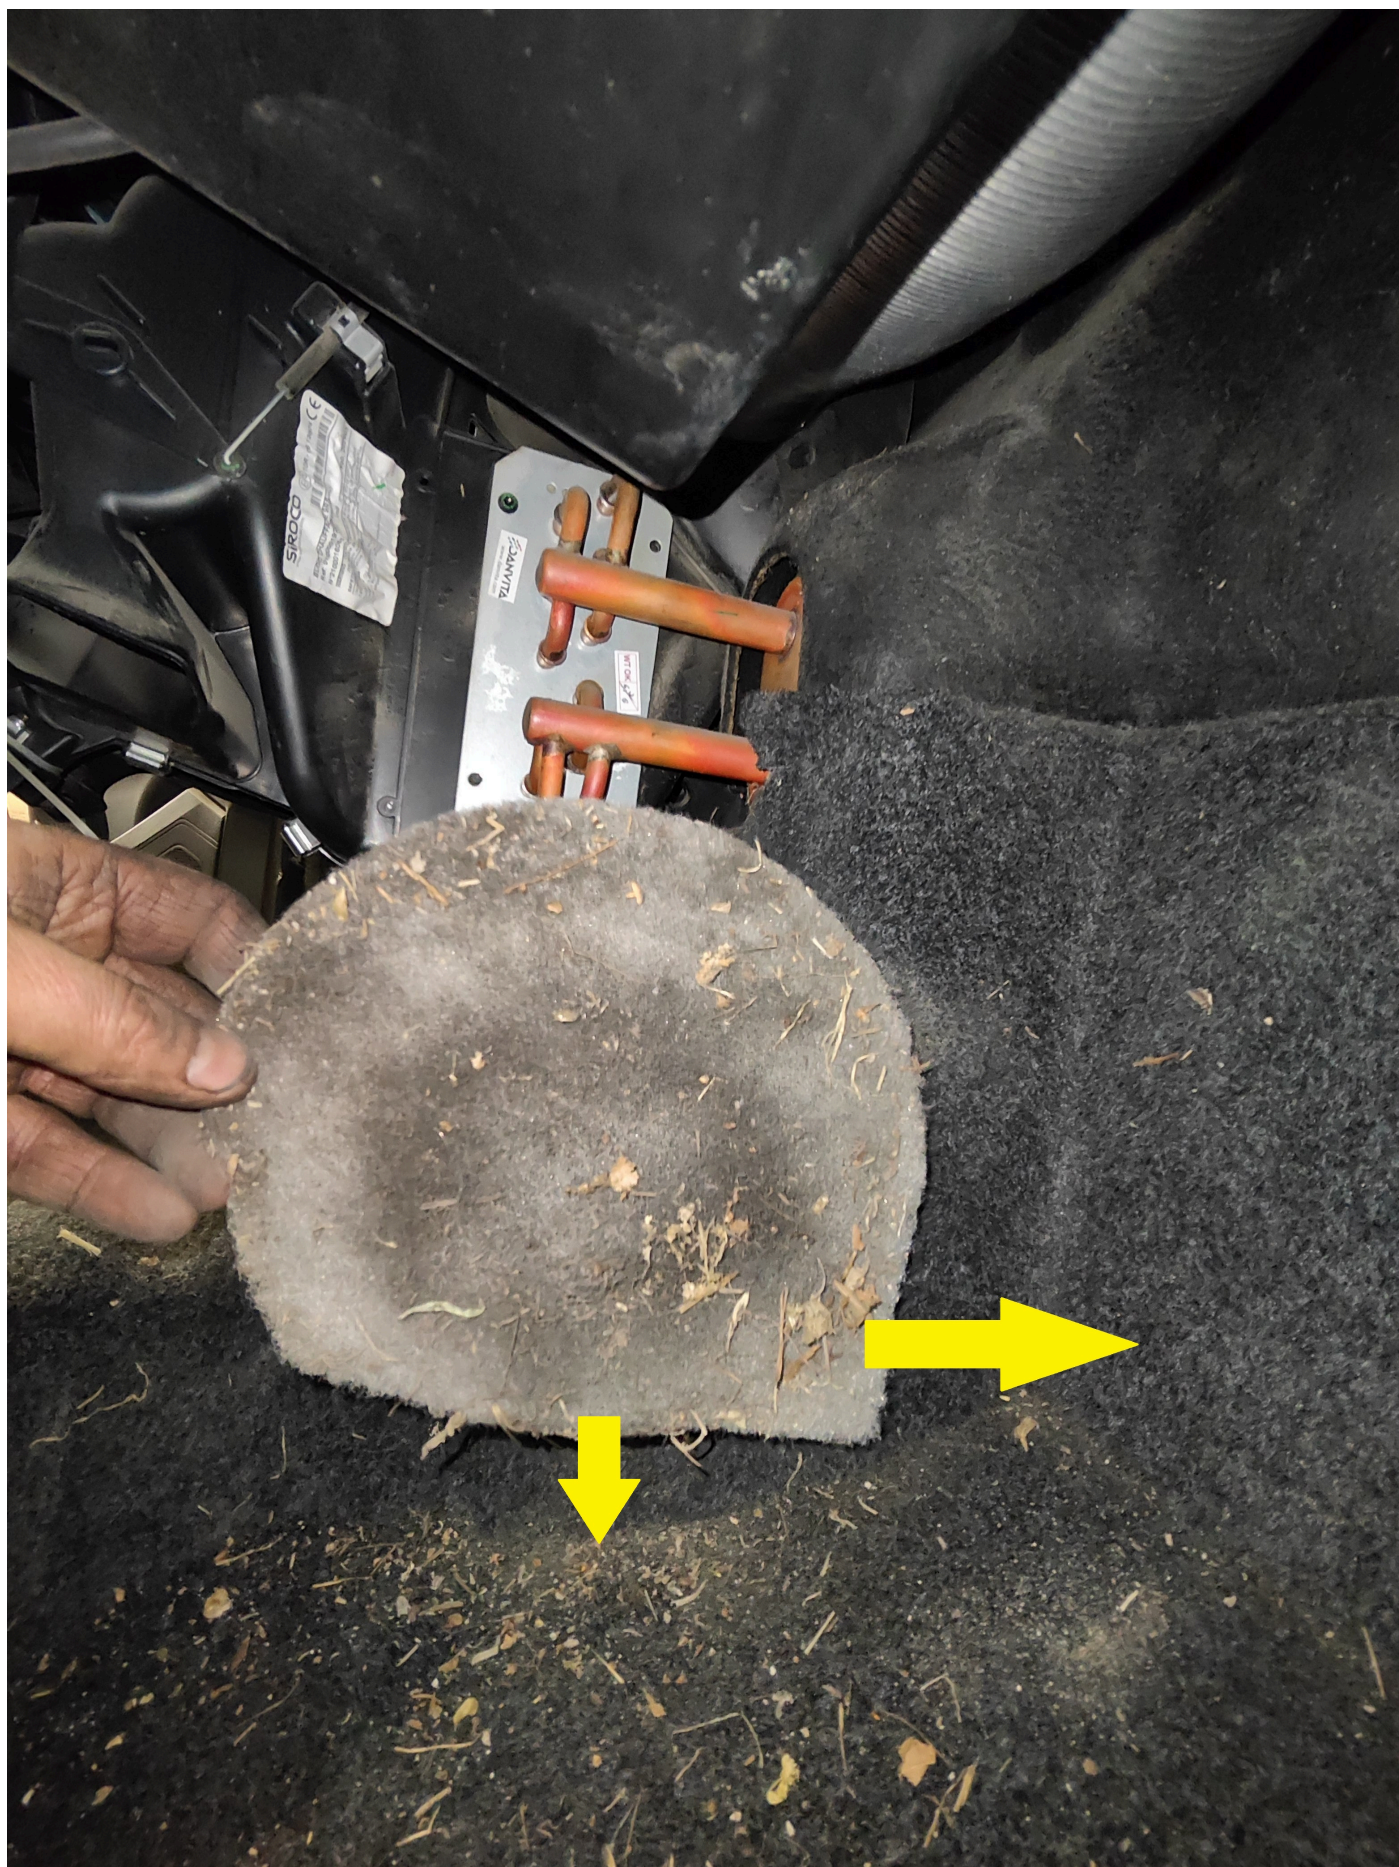
The UV53 model from AIXAM also features a cabin air filter, which is replaced during a service. This is a filter fleece without activated carbon. The filter is located on the right-hand side of the heater unit and can be accessed from the passenger footwell.

- Remove the ventilation hose on the right-hand side of the heater unit.
- Remove the old filter from the housing.
- The new filter has to be slightly bent when it is inserted. Ensure that it is fitted in the correct position (with the straight side facing downwards)

- Reattach the ventilation hose.
