# Volkswagen Polo - Heating/air conditioning temperature control | HELLA

**Polo (9N)**

## Heating/air conditioning temperature control

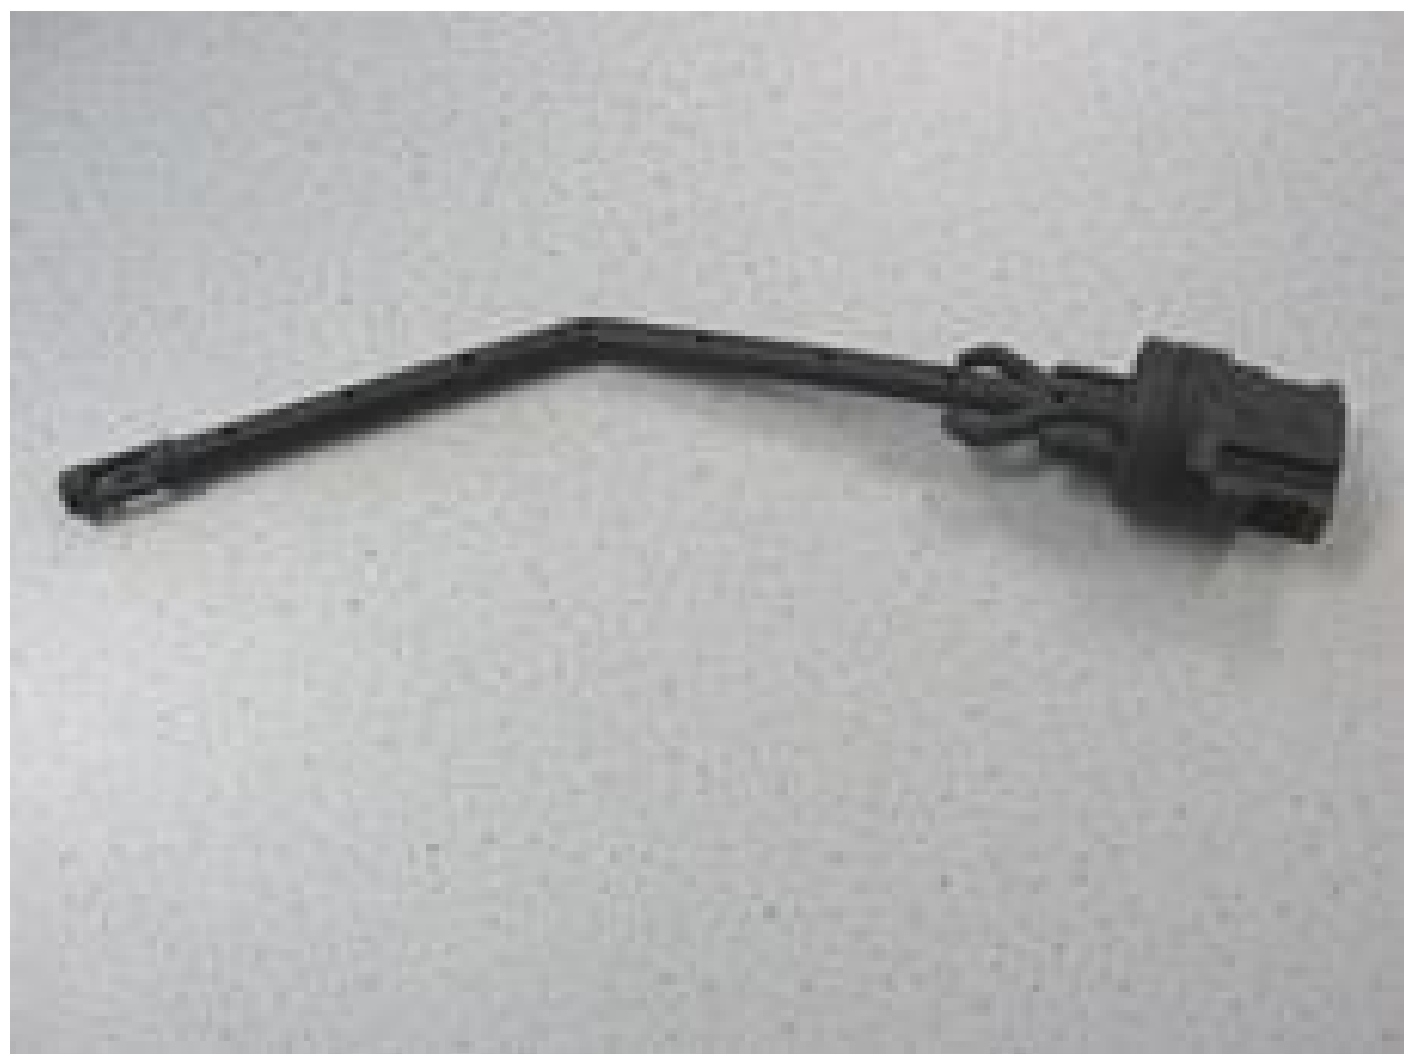
- Remove the air vent in the footwell
- Remove the comfort control module (Fig. 2, pos. A)
- Remove the comfort control module bracket (Fig. 2, pos. B)
- The sensor's connector is now visible above the footwell (Fig. 3)
- Unlatch and pull out the sensor's connector
- Pull out the sensor
- Insert a new sensor
- Reinstall the bracket, control unit and air vent
- Read out fault memory and delete if necessary
- Carry out a function test
