# VW Beetle - non-functioning parking aid

## Data sheet

| Symptoms | Failure of backup and warning alarm / parking aid |

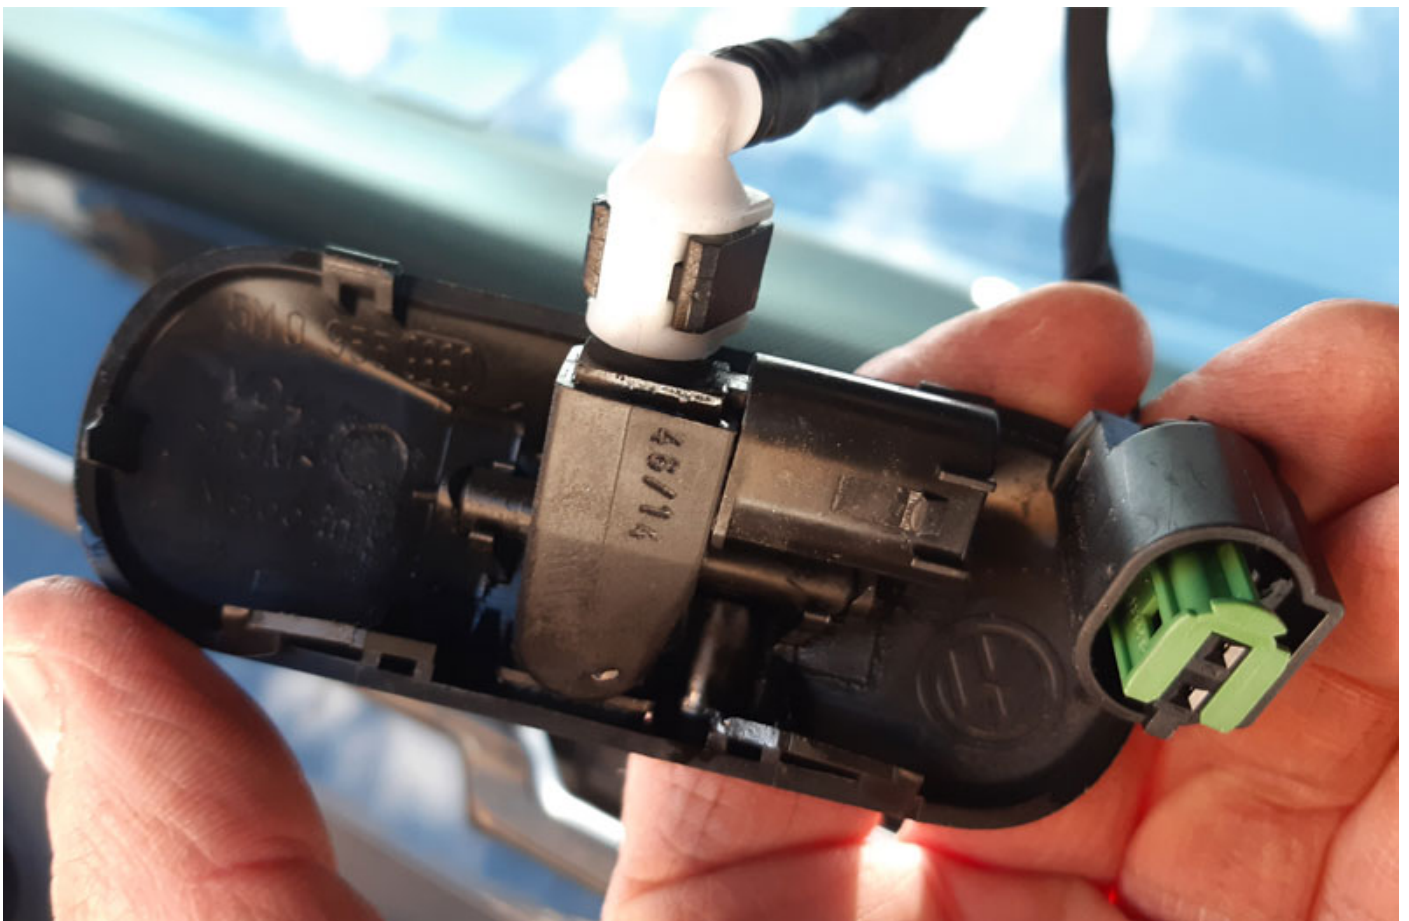
In most such cases, the fuse for the electrically heated wiper washer nozzles is defective ([Fig. 2](#)). The cause of this is a short circuit in the heating element of the wiper washer nozzle with the result that not only the fuse but also the nozzles must be replaced.

After replacing these components, functioning of both the parking aid and of the "start/stop" feature is restored.
