# Coolant pumps | HELLA

## General

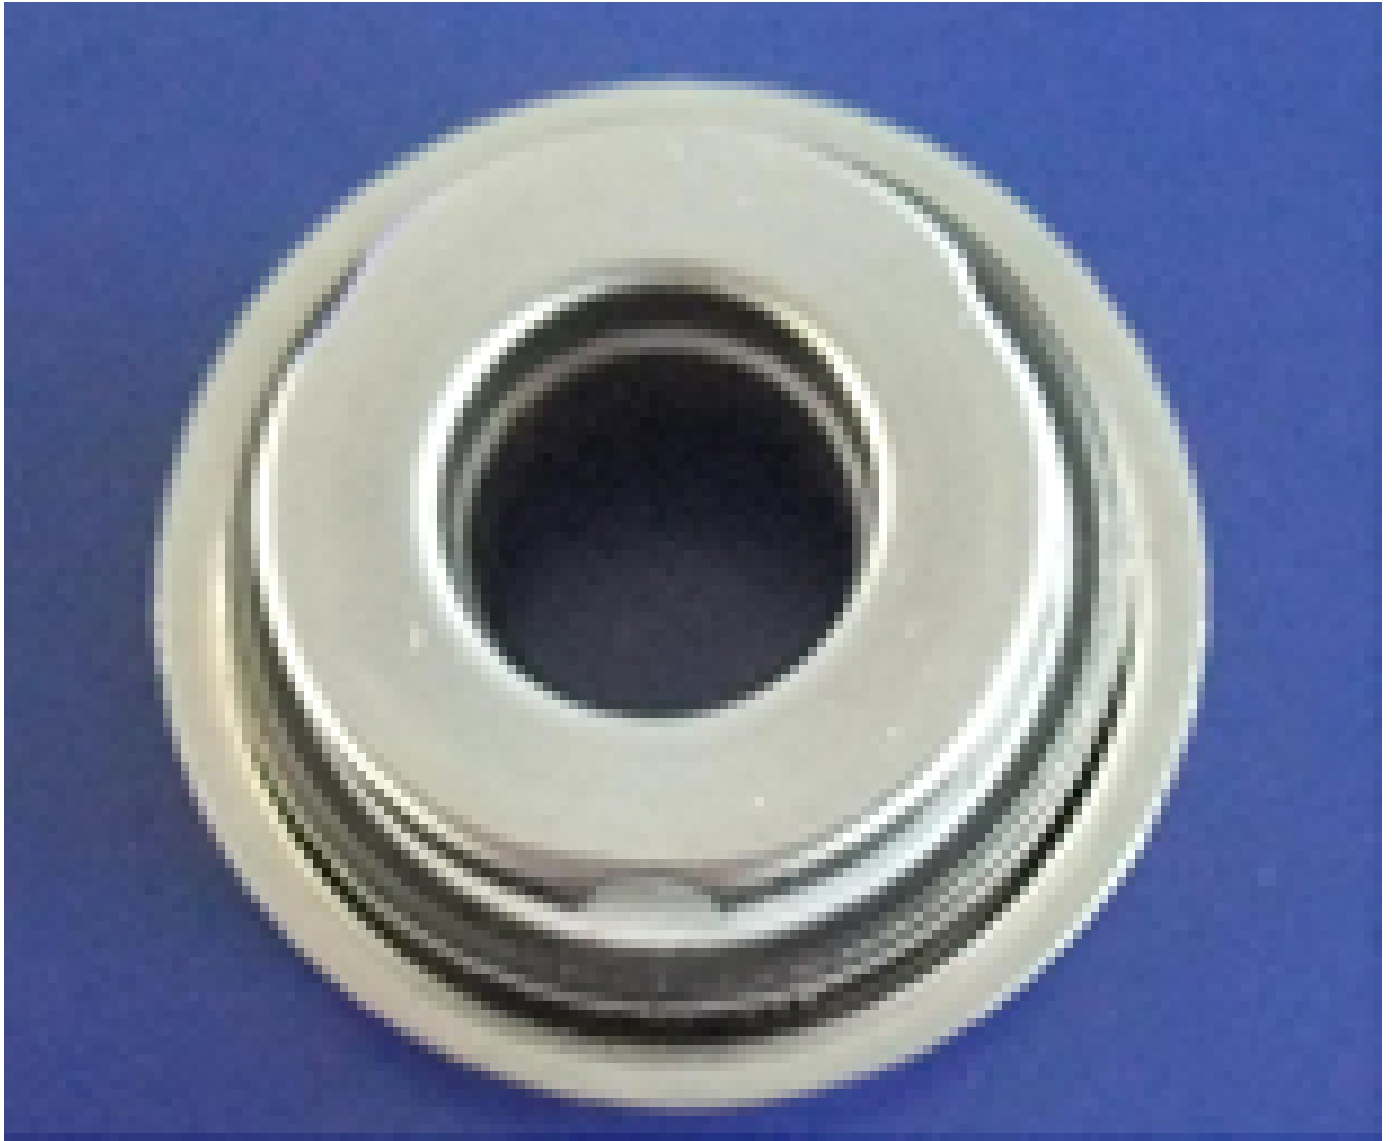
Figure 2

The mechanical seal (Figure 2) is always lubricated and cooled by the coolant. Due to the design, minimal amounts of coolant can enter the space behind the seal and exit at the relief hole of the pump. Traces of coolant that may be visible are no clear indication of a defective pump.
