# Electrical exhaust gas recirculation valve | HELLA

## Failure causes and troubleshooting

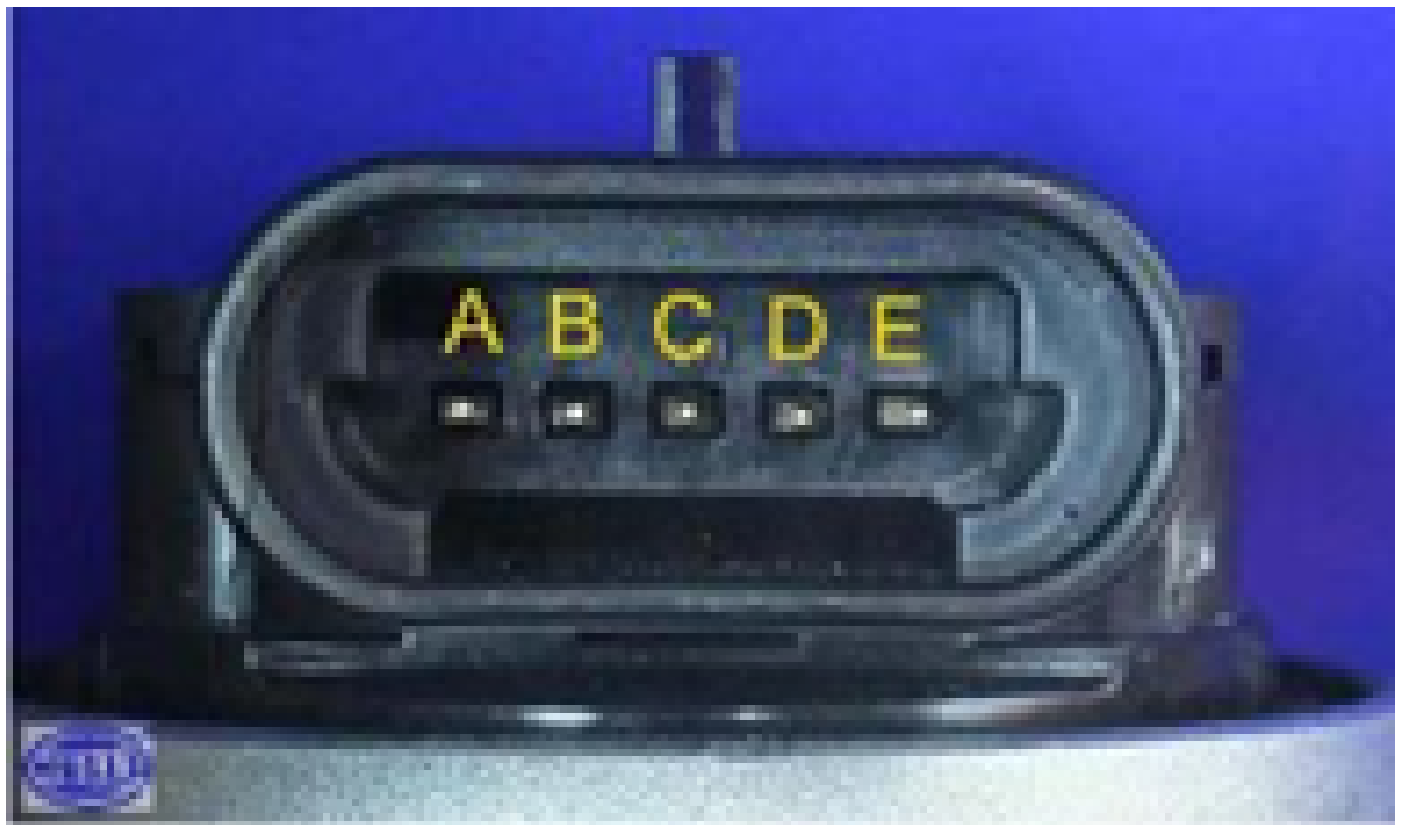
The resistance between the contact pins in the valve connector is measured at room temperature using a multimeter. Please always observe the information provided by the vehicle manufacturer when performing these tests.

Measurement:

1. connectors A and E = resistance 5.25 - 5.85  $\Omega$
2. connectors B and D = resistance 2.10 – 4.90 k $\Omega$
3. connectors B and C = resistance > 500  $\Omega$
