# Jeep Commander - Recirculation air flap malfunction | HELLA

**Model year: 2006**

**Recirculation air flap malfunction**

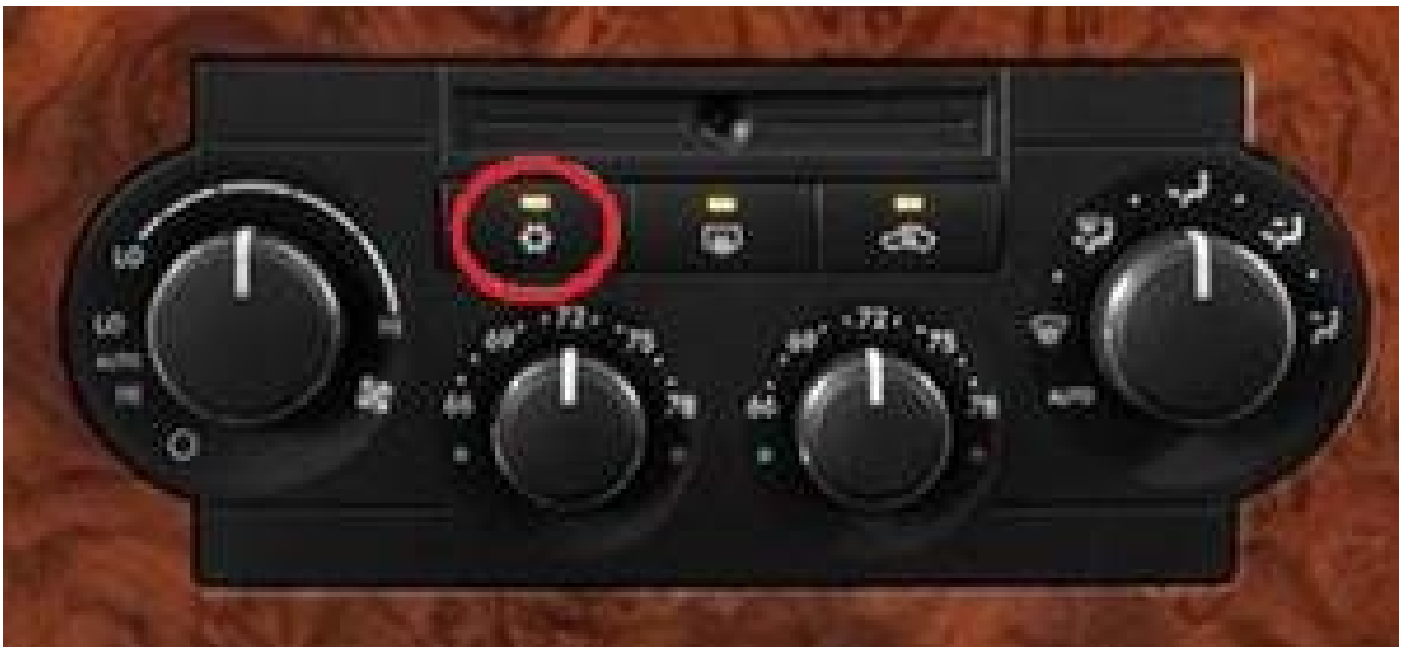
Figure

With the above vehicles the function indicator of the AC button (Figure) may suddenly start flashing at higher speeds. In addition, the recirculation air flap is repeatedly opened and closed, often noticeable by a squeaking noise.

In this case the fault should not be sought in the recirculation air system, but the flap control. Replacement of the control unit (Figure) can often rectify the problem.
