## Opel Astra-J Sports Tourer: display code 16

### Data sheet

| Symptom | Display code 16 |

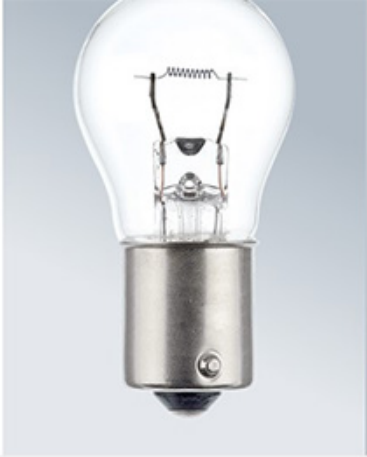
BREMSLEUCHTE

**P21W**

Fig. 3: P21W bulb

Replace P21W bulb ([Fig.3](#)). Check plug contacts for corrosion.
