# Opel Zafira B - Recirculation air flap malfunction | HELLA

### Zafira B

### Recirculation air flap malfunction

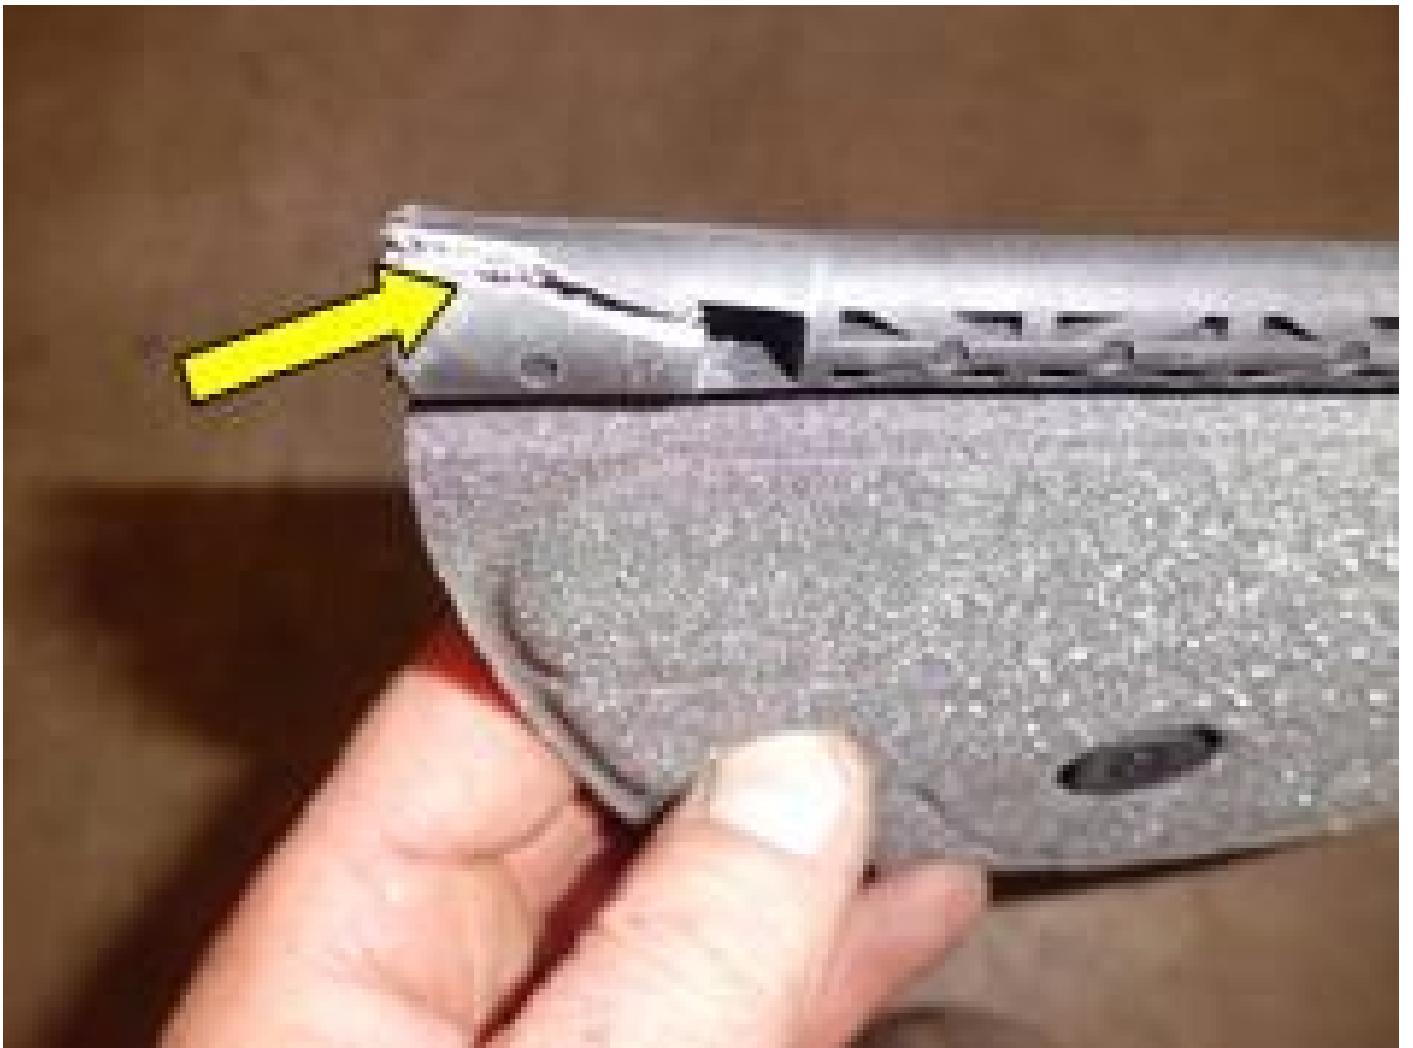
Figure 1

In the above vehicles, a damaged drive (Figure 1) between the recirculation air flap shaft and the recirculation air flap itself can lead to a malfunction.

This can be remedied using a repair kit (93196653; Figure 2). This method involves installing a modified recirculation air flap housing and replacing the short shaft in the flap motor with a longer variant.

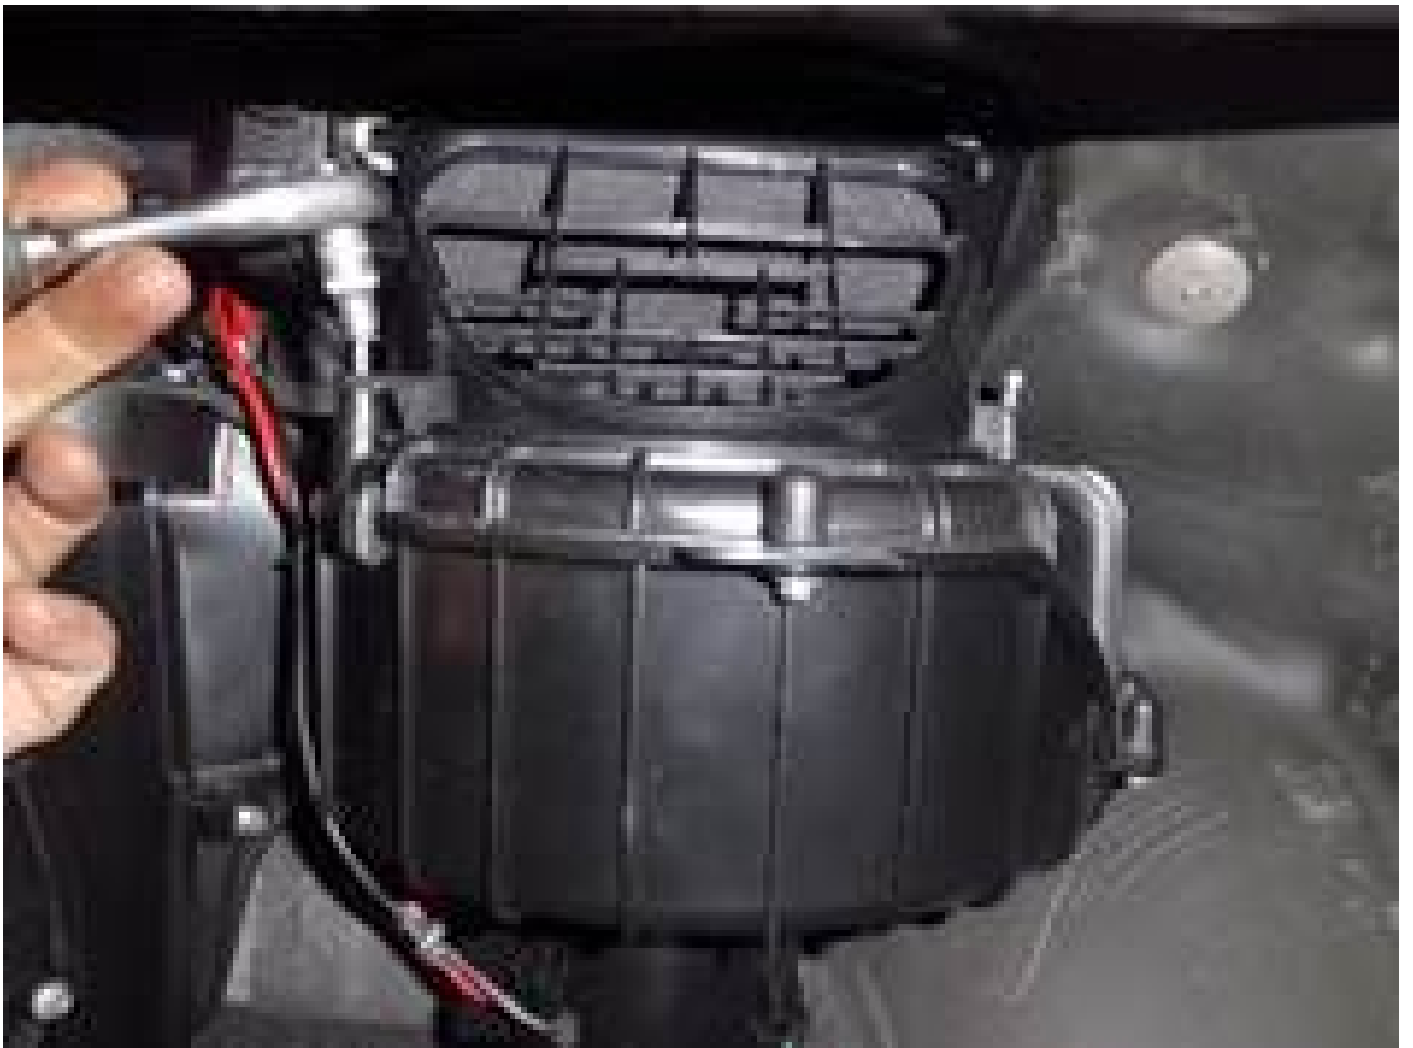
Figure 3

- Unscrew the fan motor from the recirculation air flap housing (Figure 3)
- Disconnect the recirculation air flap housing from inside the engine compartment
- Remove the housing
- Remove the recirculation air flap motor (Figure 4) from the old housing, together with the shaft
- Detach the short shaft and mount the long shaft from the repair kit (drawing)
- Mount the motor in the new housing, together with the shaft
- Install the recirculation air flap housing and fan motor
