# Coolant pumps | HELLA

## General

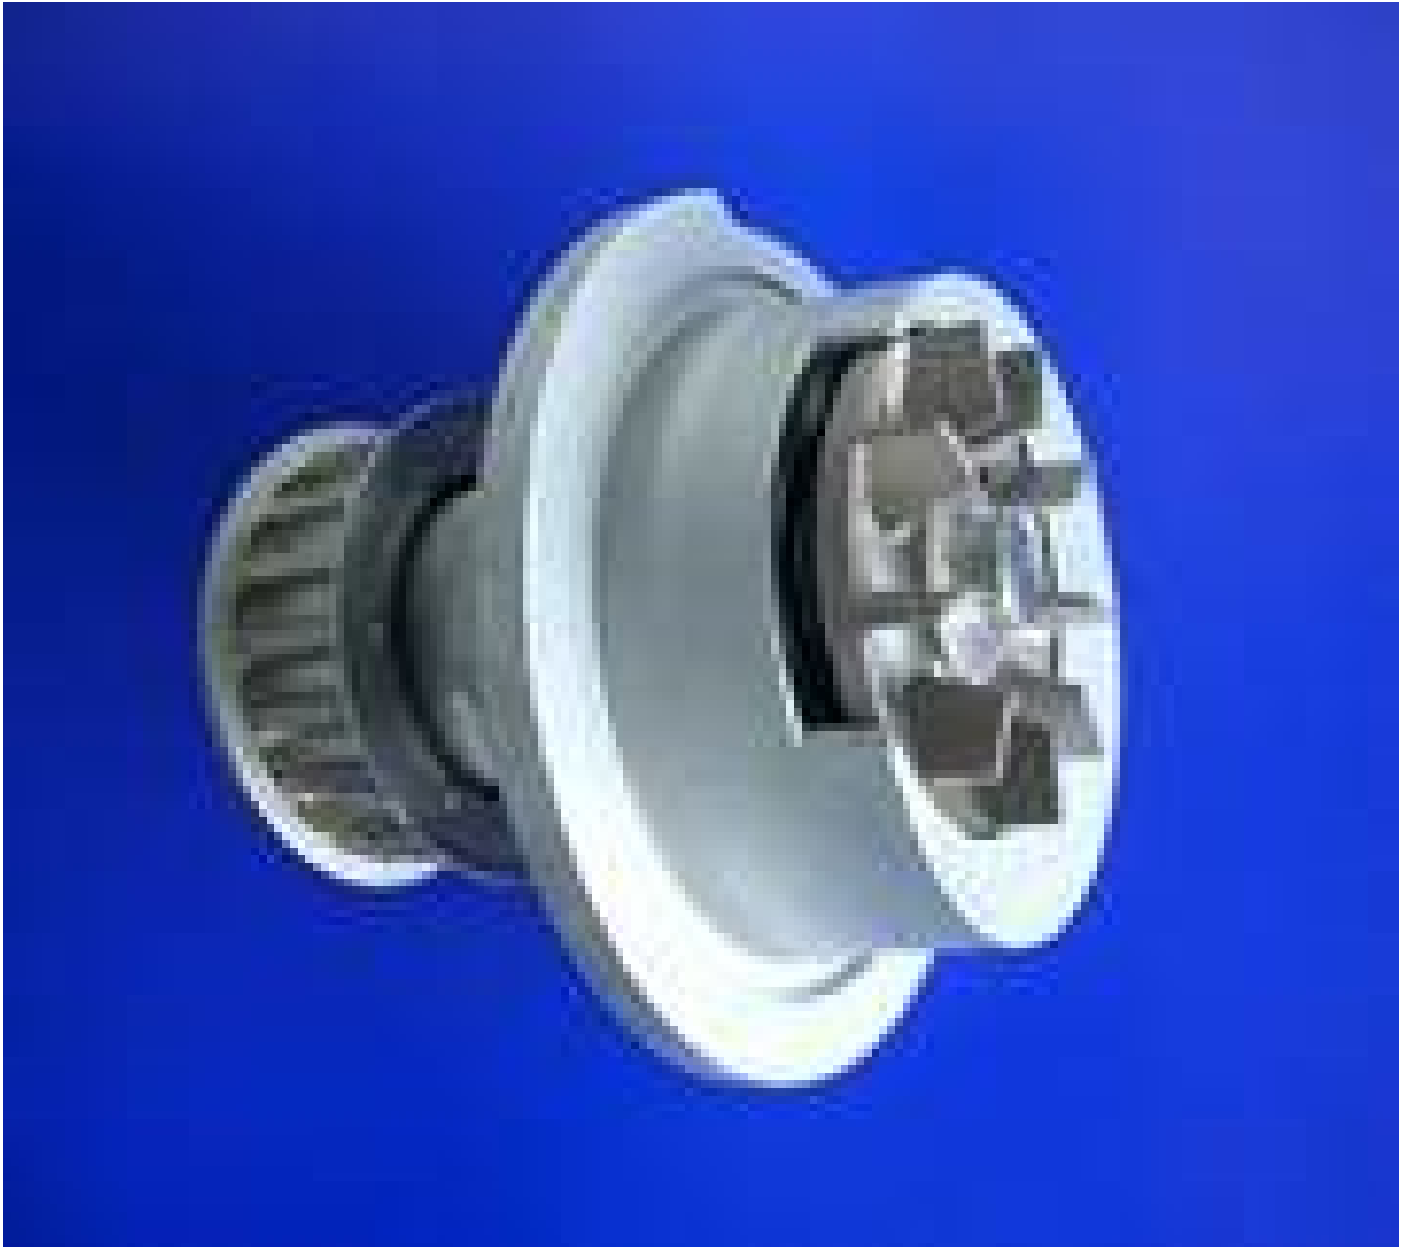
Figure 1

Coolant pumps (Figure 1) are mostly driven mechanically, by a toothed belt or V-ribbed belt, and transport the coolant through the engine's coolant circuit. The pumps can be flanged directly to the engine or also installed away from it. The designs are quite different. Coolant pumps must withstand huge variations in temperature (-40 °C to approx. +120 °C). Changing speeds (500 - 8000 rpm) and pressures of up to 3 bar require high stability of bearings and seals.

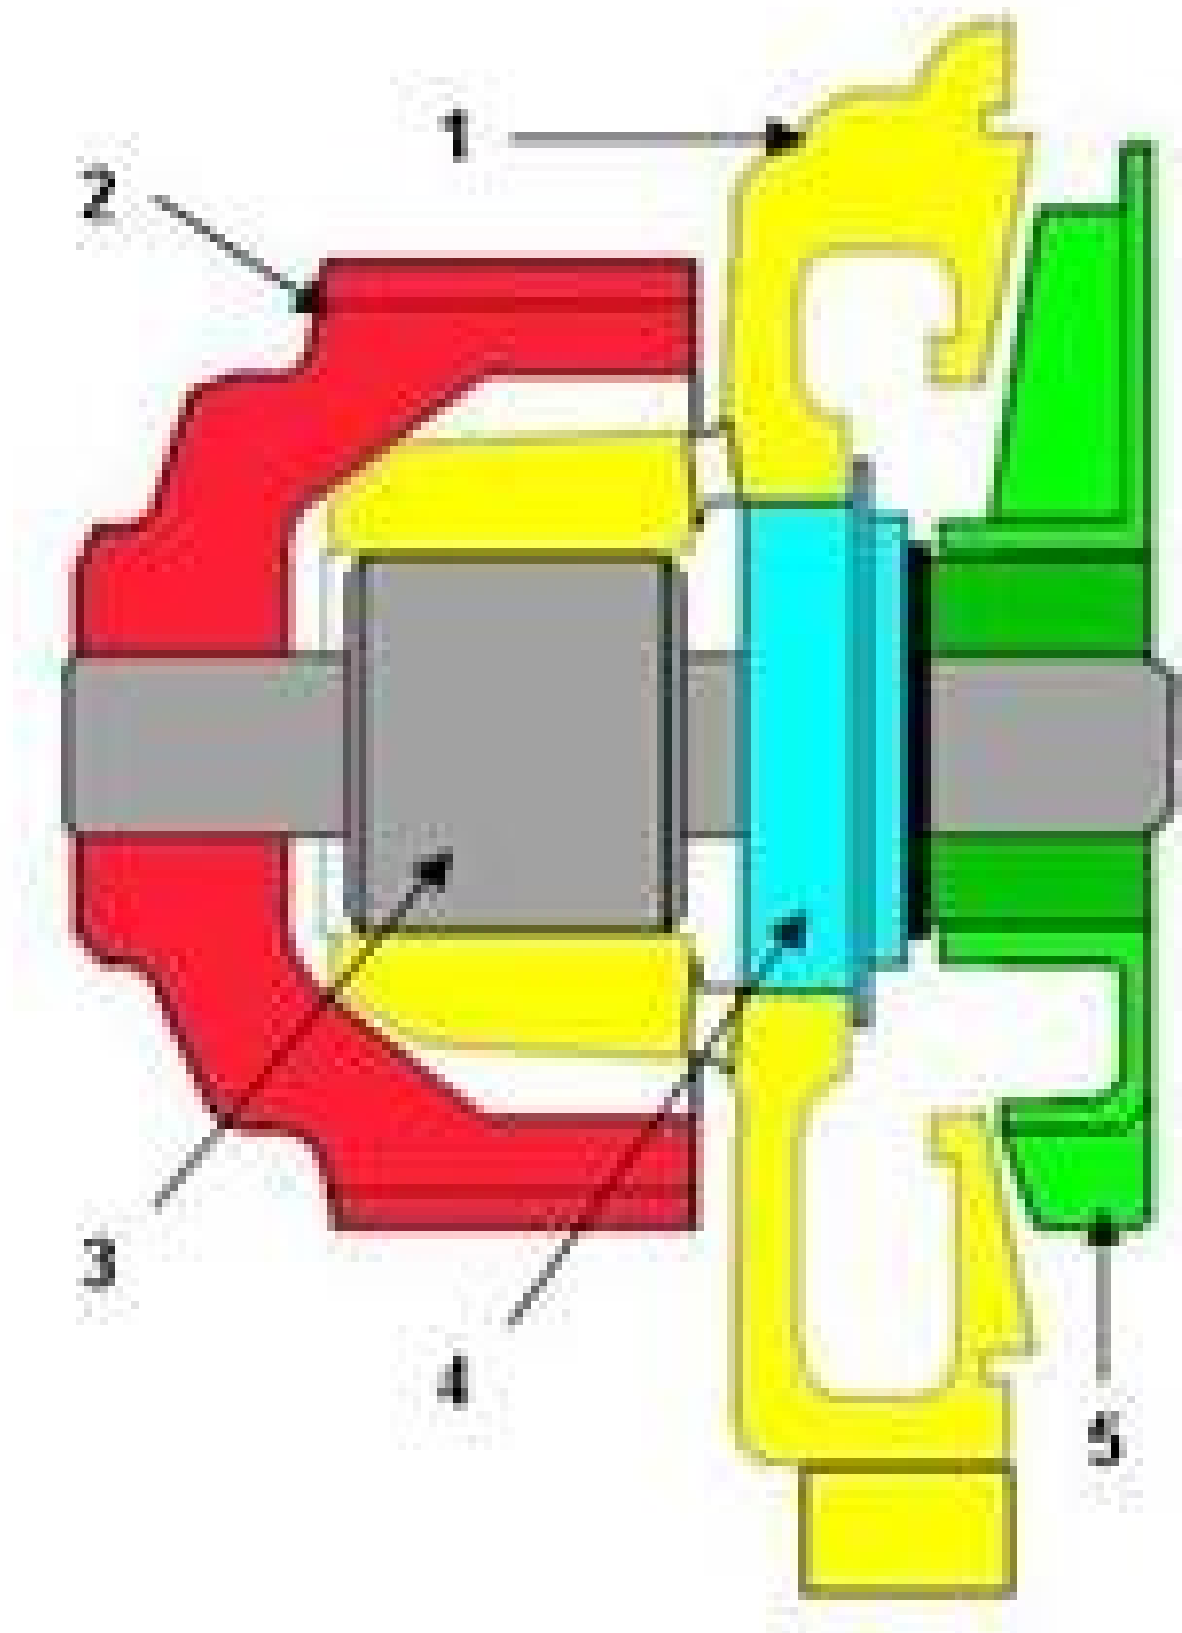
Drawing

A mechanical coolant pump consists of the following 5 sub-assemblies (drawing):

1. Body
2. Drive gear
3. Antifriction bearing
4. Mechanical seal
5. Vane

The drive gear and the vane sit on a common shaft. A mechanical seal seals off the pump shaft towards the outside. The rotation of the vane transports the coolant through the cooling system. Vanes are usually made of plastic or metal. The bearing load is lower with plastic vanes. At the same time, they are not as susceptible to cavitation.

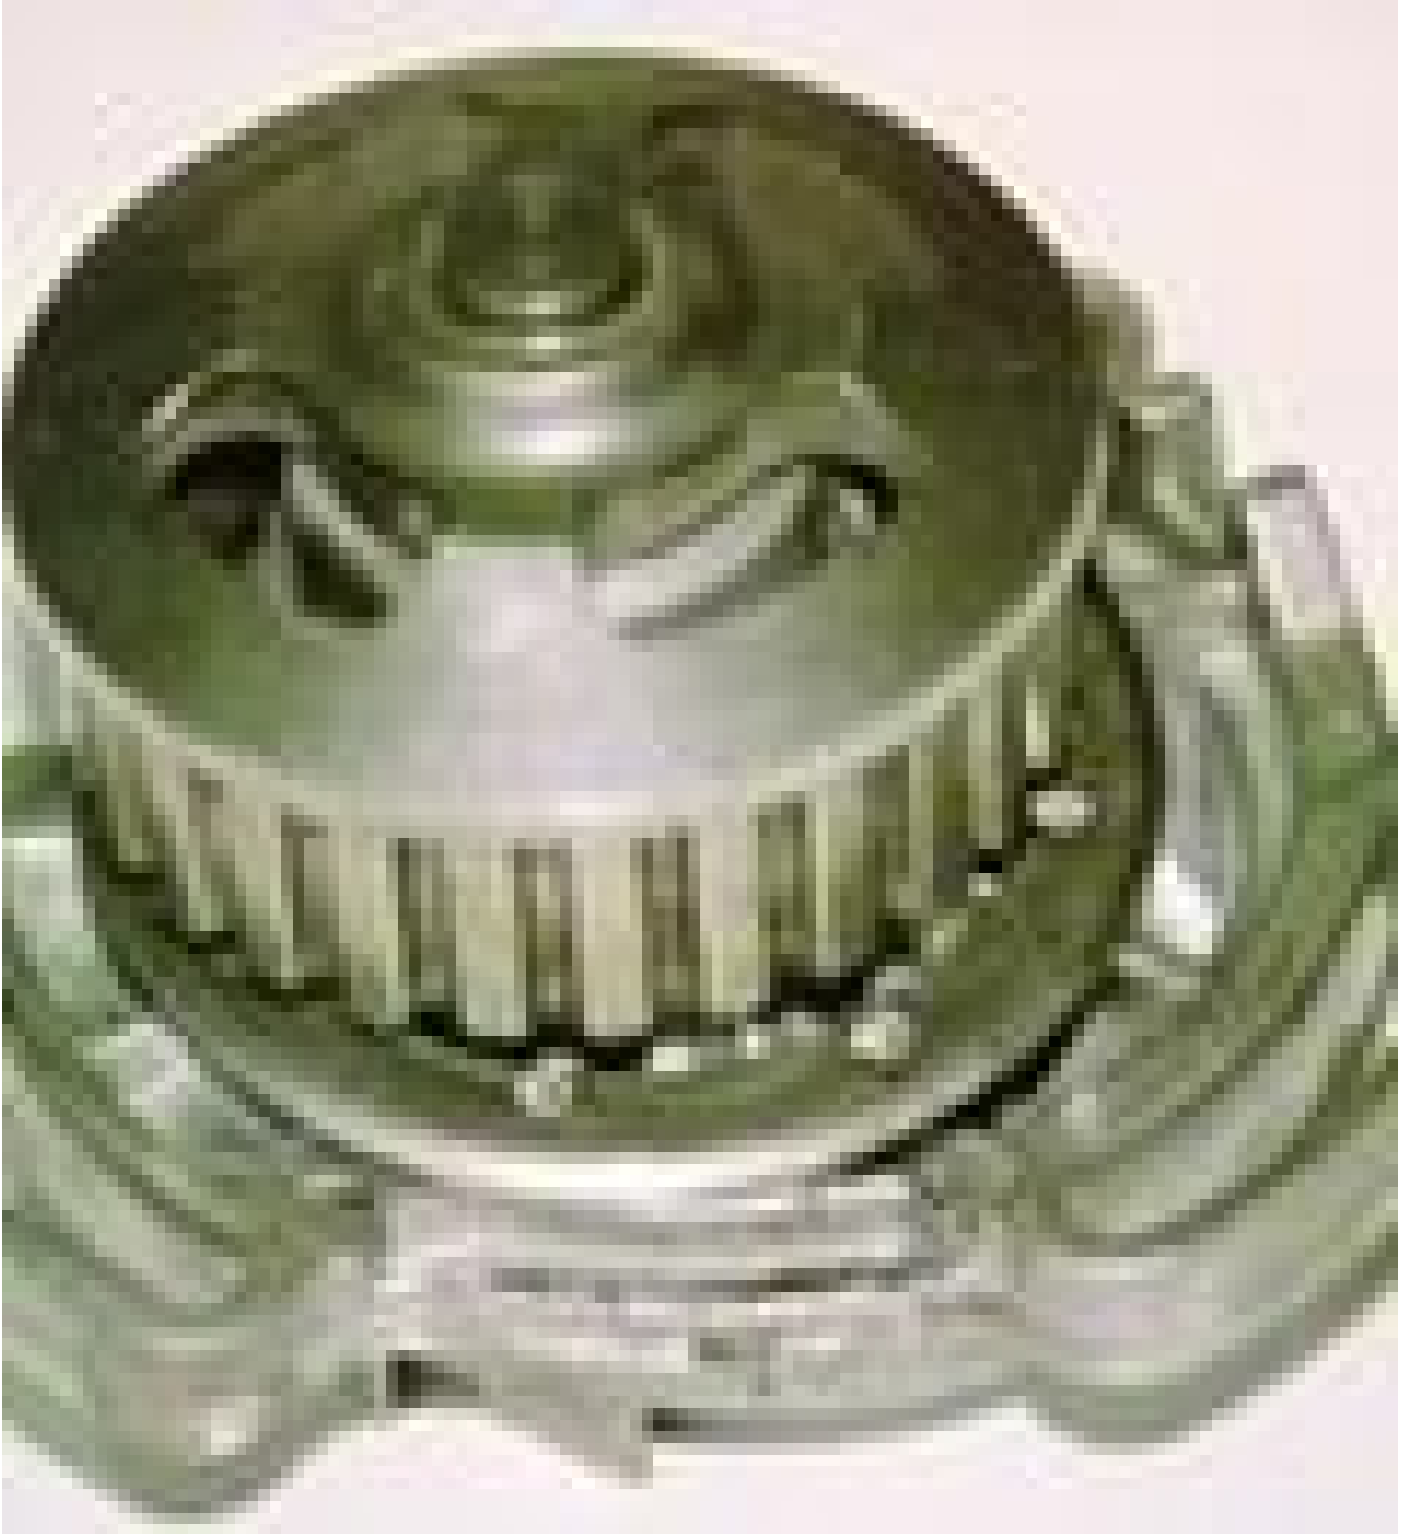
Bild 4

Drive gear damaged (loose drive gear ring), Figure 4:

- tension of the control belt too high

- Misalignment of the belt

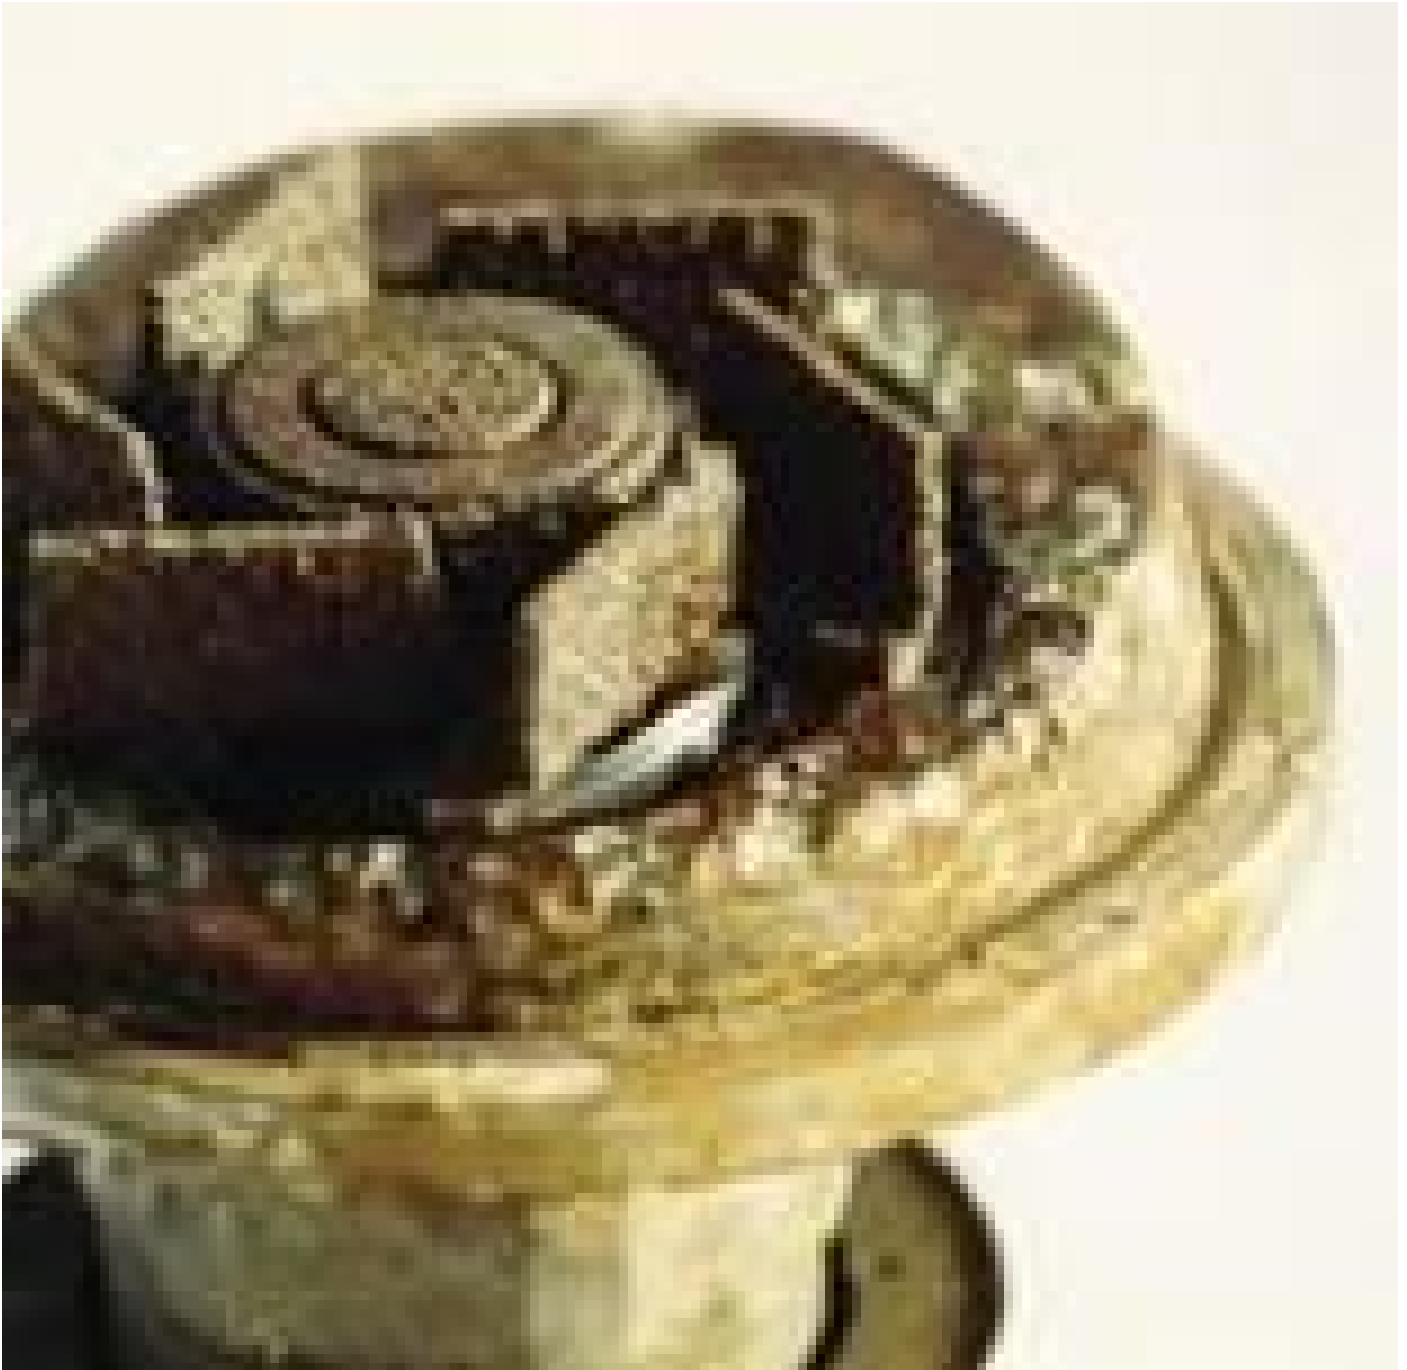
Bild 7

Pump parts such as vane, body, mechanical seal and shaft severely damaged by hole corrosion (Figure 7):

- Old/stale coolant with high content of chlorides (salt compounds) in conjunction with elevated temperatures.
