# Mazda CX5 - Alternator control lamp comes on

| Data sheet | |
|---|---|
| Vehicle model | CX 5 (KE) |
| Engine code | 2.2 16V CDI Skyactiv-D |

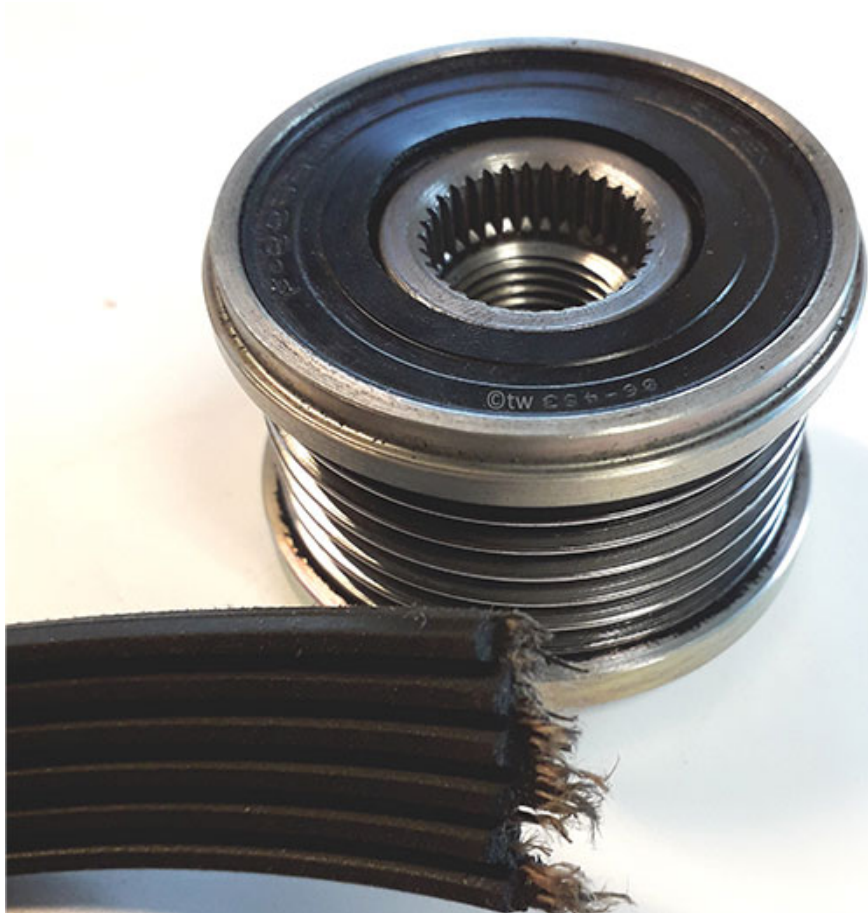
After opening the bonnet and the carrying out of a visual inspection, a damaged V-ribbed belt was immediately diagnosed as the cause. After more troubleshooting, pronounced rubber abrasion on the alternator's belt pulley was detected, which could ultimately be traced back to a defective overrunning alternator pulley.

A stuck overrunning alternator pulley leads to load change reactions on the belt drive and can lead to damage or, as in our case, to a tear in the V-ribbed belt.

Defective overrunning alternator pulley with torn V-ribbed belt

In the case of this engine variant, the water pump is also driven by the V-belt. Continuing to drive with a defective V-ribbed belt can lead to overheating and engine damage. After the repair, the relevant error memory entries in the control units must be deleted.

The overrunning alternator pulley, also called the alternator freewheel, must be checked regularly to ensure the functioning of the accessory drive and to avoid damage. A defective freewheel is noticeable as a result of an unsteady rotation of the accessory drive unit and the resulting noise. An alternator with an intact freewheel should come to a delayed stop when the engine is switched off.
