# Vauxhall Astra H - Condenser damaged and leaking | HELLA

Astra H

Model year: 2002 - 2009

## Condenser damaged and leaking

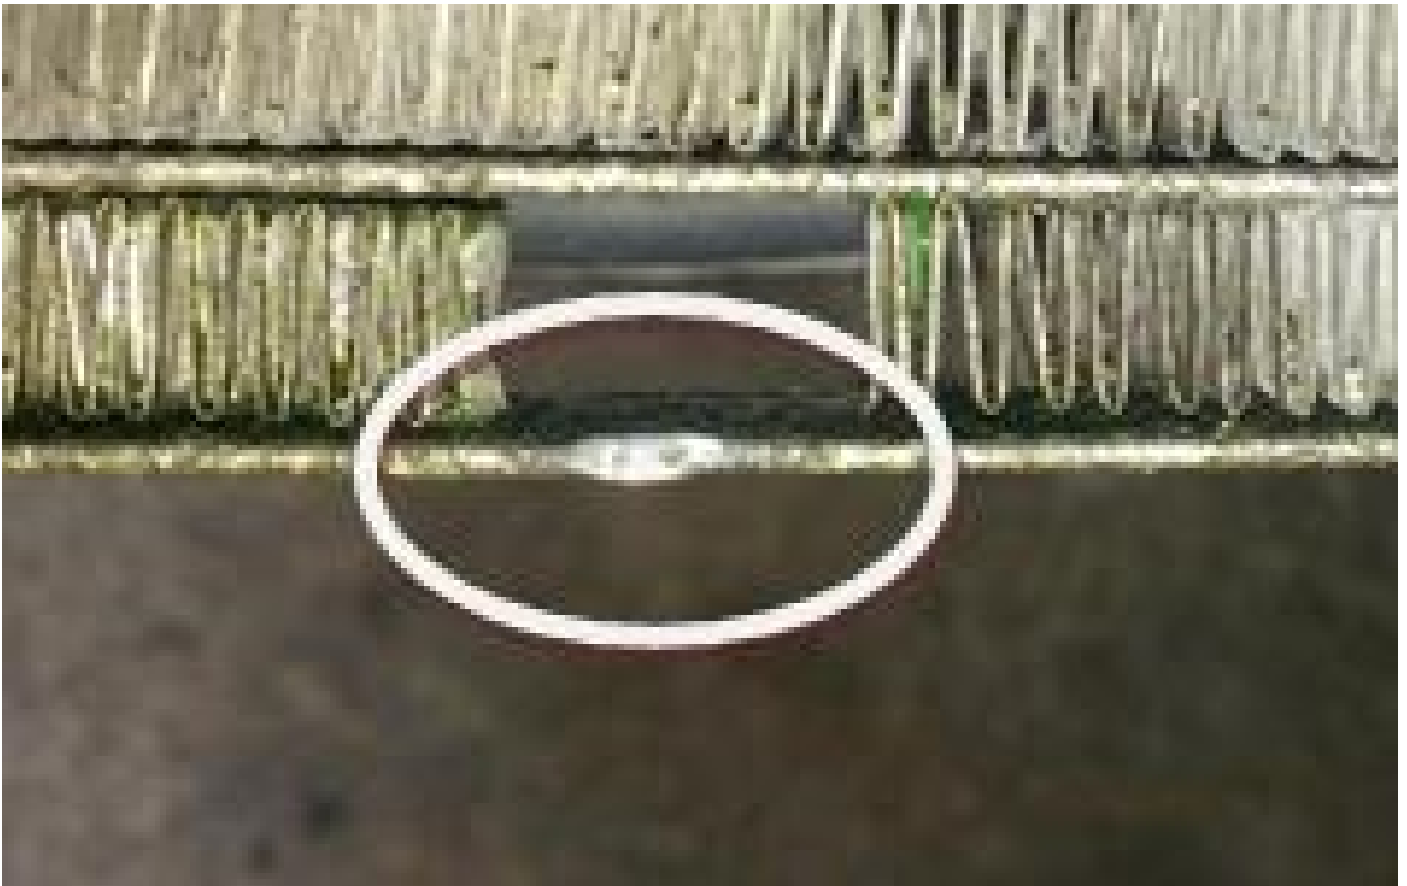
Figure 1

Failure of the fins can cause instability in the condenser network. Vibrations can cause contact with other components. This will damage the condenser (Figure 1) and, in some cases, cause it to leak.

If refrigerant loss is observed on one of the vehicles listed above, special attention should be paid to the condenser.
