# Volkswagen T5 - Problem of active cooling car windows fog up | HELLA

**T5**

**with automatic air conditioning and air quality sensor**

Problem of active cooling car windows fog up

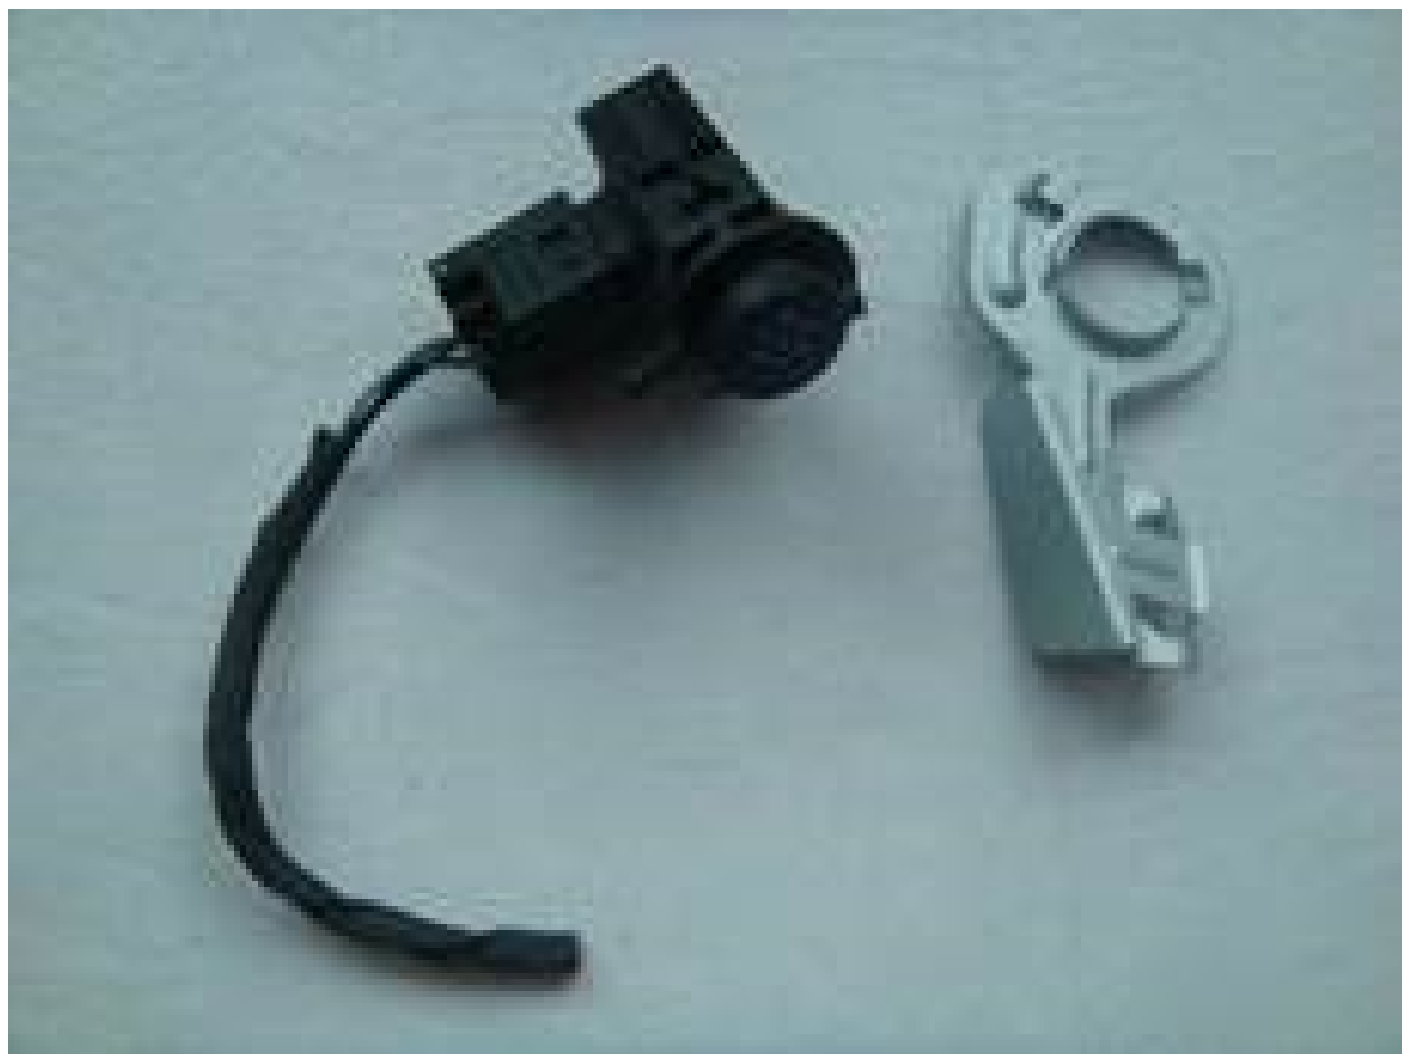
Air quality sensor (figure).

In the VW T5 vehicle type, model year 2004, the problem of fogged windows may be caused by a faulty evaluation function of the air quality sensor.

The built-in evaluation electronics in the sensor module responds to changes in the conductivity of the sensor.

Due to the design, the function or the evaluation of the air quality sensor may be affected by the influence of spray or drip water in this type of vehicle. (The air quality sensor is located below the windshield in the region of the fresh air intake.)

Check the function of the air quality sensor

Check the fuse 22

Install a spray and drip water deflector for the sensor.
