# **BMW 5 Series (G30/G31)/7 Series (G11/G12) - Stop light permanently illuminated | HELLA**

**5 Series (G30/G31)/7 Series (G11/G12)**

## **Stop light permanently illuminated**

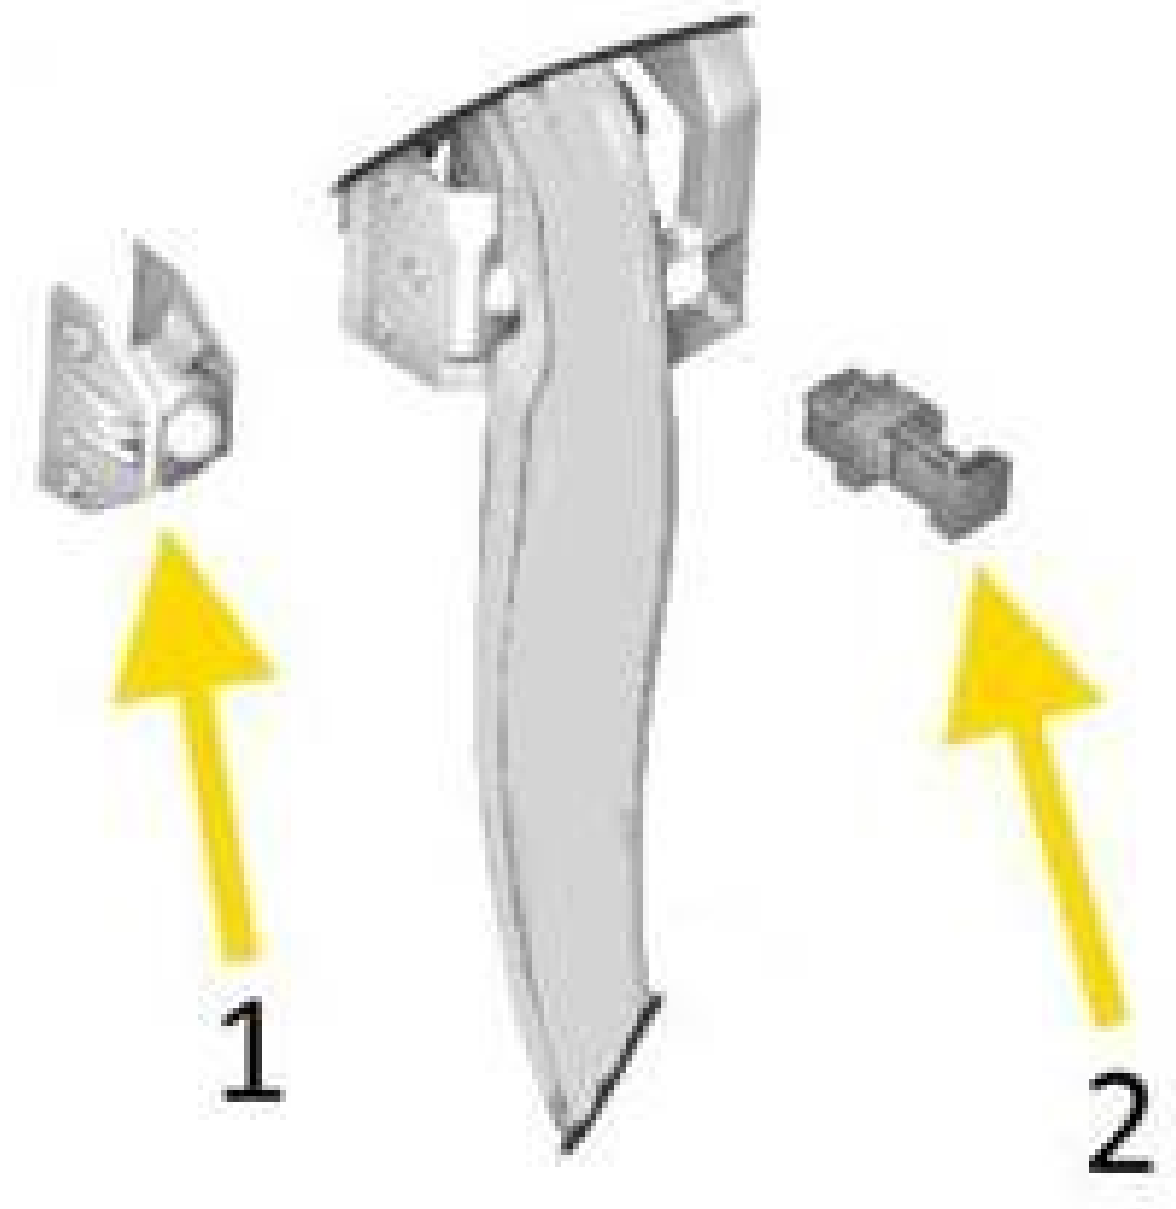
If the problem described above is determined, the cause could be a faulty ball head on the brake pedal.

If the driver accidentally raises the brake pedal, the stop-lamp switch (Item 2 on image) can be switched to permanently actuated due to a faulty ball head (Item 1 on image).

This can lead to the brake light being permanently illuminated.

In an authorized specialist garage check the foot lever (brake pedal) and completely replace in accordance with the manufacturer's specifications, if necessary.
