Kia Sportage - poor air-conditioning performance

Manufacturer	Kia
Vehicle model	Sportage (SL)
Year of manufacture	2010 - 08.2014
Symptoms	Poor air-conditioning performance

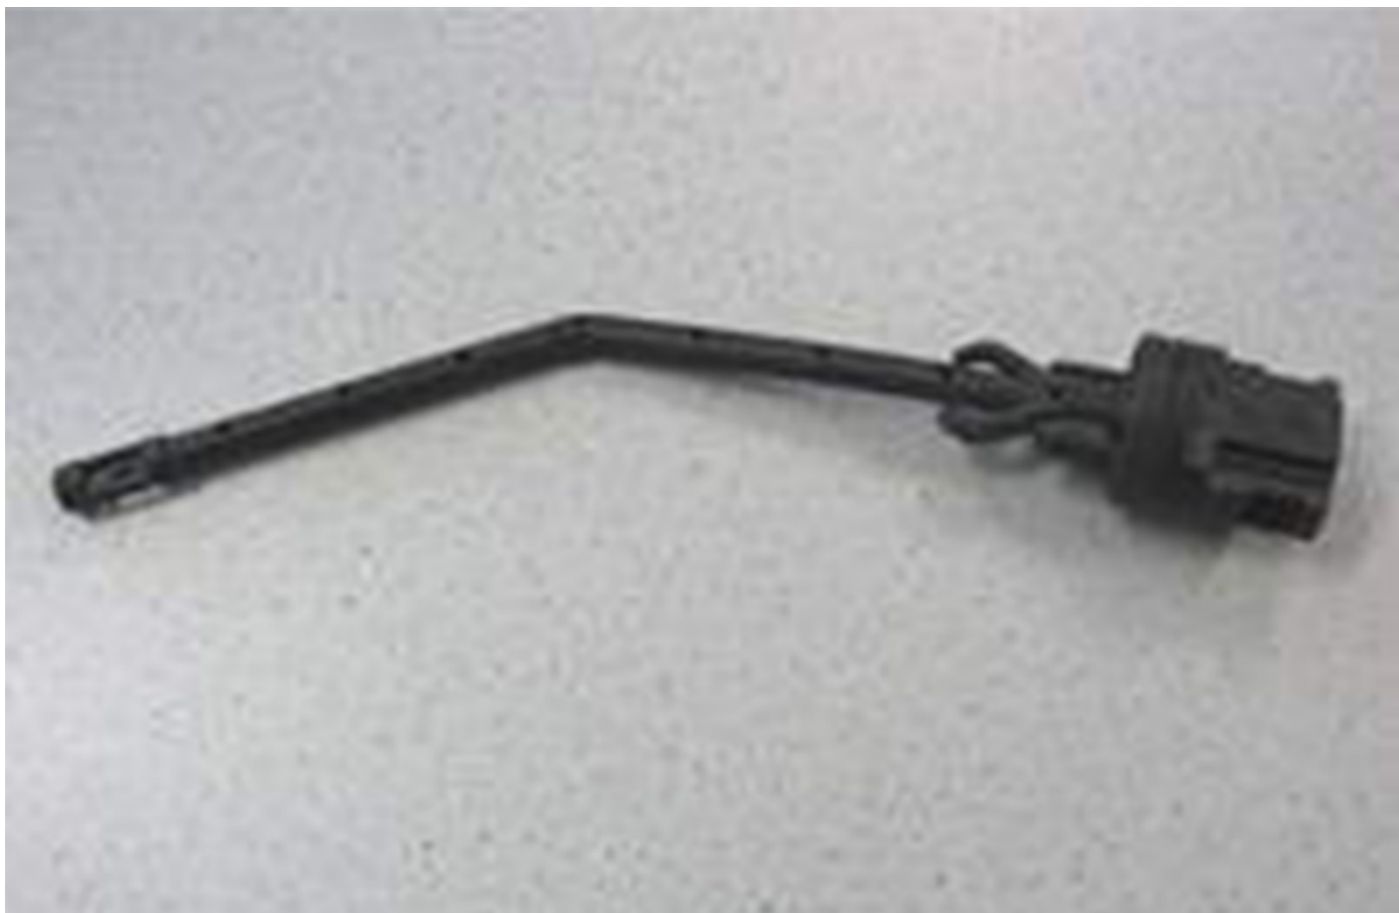
If the performance of the air-conditioning system is inadequate when outside temperatures are high, a faulty evaporator temperature sensor (see illustration example) may be the cause. Incorrectly measured values can cause the evaporator to freeze and block the air flow.

The temperature sensor is located in the upper right-hand corner of the driver's footwell. In order to access this, the cover/panelling has to be removed.

Before replacing the sensor, the air-conditioning system should be checked for correct filling quantity, pressures and other possible causes of failure (passenger-compartment air filter, condenser, radiator).

With the help of a diagnostic device, the error memory can be read out and the measured values of the evaporator temperature sensor can be checked.
