# Vauxhall Zafira C - Loss of coolant | HELLA

**Zafira C**

**Engine: A20DT/A20DTH/A20DTJ/A20DTR/A20DTL**

**Loss of coolant**

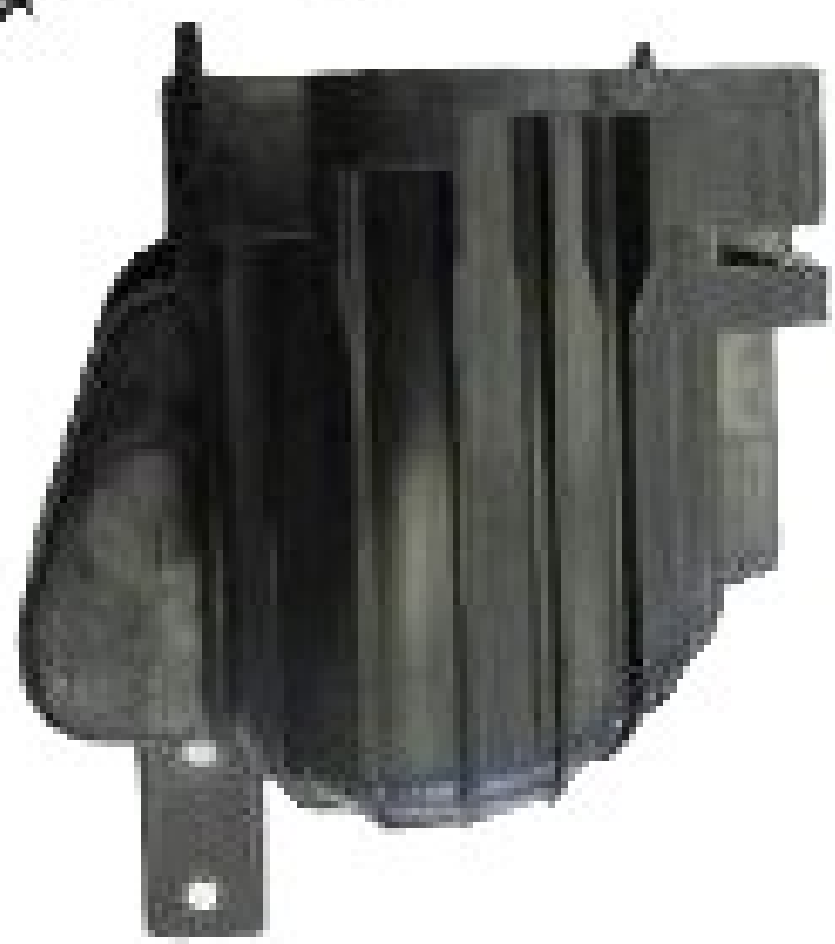
The above vehicles can experience a loss of coolant near the exhaust gas recirculation cooler (EGR cooler). When examining the cooling system, special attention should be paid to the housing of the EGR cooler. A crack can form that leads to a loss of coolant.

To remedy the situation, proceed as follows and use a repair kit (picture) comprising a housing, 2 gaskets, and 2 clips:

- Allow the engine to cool down
- Remove the EGR cooler housing (collect coolant in a drip pan)
- Remove EGR cooler from the housing
- Clean sealing surfaces

Use repair kit (part no.: 55590953):

- Fit EGR cooler in new housing
- Install cooler housing with the new gaskets
- Add coolant
- Bleed cooling system
- Inspect gaskets for tight fit
