## VW T5 - coolant thermostat

## Operating temperature is not reached, thermostat and coolant flange

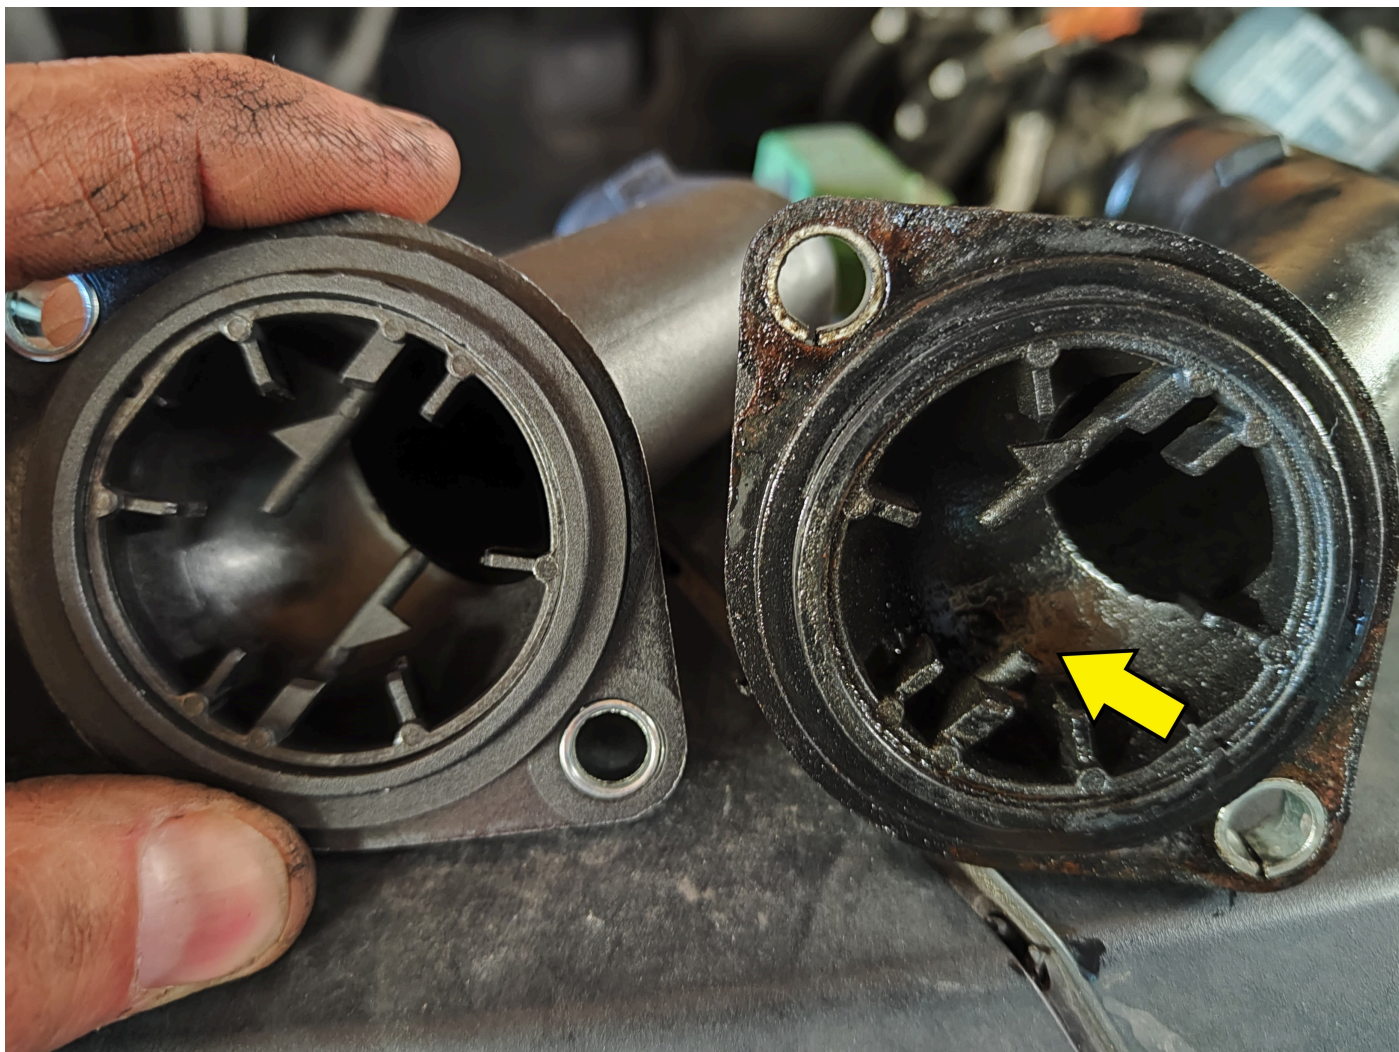
Part of the plastic guide (installation aid) often breaks off here.

Plastic guide for T5 coolant flange

It is then advisable to replace the flange.
