# Electrical exhaust gas recirculation valve | HELLA

## Failure causes and troubleshooting

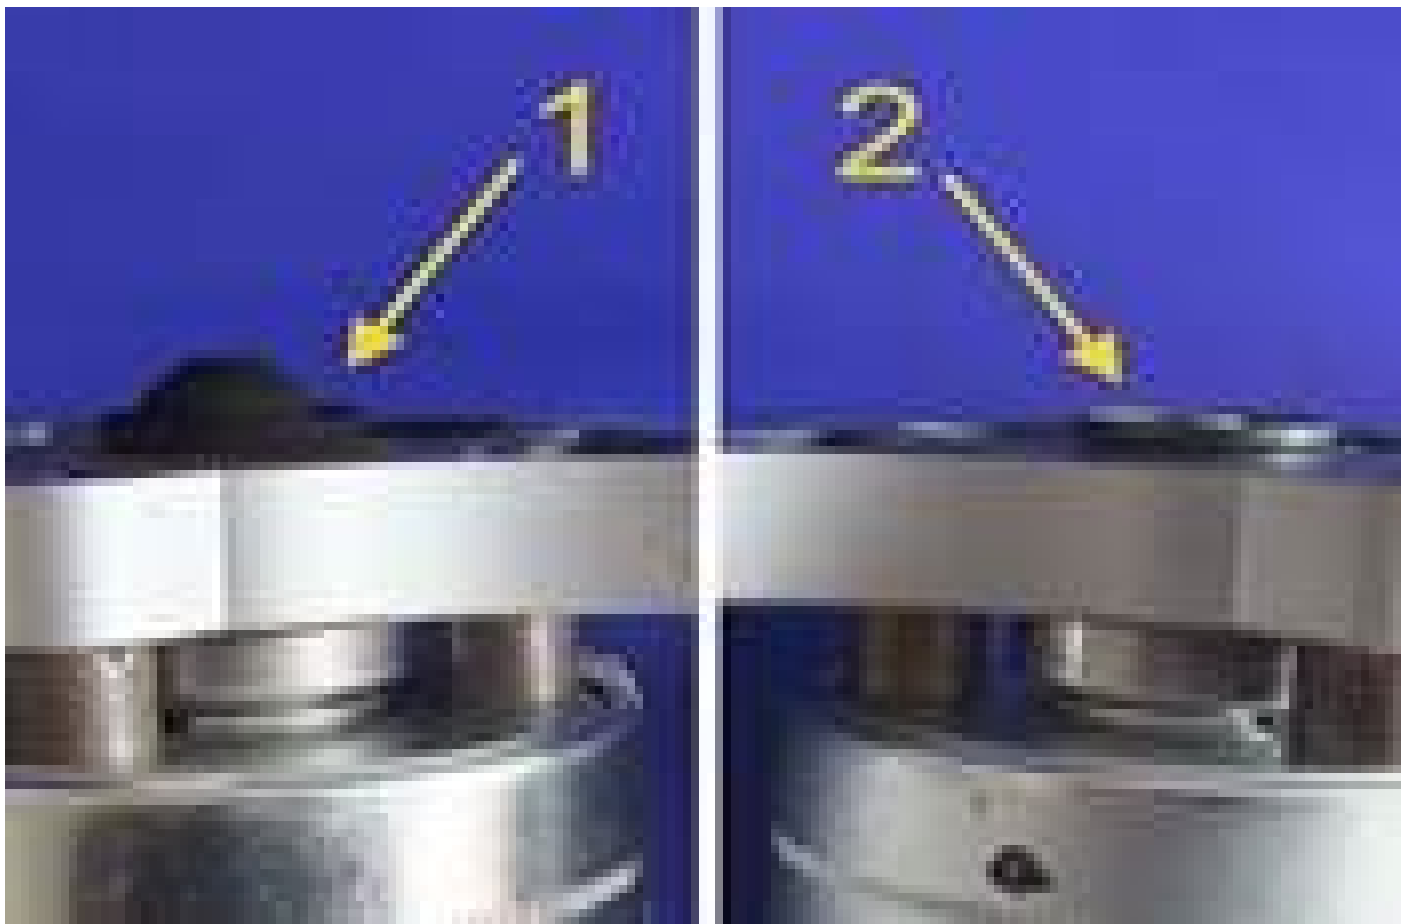
As can clearly be seen in the image, the contaminated EGR valve (1) is already open in de-energized state.

The new valve closes perfectly at the pintle (2).
