# BMW 530d GT F07 - driving dynamics control failure

## Communication fault in the driving dynamics control unit

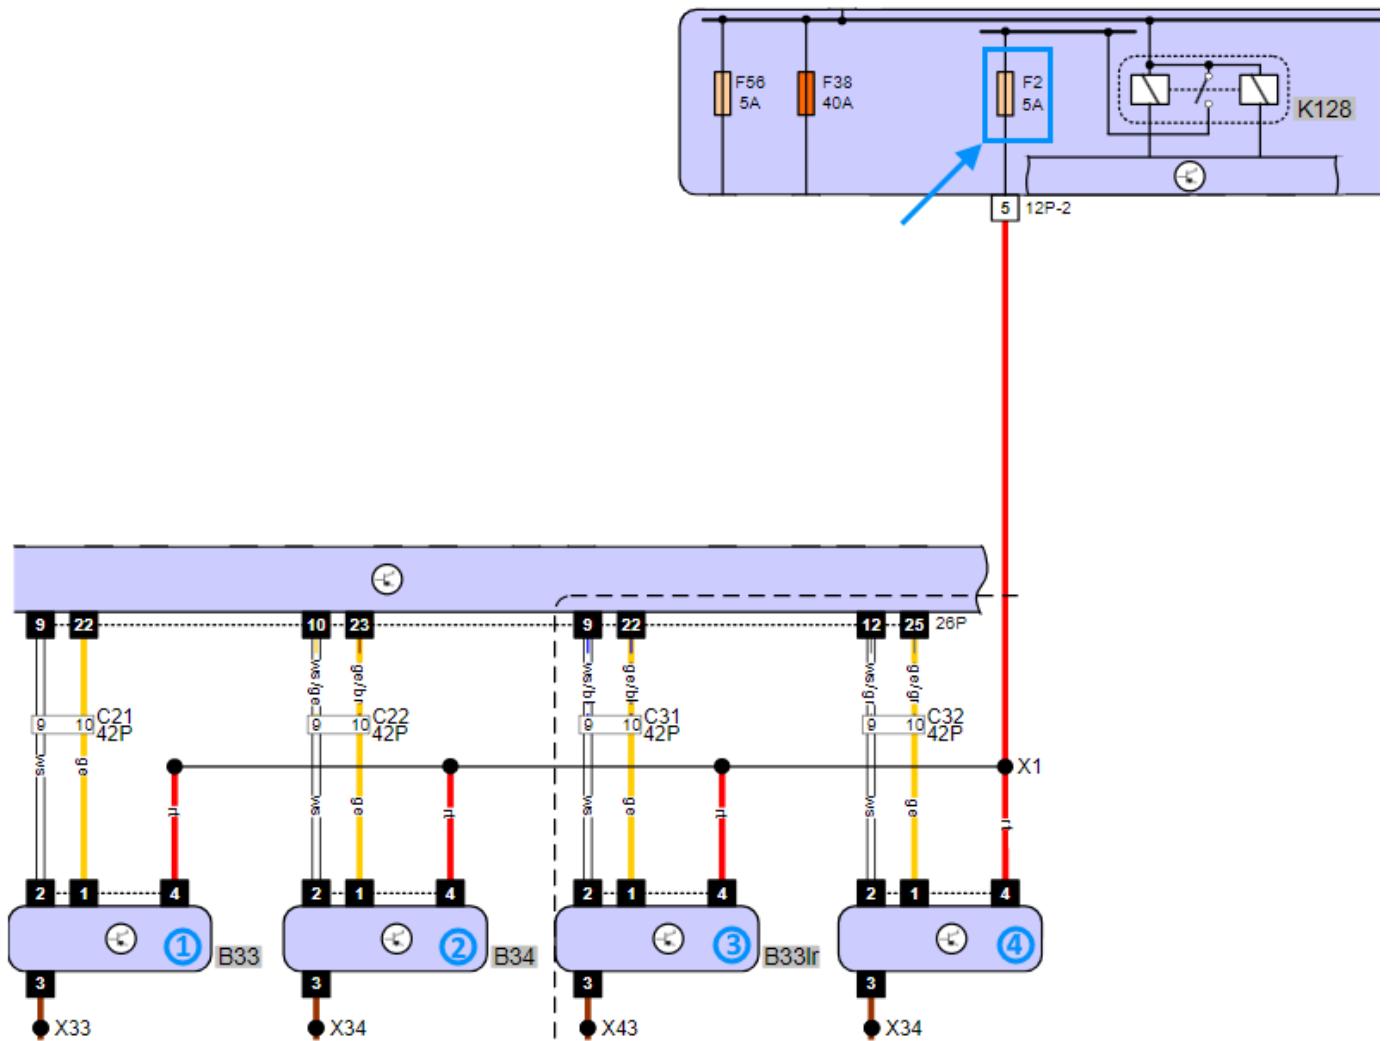
Caption of circuit diagram: 1-4 = Door handle electronics

Water ingress into the door handle and the resulting corrosion on the plug connections can cause short circuits. This triggers fuse F2 (5A). To check, the door handles must be dismantled in accordance with the manufacturer's instructions.

If corrosion or water ingress is visible at the plug connections, the affected door handle electronics must be replaced and the plug connections repaired if necessary.

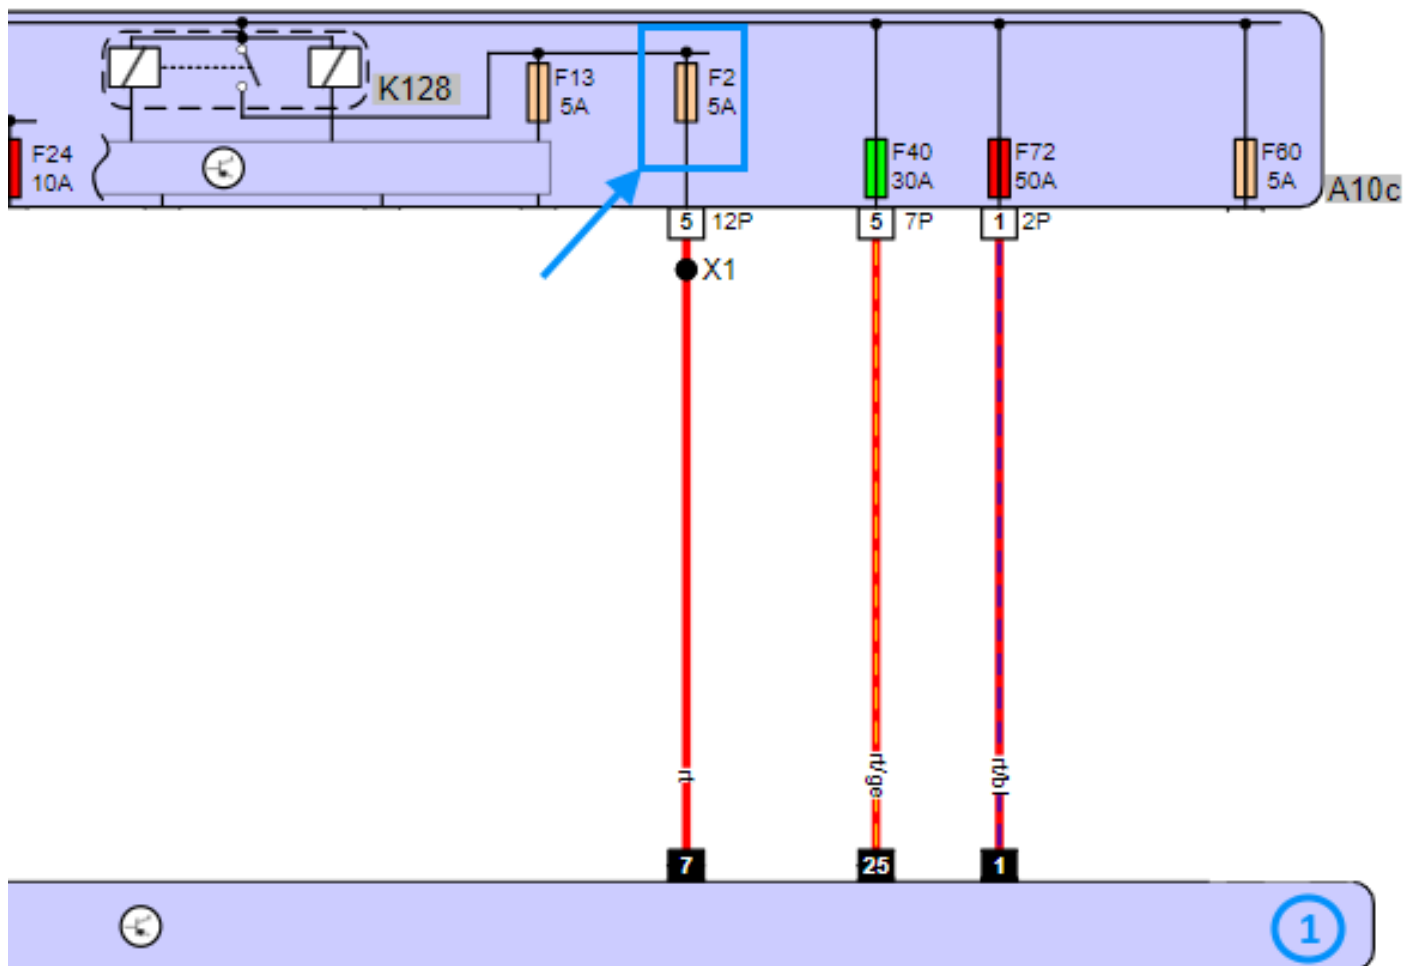
Caption of circuit diagram: 1 = Driving dynamics control unit

With the above vehicle type, the warning lamp for the driving dynamics control system in the instrument cluster may light up. The control unit diagnostics has detected that communication with the control unit of the driving dynamics control has been disrupted. It is no longer possible to read out the fault memory of this control unit.
