# VW Beetle - non-functioning parking aid

## Data sheet

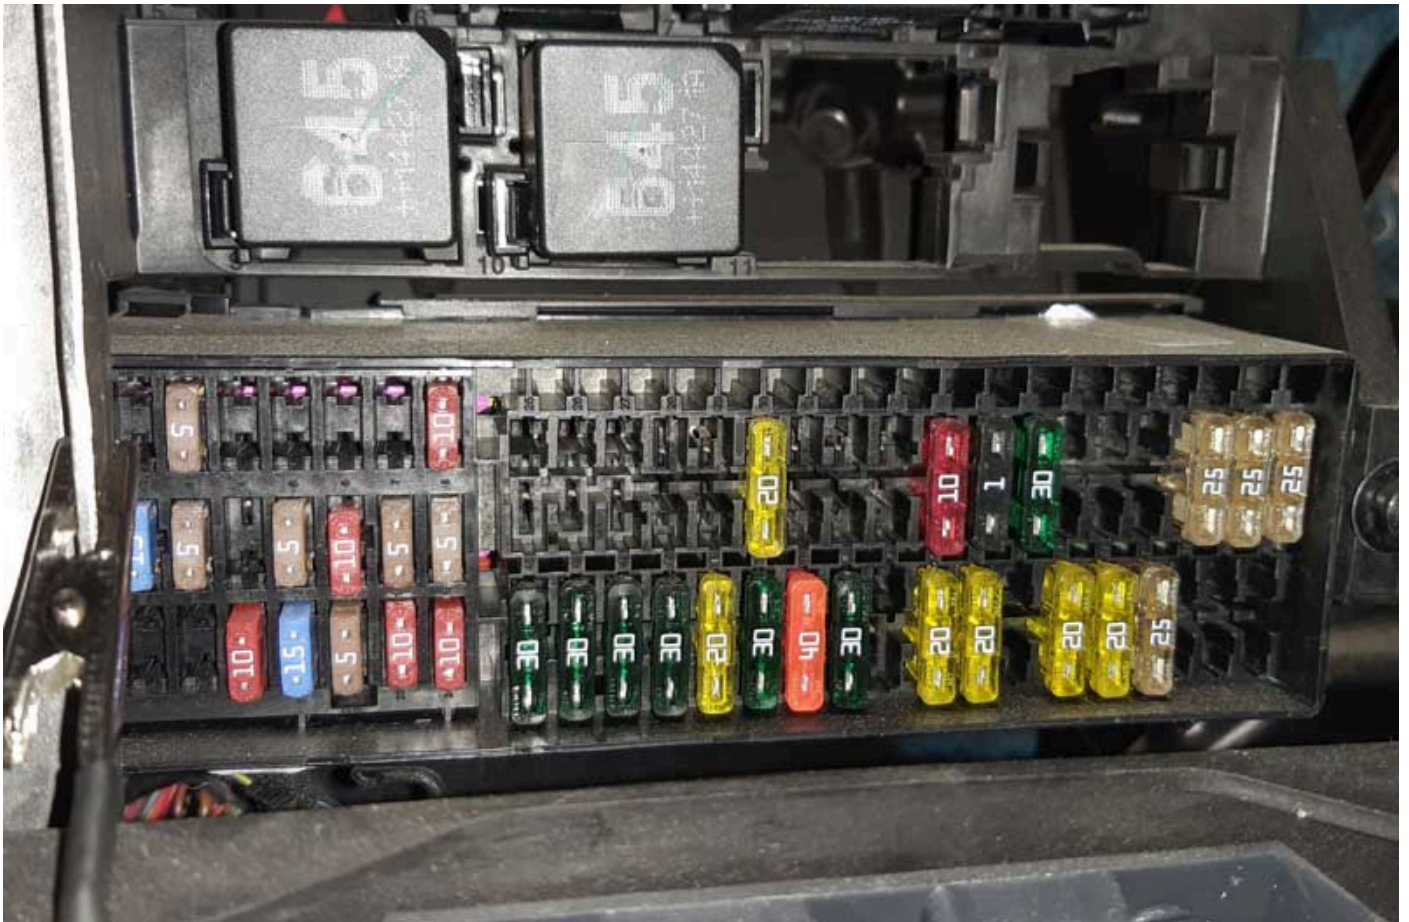
In this case, the cause is not necessarily to be found with the software or with the electronic components. The first thing to do is to check the fuses in the fuse box located in the driver's footwell (Fig. 1).

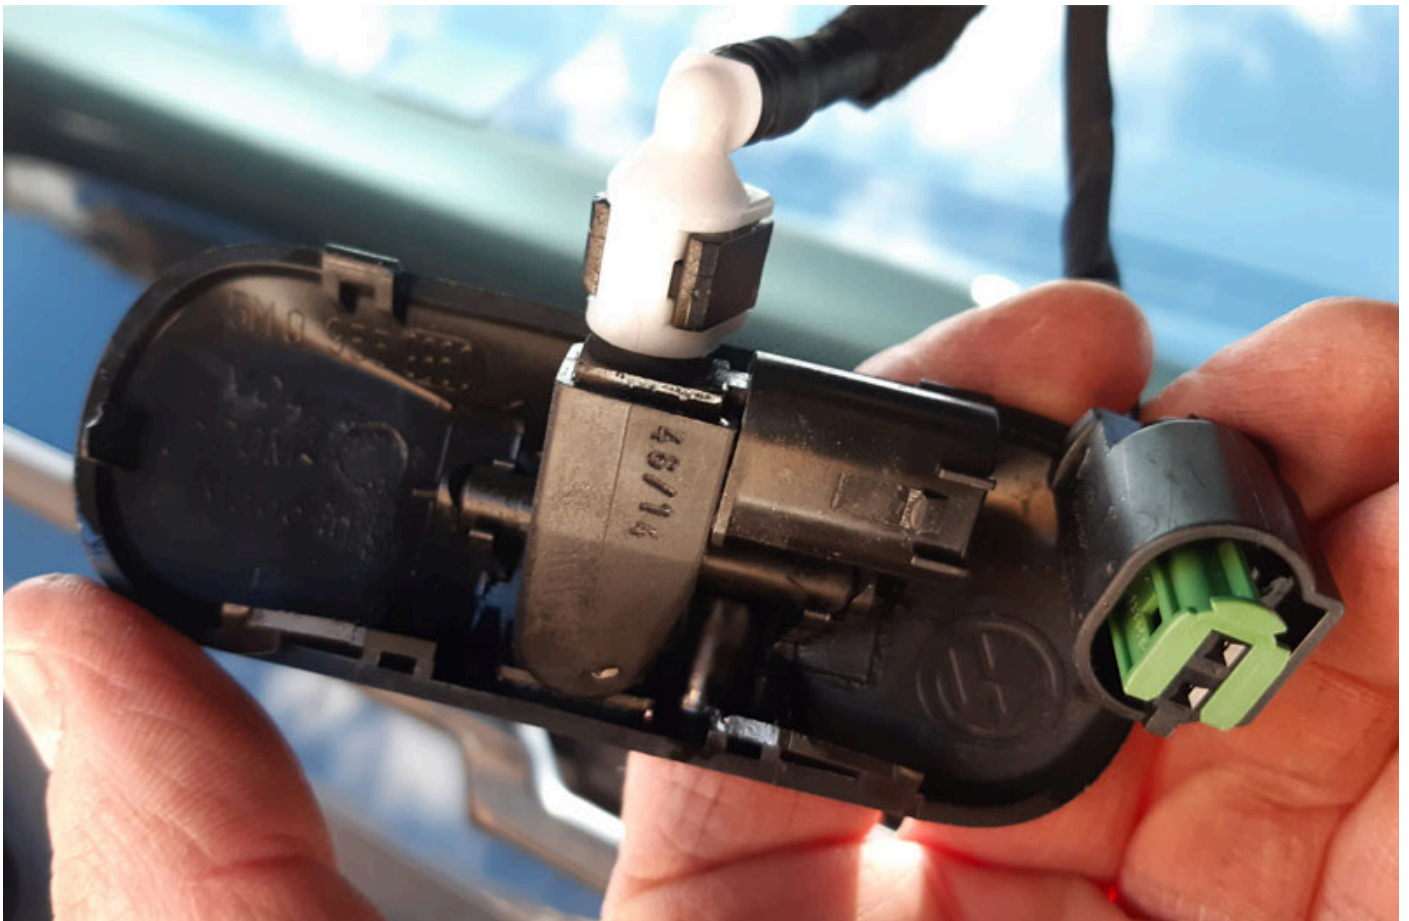
In most such cases, the fuse for the electrically heated wiper washer nozzles is defective (Fig. 2). The cause of this is a short circuit in the heating element of the wiper washer nozzle with the result that not only the fuse but also the nozzles must be replaced.

After replacing these components, functioning of both the parking aid and of the "start/stop" feature is restored.
