## VW T5 - coolant thermostat

### Data sheet

## Operating temperature is not reached, thermostat and coolant flange

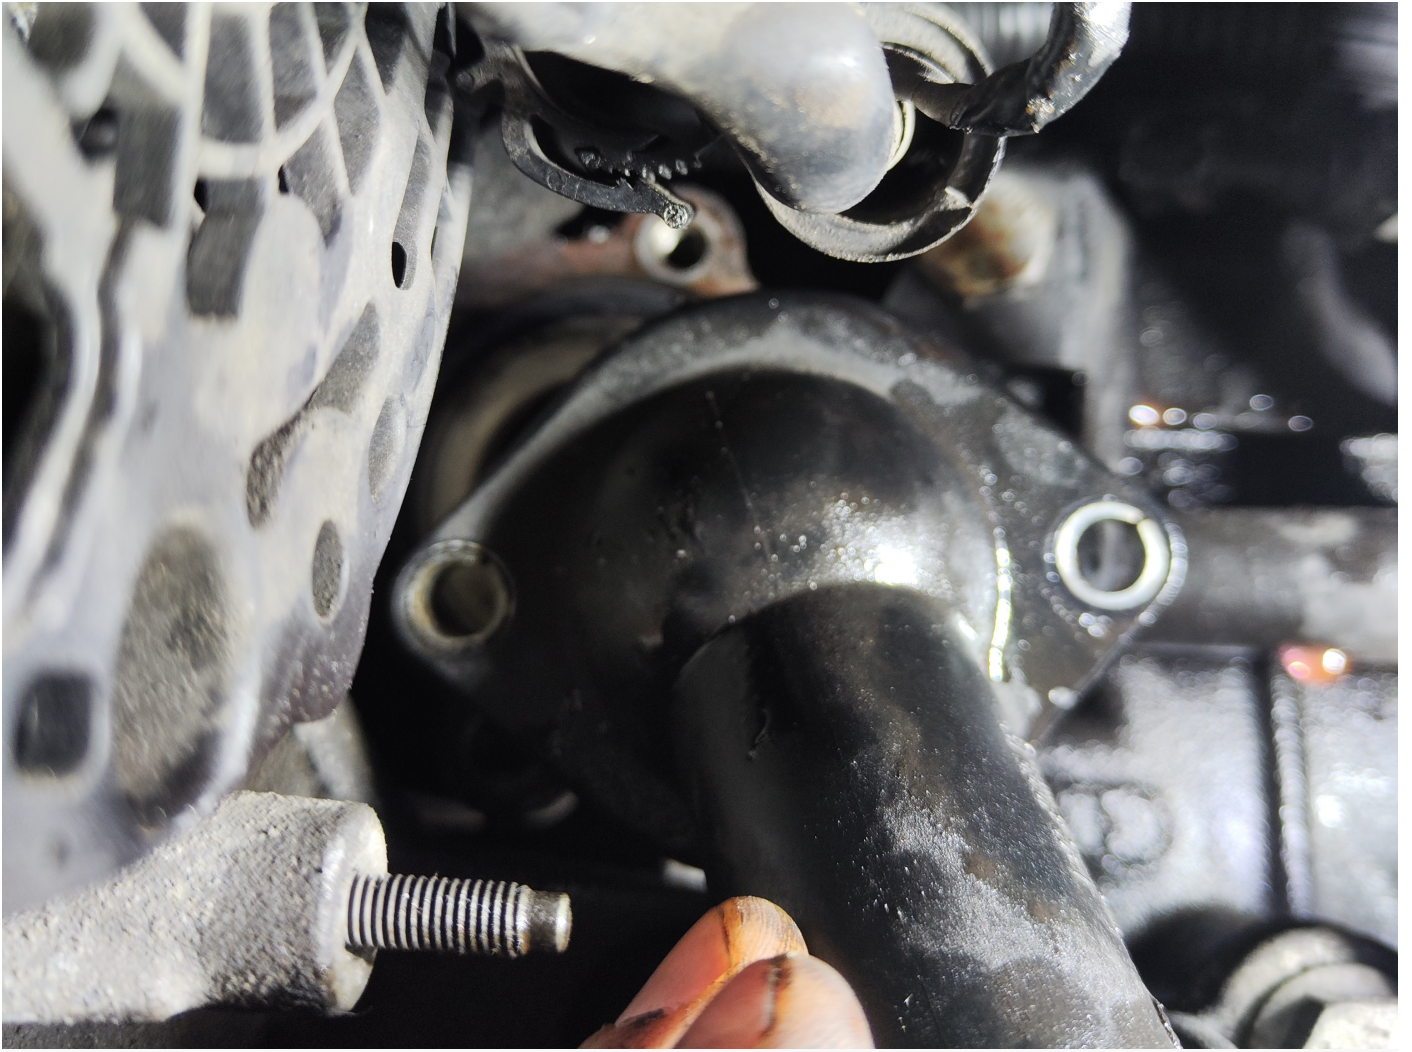
Before installing the new thermostat, the coolant flange should be inspected.

Coolant flange T5

It is then advisable to replace the flange.
