Citroen Saxo All models from 1996 to 2003

Interior fan without function

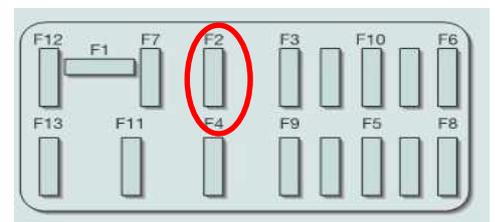
Fig. 1

If there are complaints about the above-mentioned fault, the contact plate from the ignition-starter switch could be the cause. Individual contacts could be damaged there. In addition, there can be complaints that the rear window heating is not working. In this case, fuse F2 (25 A, see Fig. 1) must be checked in the fuse box / relay plate 1.

The fuse box is in the lower part of the cockpit. In addition, the voltage supply from the ignition-starter switch at the relay (see Fig. 2, pin 3) must be checked for the interior blower. On-board mains voltage must be applied here. If this is not the case, check the ignition-starter switch and the wiring to the relay and repair or replace as necessary.

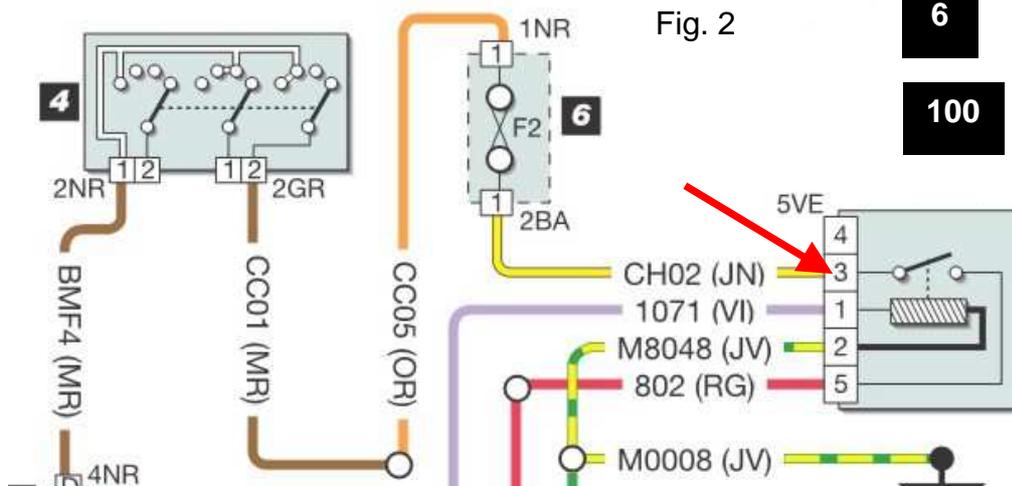
Fig. 2

- 4** Ignition-starter switch
- 6** Fuse F2
- 100** Relay, interior blower
