## **Skoda Fabia (6Y) Model year: 1999–2006**

### **Blower-motor ballast resistor/ Development of odour in the interior**

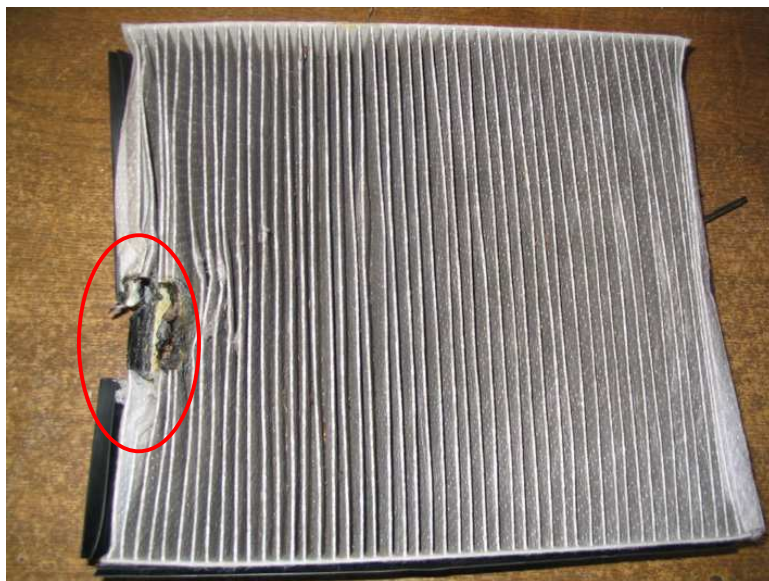
If, in the case of the above-mentioned vehicles, the ballast resistor of the interior blower is removed/replaced, it must be ensured that the resistor is fitted in the same position that it was in before removal. If the installation position is incorrect, the resistor may come into contact with the interior filter. Due to the high level of heat development of the resistor, the carrier frame of the interior filter, or the filter itself, may start to char (see photo). This leads to an unbearable odour developing in the vehicle interior. In addition, there is the danger of fire. Please take this into consideration during all work in connection with the blower resistor or the interior filter.
