Audi A3, A4, A6, A8

Airbag light comes on

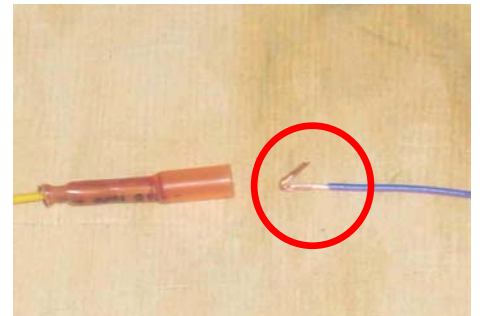
If there are complaints about the above-mentioned fault, a faulty plug connection between the interior wiring harness and the airbag module could be the cause.

In this case, replace the plug by using crimp connectors with flux.

Carry out the procedure as follows:

- Disconnect the battery
- Separate the plug from all cables
- Insulate the 0.35 mm² cable approx. 12-14 mm and the 0.5 mm² cable approx. 6-7 mm. Fold the ends of the 0.35 mm² cable back by about half (see photo)
- Insert the ends of the cables into the crimp connector and press together on both sides using a suitable crimping tool. The insulation at the ends of the cables must not be squeezed as well!
- Before shrinking, a pull test should be carried out to check that the cables are fitted securely
- Now shrink the crimp connector using a hot air gun until adhesive escapes at the ends
- Connect the battery and delete the fault memory
