## **Bulletin**

## Opel Corsa-C and Corsa-C Combo **Opel Agila** From model year 2004 All models with 1.3 L CDTI engine

## Insufficient engine performance

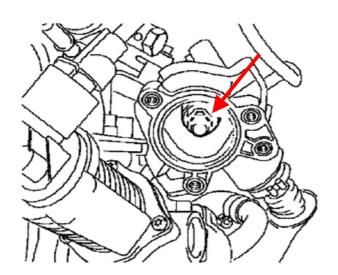
If there are complaints about the above-mentioned fault, the cause could be the EGR diffuser. In addition, it may be that the engine control lamp illuminates, and fault code P 0400 (exhaust gas recirculation – malfunction, flow rate) is stored in the engine control unit. The accumulation of unburned exhaust gas residues causes blockage of the EGR diffuser. In this case, the diffuser must be cleaned. The diffuser is part of the intake pipe (see illustration).
