Ford Focus build year till 12.07.1999 Moisture in the headlamp

Misted headlamps due to broken lens.

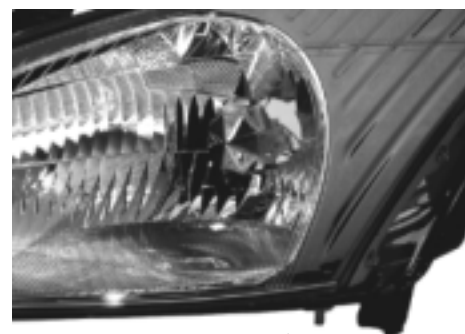
Fig.1

On the new headlamps there may be aligning pins on the lens (Fig.1). In this case proceed as follows.

- Cut off the alignment pin flush with the lens, and deburr the edge (Fig.2).
- Refit the headlight levelling motor (when fitted)
- **When installing the headlamp, tighten only the three fastening screws (Fig.3).**
- Mount the other components in reverse order.
- Check and if necessary adjust the headlamp beam setting
