VW Touran

Bulb replacement in combination rearlight

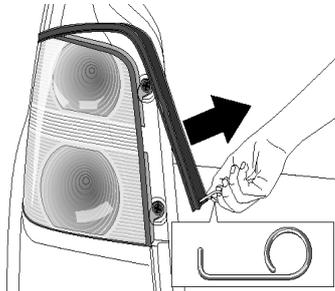
- Open the boot
- Insert the wire hoop (is included in the on-board tools) into the small bore hole in the trim of the combination rearlight, turn the hoop to the centre of the vehicle and pull the trim off about 1 cm in the direction of the arrow.

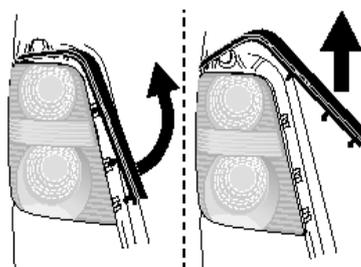
- Pull the trim down first, then up and off completely to the rear.

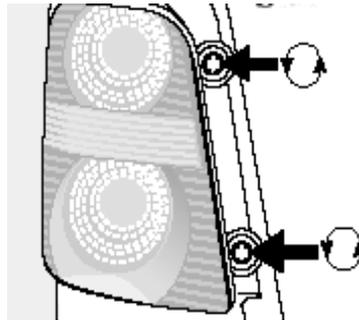
- Two screws become visible behind the trim, unscrew these with the aid of a screwdriver (is included in the on-board tools).

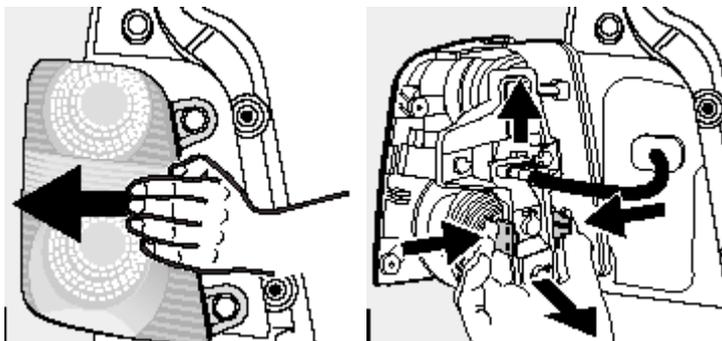
- Push the combination rearlight outwards slightly and remove it. The combination rearlight can now be accessed from the rear, and the bulb holder can be removed from the combination rearlight by pressing the lugs together.
