BMW X3 F25 - DSC warning lamp lighting up sporadically

Dynamic Stability Control (DSC) warning lamp lights up sporadically - additional failure of various systems possible

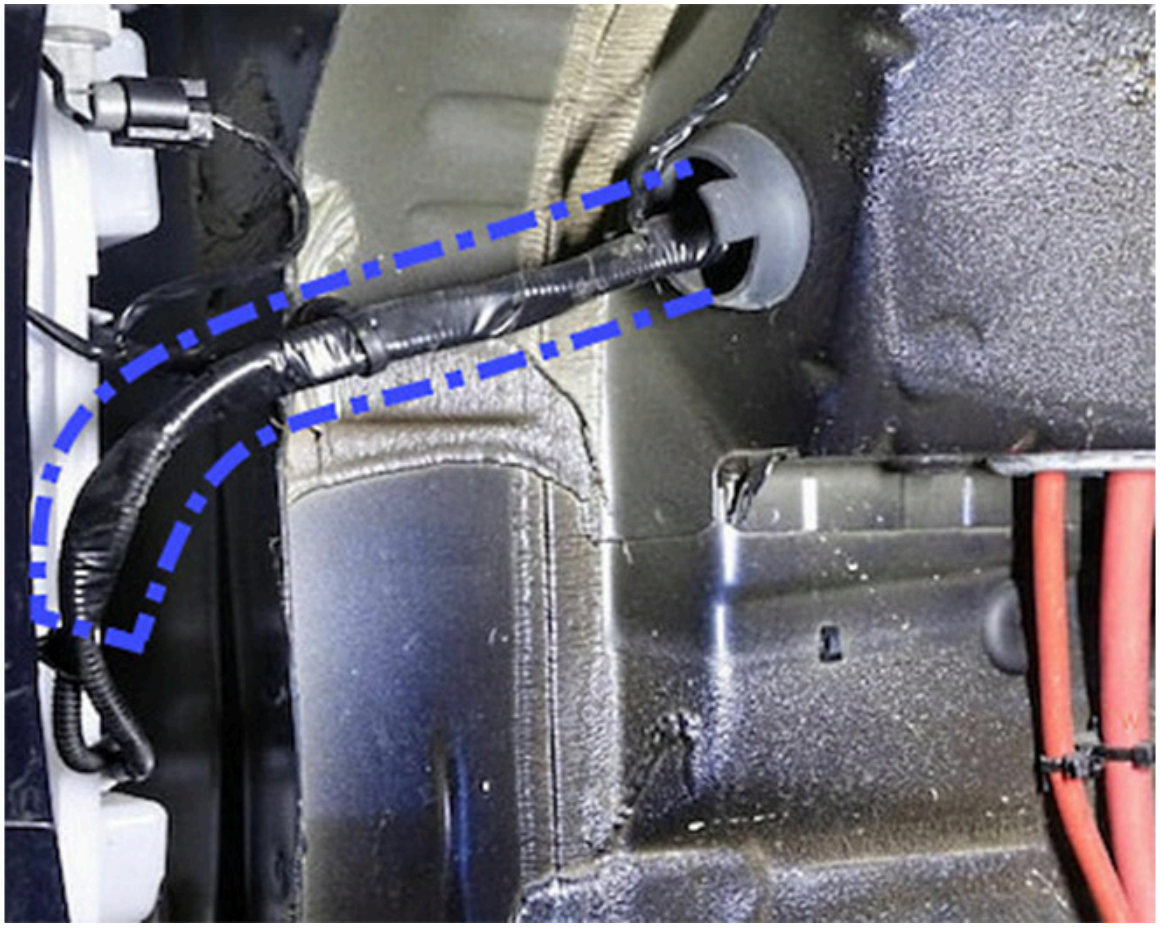
The DSC warning lamp on the above-mentioned vehicle series has been known to light up sporadically. In addition, various Check Control messages can be displayed in the instrument cluster. If no definite faults have been detected in the periphery of the affected systems during the diagnosis, special attention should be paid to the harness in the front right wheel well.

The windscreen washer fluid running off the windscreen can cause the sheathing of the individual cables to swell. Water penetrating the harness can lead to corrosion and increased contact resistances. In order to carry out further testing, remove the front right wheel well trim. Check the harness in this area for swollen cable insulation, corrosion on the cables and also check the plug connections.

If a defect is found here, it is then necessary to replace the harness. To prevent further damage, the vehicle manufacturer is able to provide a special water drainage tray. Part number: 6112 6825706
