Mercedes Benz E- class - Engine warning light comes on

E- class (W 211)

All vehicles with engine code 642.xxx

Engine warning light comes on

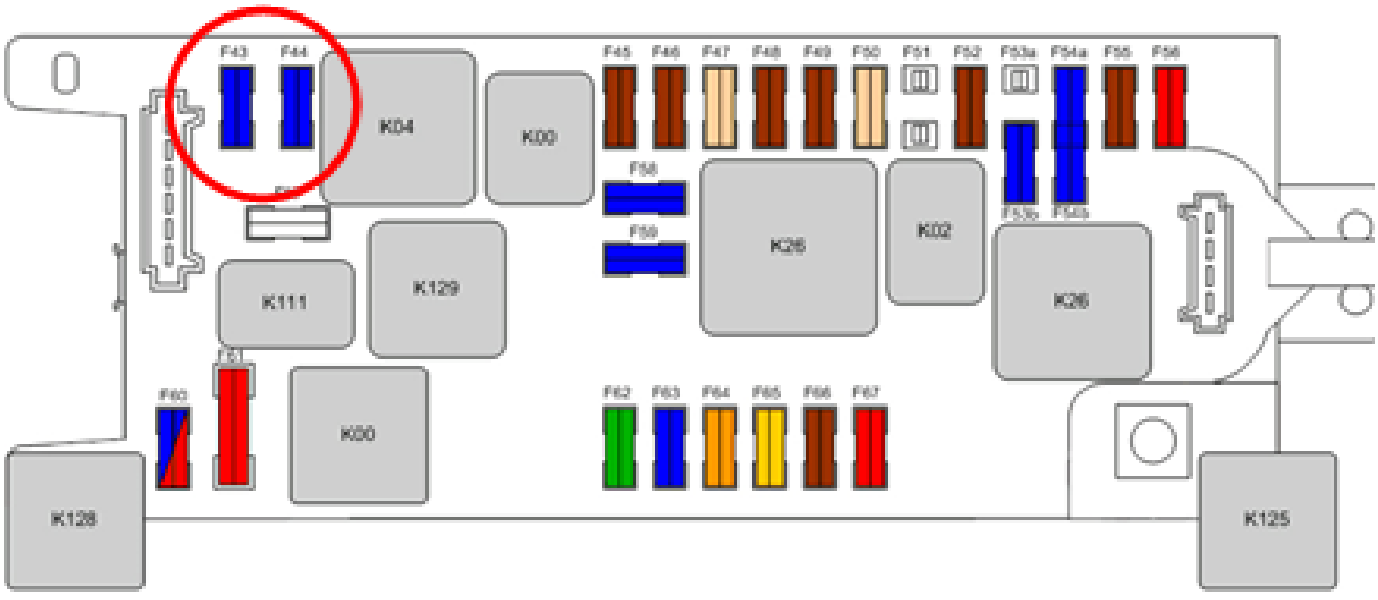
Fig. 1

If a customer complains about the above problem, this could be caused by the servo motor for the swirl flaps (see Fig. 1). Oil may reach the servo motor through the air hose. Under certain circumstances this can cause a short circuit inside the servo motor. This causes the engine to go into emergency mode, resulting in fault code entries for the servomotor. In addition, the fuses for the motor control unit (F43, F44, Fig. 2) may blow. They are located in the fuse box in the engine compartment. The fuse box is located on the front left, near the splash wall. In this case, the servo motor must be replaced. Furthermore, the oil deposits in the turbocharger hose should be removed and the fuses should be replaced if necessary. Clear the fault codes after the repair.
