BMW X3 G01 - check engine lamp comes on

Data sheet	
Manufacturer	BMW
Vehicle model	X3 G01
Engine	2.0 d
Engine code	B47
Year of manufacture	2019 to 2021
Symptoms	Check engine lamp comes on

Error memory entries relating to the diesel particulate sensor

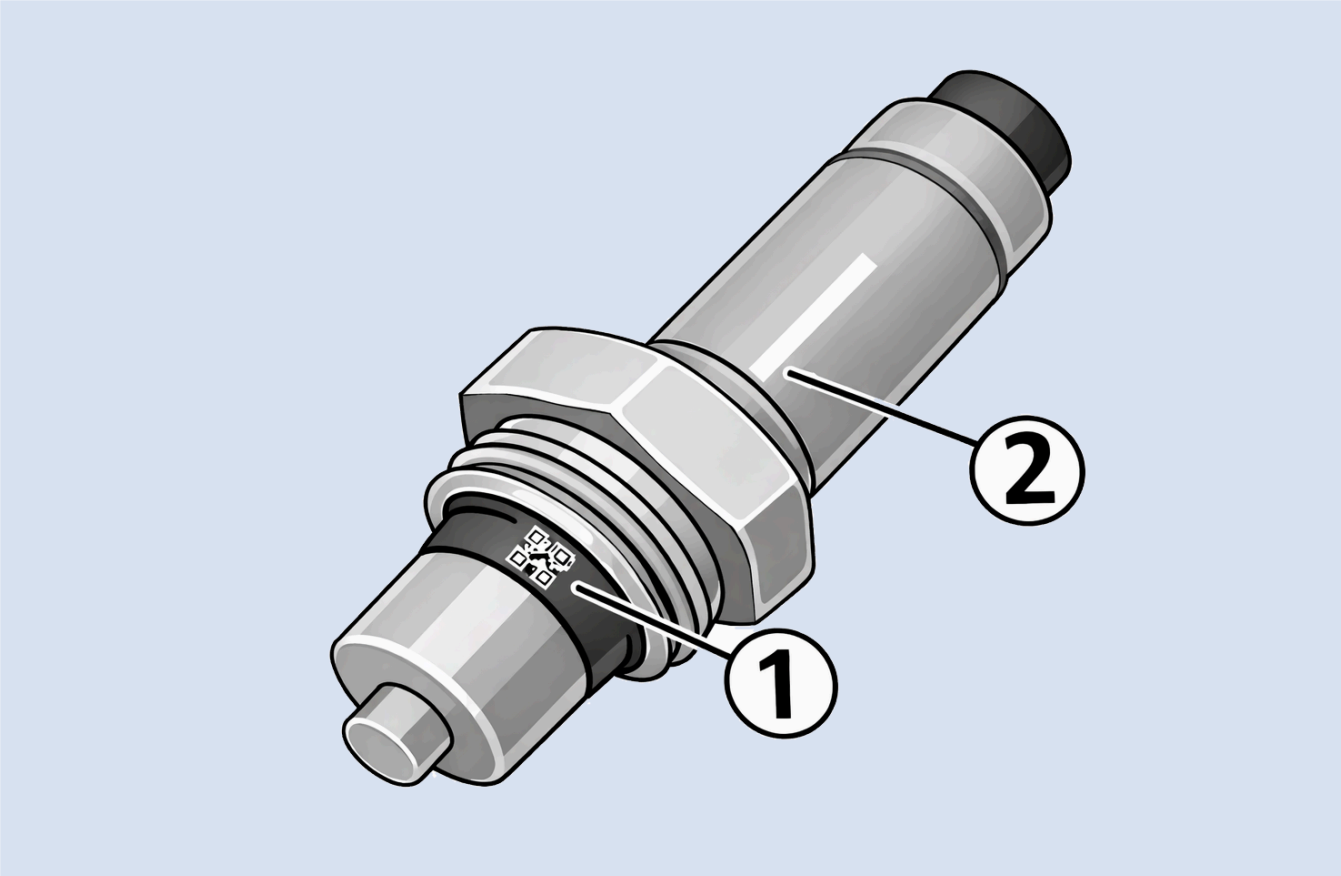
An example illustration of a diesel particulate sensor.

On models marked appropriately, the marking (2) or the QR code (1) is used to ensure correct alignment in accordance with the vehicle manufacturer’s specifications

If the diesel particulate sensor needs to be replaced, it is essential to ensure that it is installed in the correct position. For models identified appropriately, the marking or QR code on the sensor housing must face downwards (see illustration). Incorrect installation may result in the sensor

failing again. The vehicle manufacturer’s specifications are applicable. Any markings on the spare part are intended to guide you during the installation process.
