Jaguar S-Type - Ticking Sounds From Instrument Panel Area | HELLA

Jaguar

S-Type (X200)

Model Year: 1999 – 2008

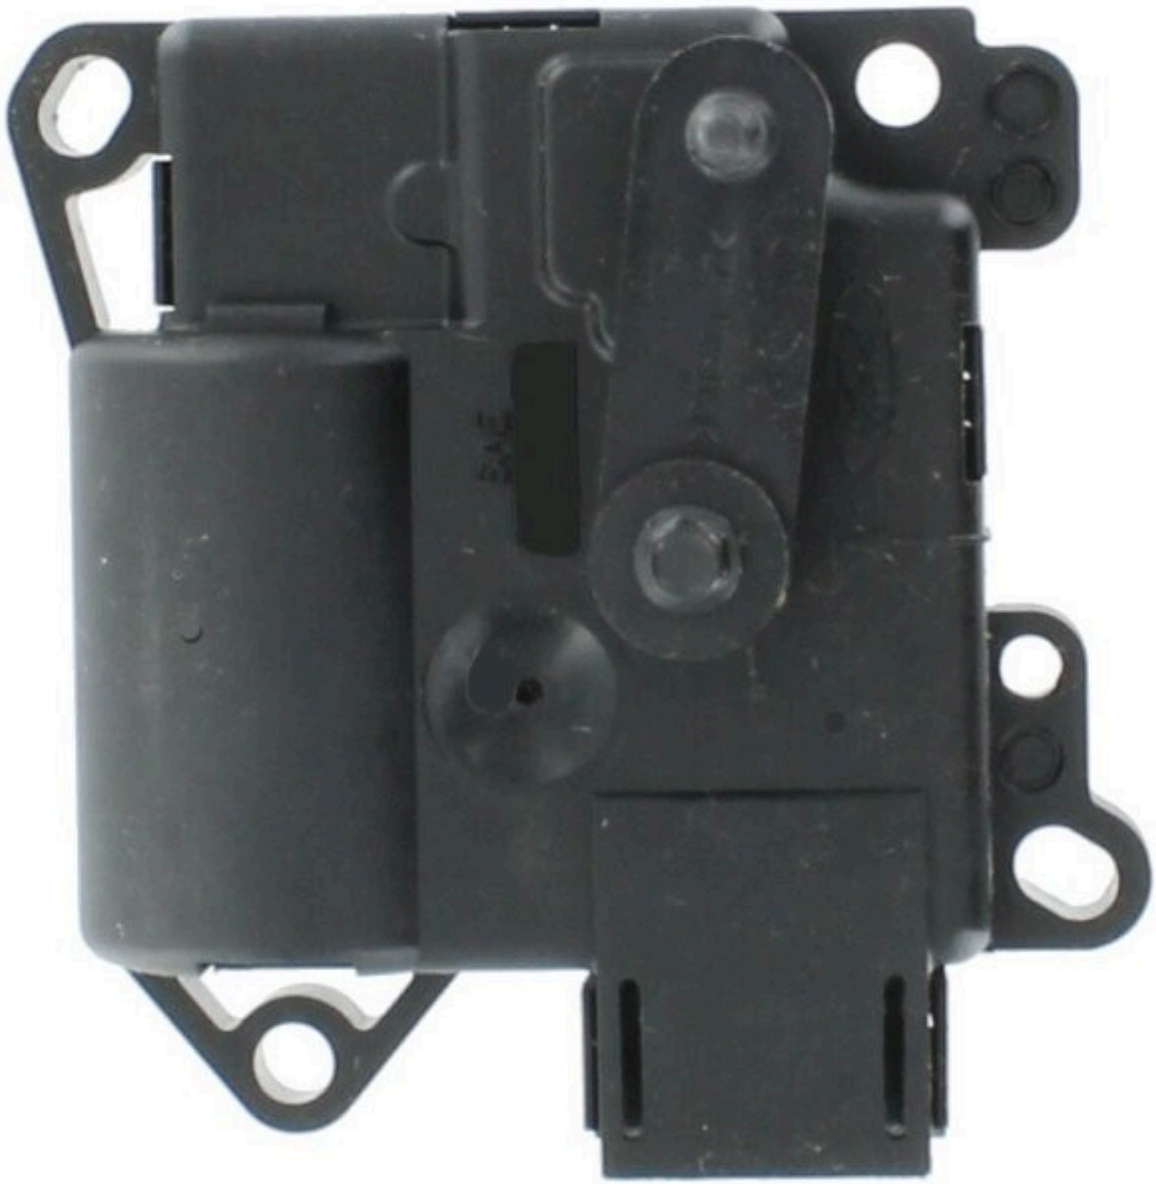
In the vehicles listed above, ticking noises can arise from the instrument panel or the instrument cluster area.

The potential cause for this is one or more actuator motors of the heating/air-conditioning system.

- Exactly locate the source of the noise
- If required, carry out an actuator test
- Replace the affected actuator motors
- Read out/clear the error memory
- Program the actuator motors
