KIA Niro - error message in the instrument cluster

Data sheet	
Manufacturer	KIA
Vehicle model	Niro
Year of manufacture	08/2017 – 01/2018
Symptoms	Error message in the instrument cluster

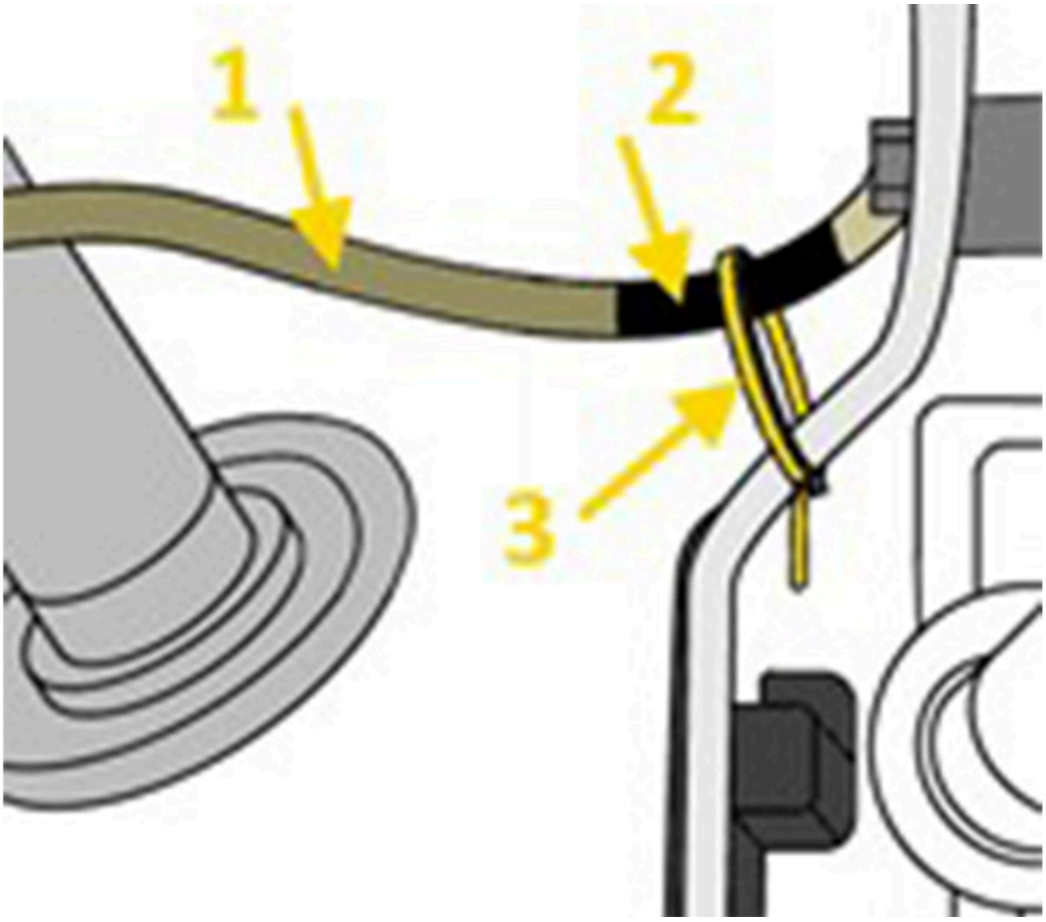
With this repair issue, the customer complains about receiving a variety of error messages in the instrument cluster. The cause of the above-mentioned problem is a damaged electrical cable (rubbing against the steering column).

- Check the electrical cable for damage and repair or replace if necessary
- Wrap the electrical cable (Pos.1) with adhesive tape. (Pos.2)
- Install cable ties and fix the electrical cable in place. (Pos.3)
