BMW 3 Series Gran Turismo - Howling noises in the area of the vehicle underbody

Data sheet	
Manufacturer	BMW
Vehicle model	3 Series Gran Turismo
Type	F34
Year of manufacture	From 2013
Symptoms	Howling noises in the area of the vehicle underbody, starting at a speed of 90 km/h and upwards.

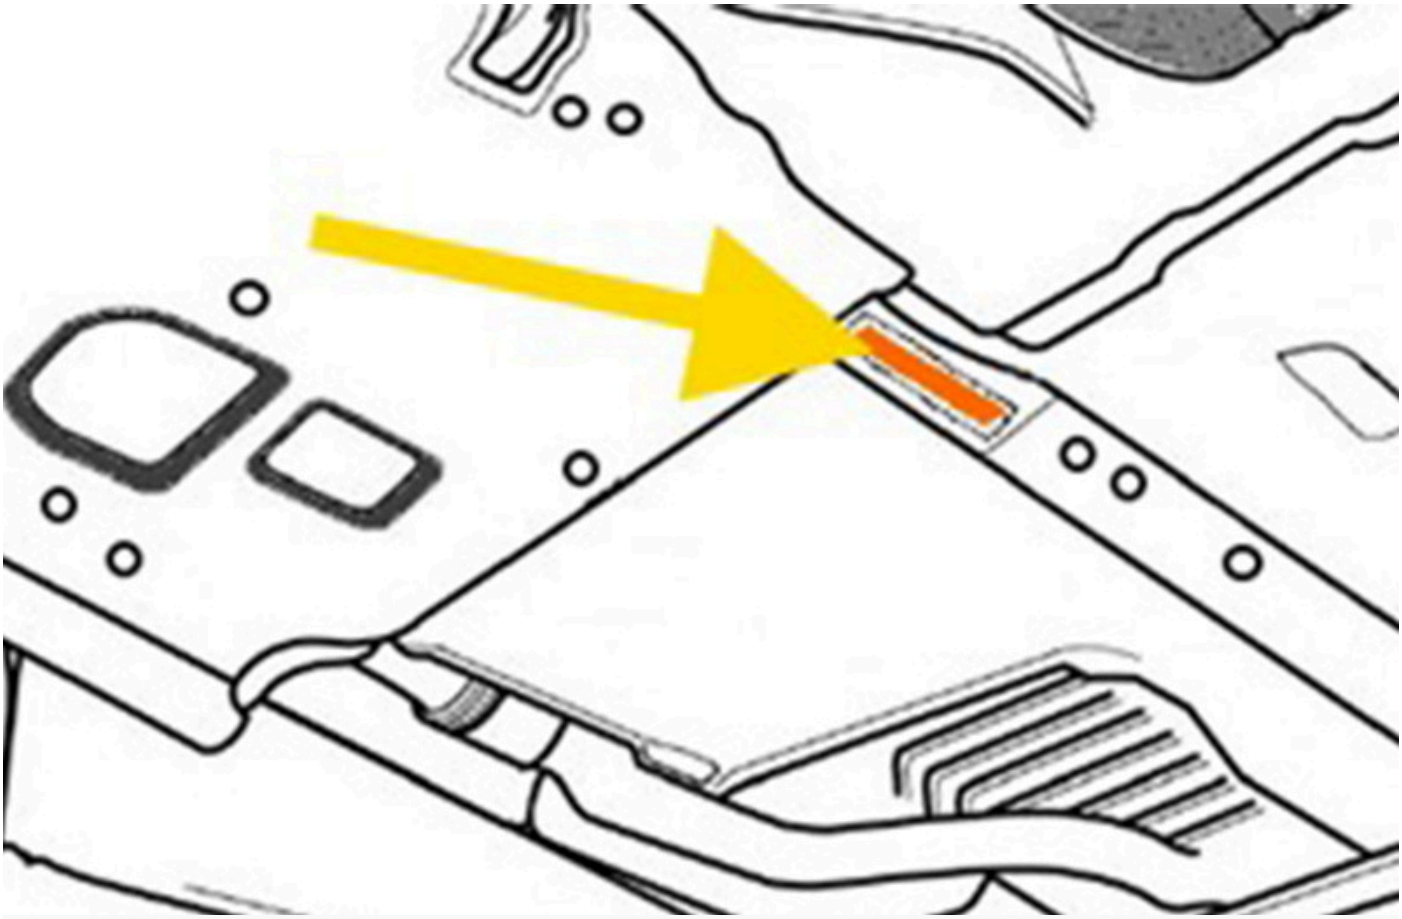
If the above-mentioned problem is detected, a possible cause may be too large a gap at the transition between the front and central underbody cover.

Thoroughly clean the area marked in the picture and fit the foam pad OE No. 16111181918 according to the vehicle manufacturer's instructions.

- First remove the central underbody protection cover.
- Thoroughly clean the area marked in the picture and fit the foam pad OE No. 16111181918 according to the vehicle manufacturer's instructions.
- Refit the central underbody protection cover.

Finally a test drive should be performed in order to run checks on the repair work.
