Mini F56 - water ingress in the vehicle interior

Data sheet	
Manufacturer	Mini
Vehicle model	F56
Engine	2.0i
Engine code	B48
Year of manufacture	2014
Symptoms	Water ingress in the footwell

Moisture in the vehicle interior caused by condensation draining from the air-conditioning system

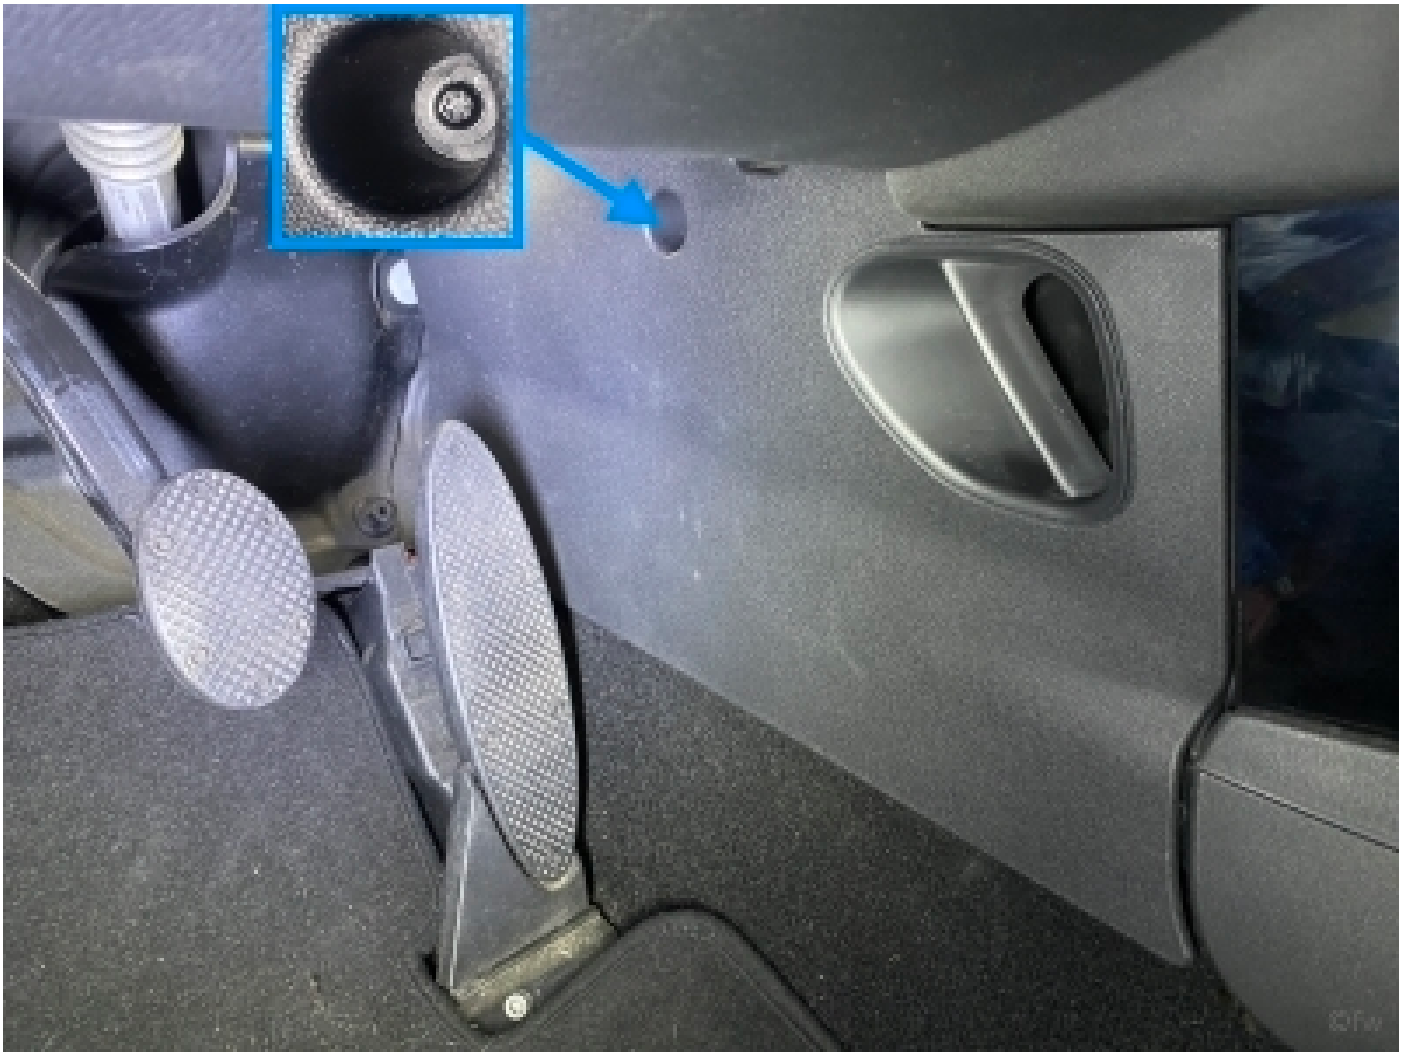
With the above-mentioned vehicle type, water may collect in the driver or front passenger footwell. If the above-mentioned defect is detected and water ingress from the outside via body parts can be ruled out, special attention should be paid to the condensation drain below the air-conditioning unit.

Deformation of the rubber seal means that condensation can no longer drain off properly. The water collects and is not drained off as intended, but enters the vehicle interior as a result of the deformed seal. The interior carpet absorbs the water, which can lead to unpleasant odours and, under certain circumstances, mould growth.

An endoscope is recommended for easier inspection. In the event of a fault, traces of water are usually visible on the side of the drain, indicating that the seal does not fit properly.

The side panelling (Fig. 1) in the footwell must be removed to carry out the necessary checks. In order to do this, the fastening screw has to be undone and the panelling removed from the brackets. The carpet can be pressed down slightly on the side underneath the air-conditioning unit in order to check it. The rubber seal of the water drain must fit all the way round the air-conditioning unit (Fig. 2) and have no kinks in it.

One test option is to set the air-conditioning system at maximum cooling capacity. In warm ambient temperatures, this causes condensation. In the event of a fault, this condensation would then run visibly past the seal and into the vehicle interior. If kinks or traces of water are visible, the condensation drain must be replaced. If mould is visible on the interior carpet, this should also be replaced.
