BMW X5 F15 - coolant level warning message in the instrument cluster

Data sheet	
Manufacturer	BMW
Vehicle model	X5 F15
Engine	3.0 d
Engine code	N57
Year of manufacture	2013 to 2018
Symptoms	Coolant level warning message on the instrument cluster

Coolant loss caused by a leak at the coolant flange

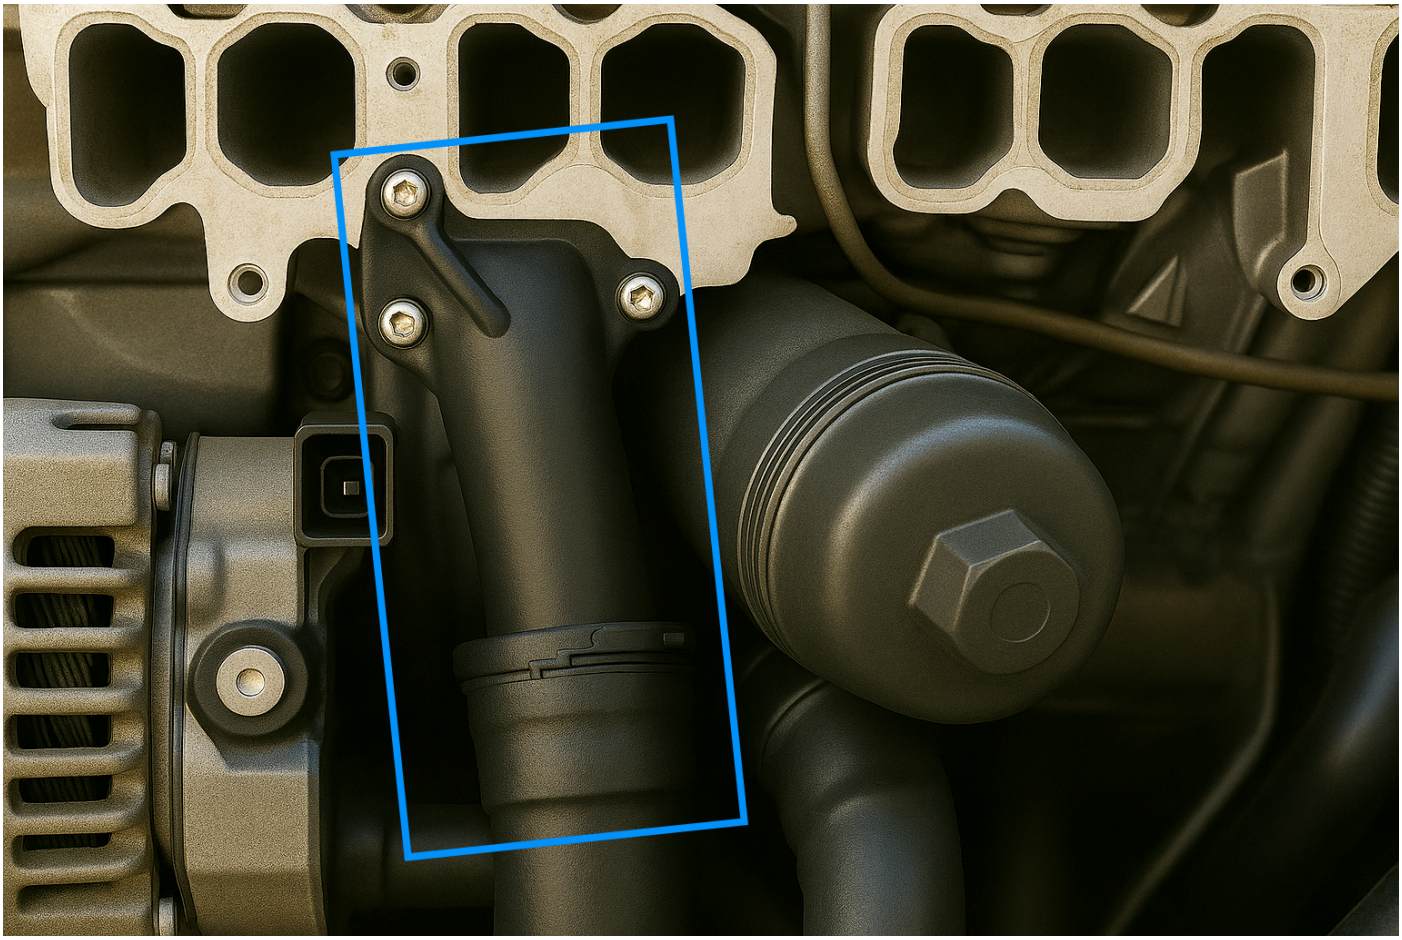
In the case of the vehicle type mentioned above, a warning message may appear in the instrument cluster indicating that the coolant level is too low, or stating that the coolant level in the expansion tank has reached the minimum. In addition, a distinct smell of coolant is often noticeable in the engine compartment. There are not necessarily any drip marks underneath the vehicle, but on closer inspection, damp patches or crystallised coolant residues can be seen in the area between the alternator and the oil filter housing.

If the fault mentioned above applies, particular attention must be paid to the coolant flange (coolant neck) on the cylinder head (see illustration – installation location of the coolant flange). The component is made of plastic and, because of its installation position, is subjected to high thermal loads. Material fatigue may lead to hairline cracks in the area of the connection neck or spigot or also to leaks at the seal. As a result, coolant leaks out, particularly when the engine is at operating temperature and system pressure is rising. Because the installation location is concealed, the leak often goes unnoticed at first.

Example illustration – coolant flange installation location

In order to troubleshoot the problem, the area around the coolant flange on the cylinder head has to be visually inspected thoroughly. Where necessary, a mirror or endoscope might need to be used. In addition, the cooling circuit should be pressurised using suitable test equipment in order to pinpoint the exact location of the coolant leak. If a leak is detected, the coolant flange, including the seal, must be replaced in accordance with the manufacturer’s instructions. As part of the repair, adjacent coolant pipes and hose connections must be checked for any further leaks, brittleness or damage.

Once the work has been completed, the cooling circuit must be filled, bled and pressure-tested again in accordance with the manufacturer’s specifications.
