Mercedes M-Class - Loss of engine power | HELLA

ML 270 CDI (163)

Engine code: 612.963

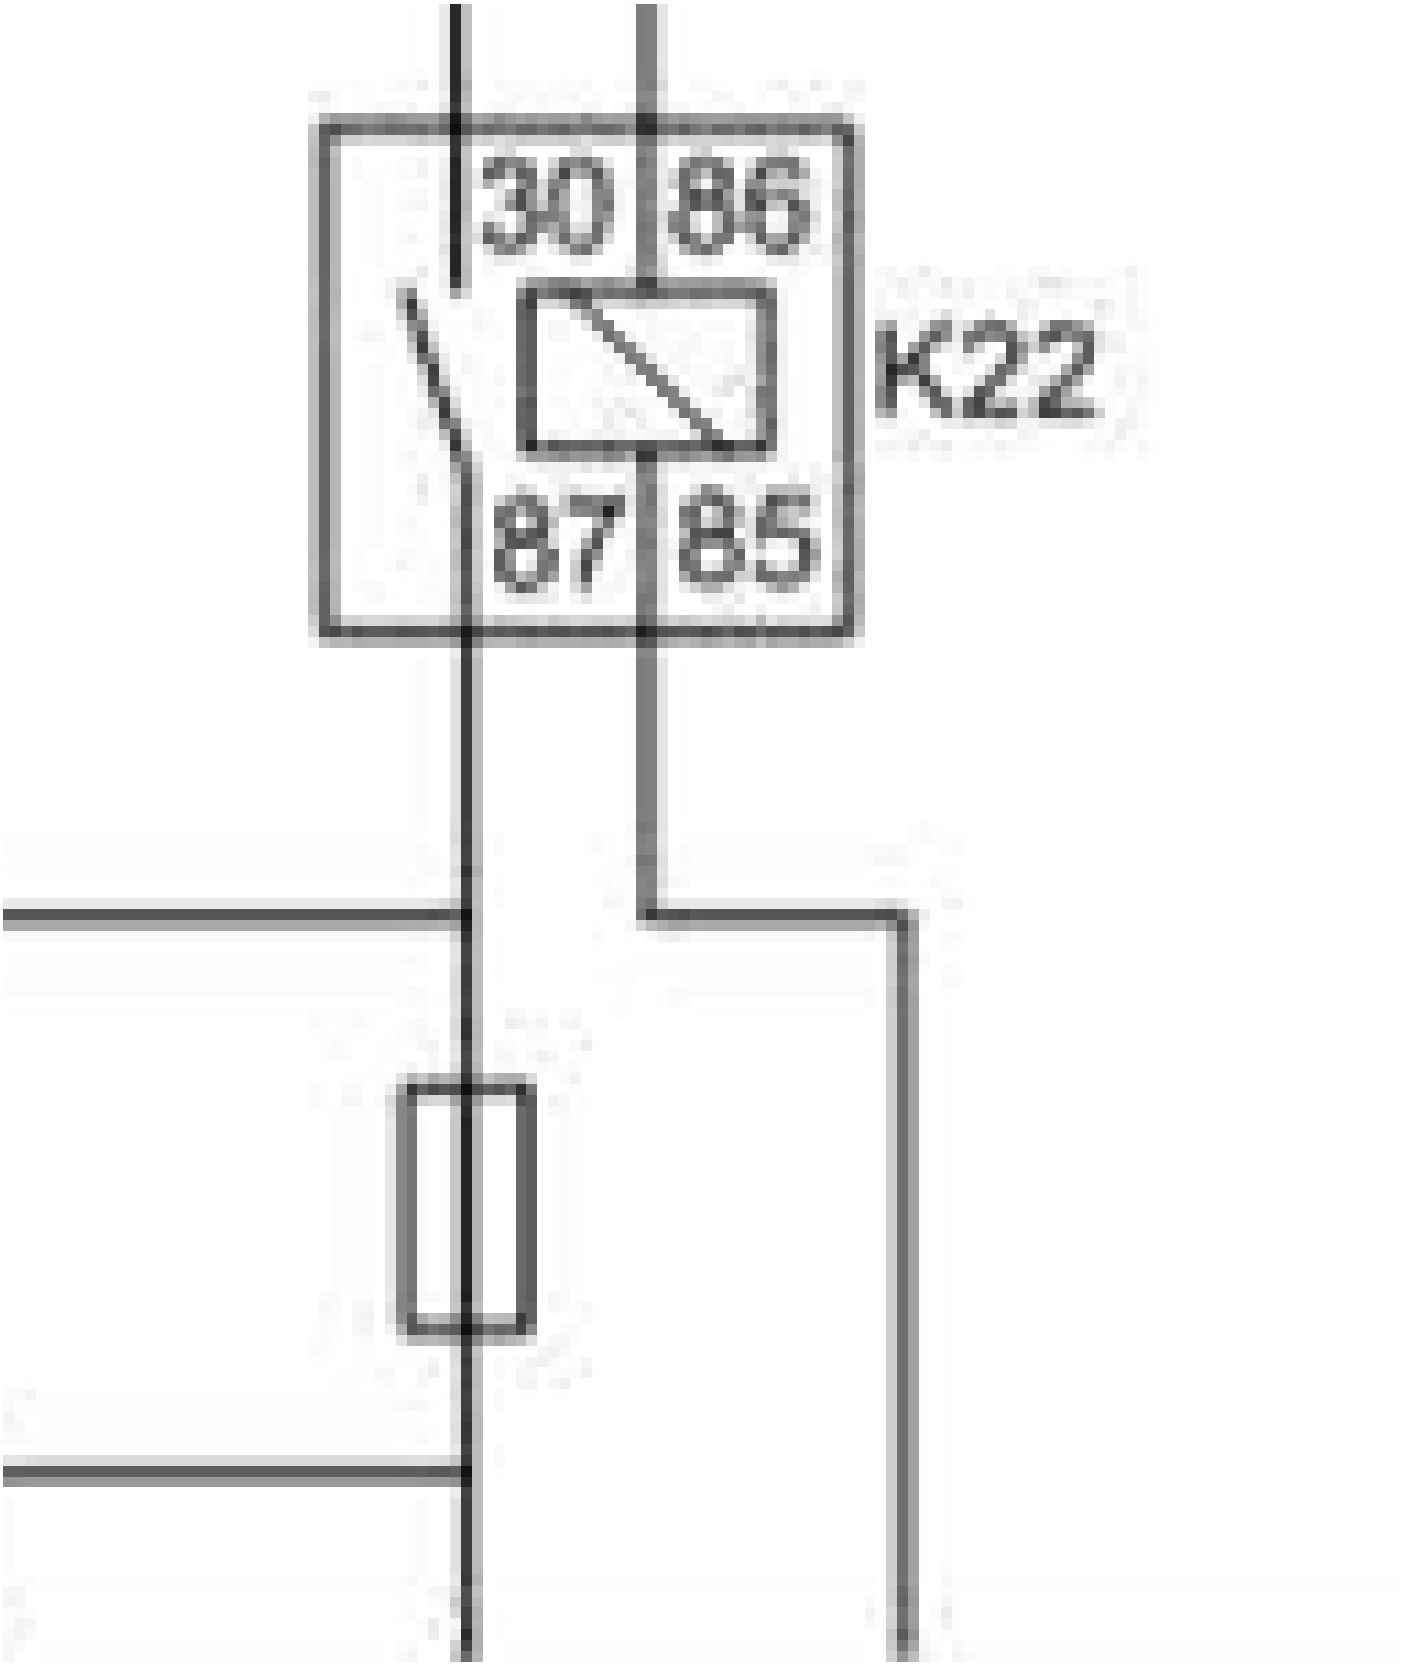
If complaints are made regarding the above-mentioned vehicles that the engine is losing power or going into limp-home mode, a possible cause is a defective 10 A fuse for terminal 87 (see Figure 1) of the control unit.

The 10 A fuse for the control unit is located in the module box in the engine bay (This fuse is not shown in all circuit diagrams). In order to remedy any problem, a faulty fuse should be replaced and any fault codes that have been stored should be deleted.

The above-mentioned fault codes could lead to the components listed here (mass air flow sensor, cooling fan control unit, etc.) being misinterpreted as defective because of inadequate voltage supply of the engine control unit.
