Skoda Fabia II - Functional failure; side direction indicator | HELLA

Skoda Fabia II

Model year: 2007 - 2014

Functional failure; side direction indicator

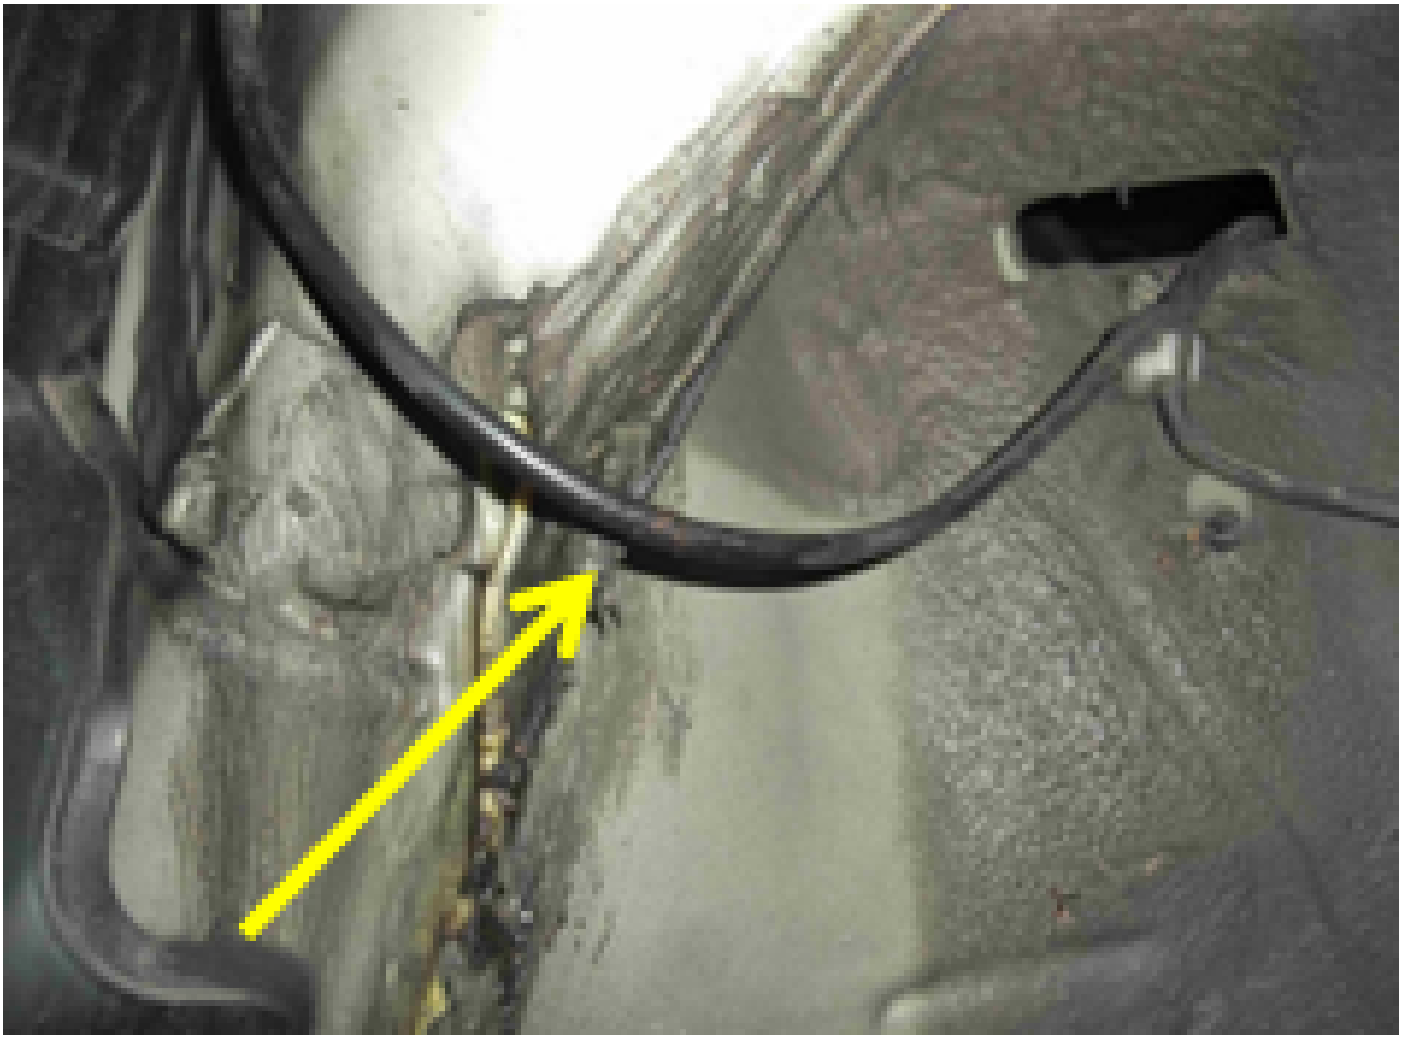
Fig. 3

If cables are not laid correctly (Fig.3), the connecting cable and insulation can wear through while the vehicle is being driven as a result of vibrations, shocks, etc. against sharp edges of the body or on sharp folded edges.

This can even lead to cable breakage/short circuit.

- For fault analysis, disassemble the wheel and the wheelhouse covering. Repair and return the defective cable to full working order. Then ensure that the cables are laid correctly (edge protection).
- Check fuses and replace if necessary.
