Peugeot 307cc- engine cuts out

Data sheet	
Manufacturer	Peugeot
Vehicle model	307cc
Engine	2.0 16 V
Engine code	RFK
Year of manufacture	2003 to 2009
Symptoms	ABS warning lamp lights up, engine cuts out
HELLA parts to replace	HELLA circuit breaker 30A: 8JS 174 320-061 Lambda sensors: 6PA 009 165-701 / 6PA 009 165-691 6PA 358 066-211
Recommended HGS tool	megamacsX

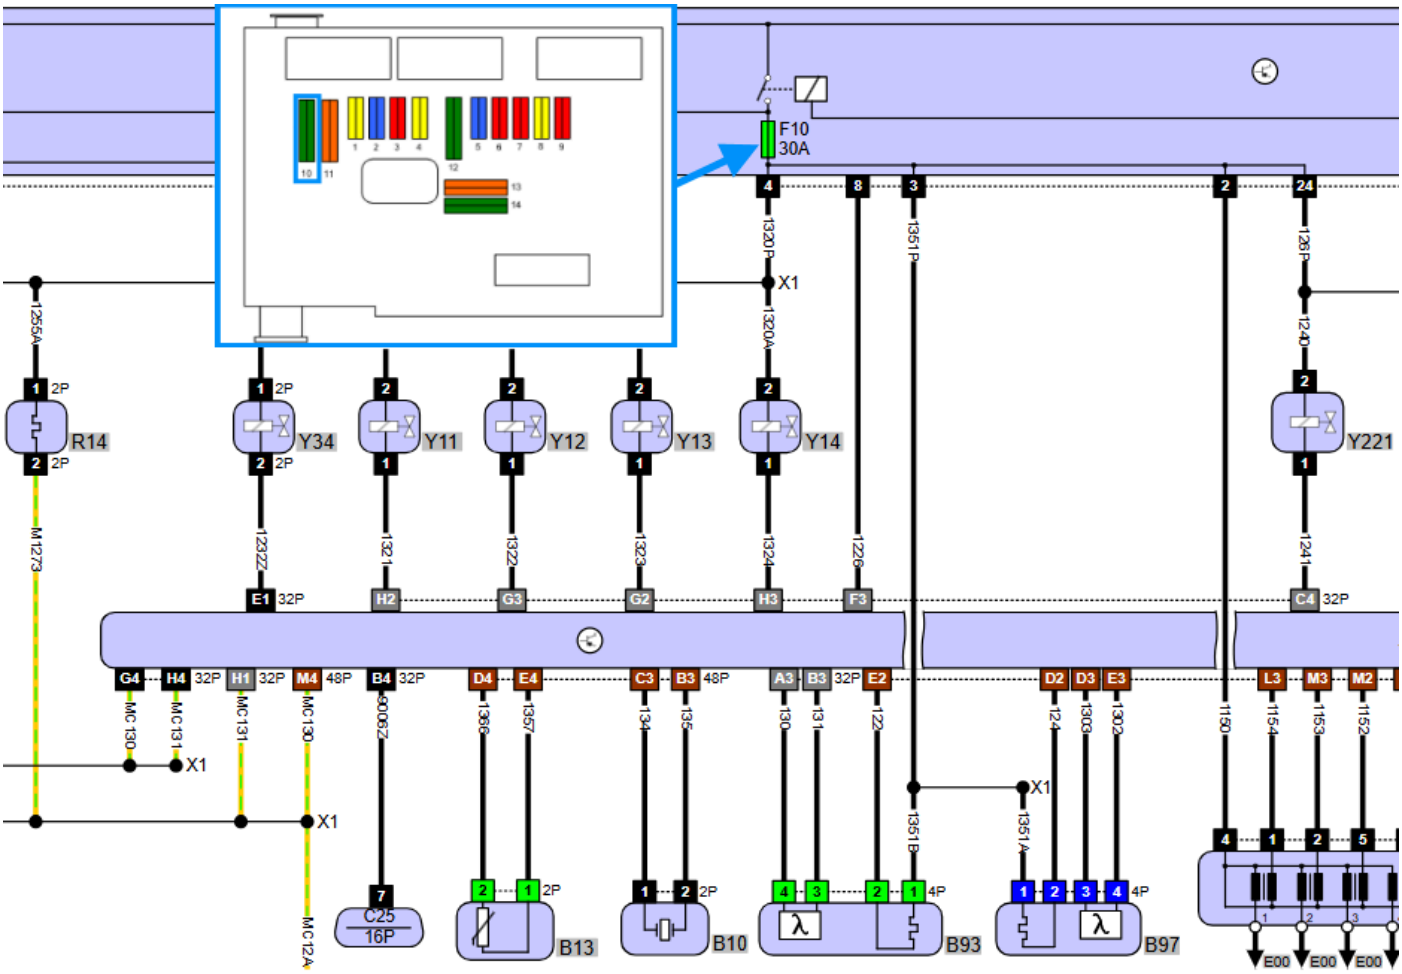
With the above-mentioned vehicle type, it can happen that the warning message "ABS/ASR/ESP faulty" is displayed while the car is being driven. In addition, the vehicle may no longer accelerate and the engine may switch off. The error memory contains entries including those for the injection valves and lambda sensors.

The fuses should be carefully checked as the first troubleshooting step. Pay particular attention to fuse F10 (30A) in the fuse and relay box in the engine compartment. The fuse must be removed and visually inspected for defects. If there are no obvious defects on the fusible wire, a continuity test can be carried out with a suitable measuring device for a more precise check. If the fuse is visually defective or measurements are out-of-spec, a possible cause may be a defective heating element on one of the two lambda sensors.

In order to check whether the lambda sensors are responsible for tripping the fuse, a circuit breaker with 30 A can be temporarily inserted in the slot of fuse F10 for troubleshooting purposes. This circuit breaker trips in the event of a short circuit and can then be switched on again. After inserting the circuit breaker, the plug connections of the sensors are disconnected one after the other. Each time the plug connection is disconnected, the engine has to be started and, if necessary, a test drive carried out to check whether the short circuit is still present. If the circuit breaker no longer trips, the fault is in the previously disconnected component.

The fuse F10 (30A) not only protects the power supply to the lambda sensor heating elements, but also other components such as the crankcase ventilation heater or the ignition coils. This means that other components as well as the heating elements may also be a cause of the faults. It is therefore recommended to use the circuit diagram that matches the vehicle and the system so as to achieve precise troubleshooting.

Once the cause of the fault has been rectified, delete the error memory and then carry out a test drive.
