VW T6 - fuel loss

Data sheet	
Manufacturer	Volkswagen
Vehicle model	Transporter T6
Engine	2.0 TDI
Symptoms	Fuel loss

Vehicle smells of diesel - fuel loss

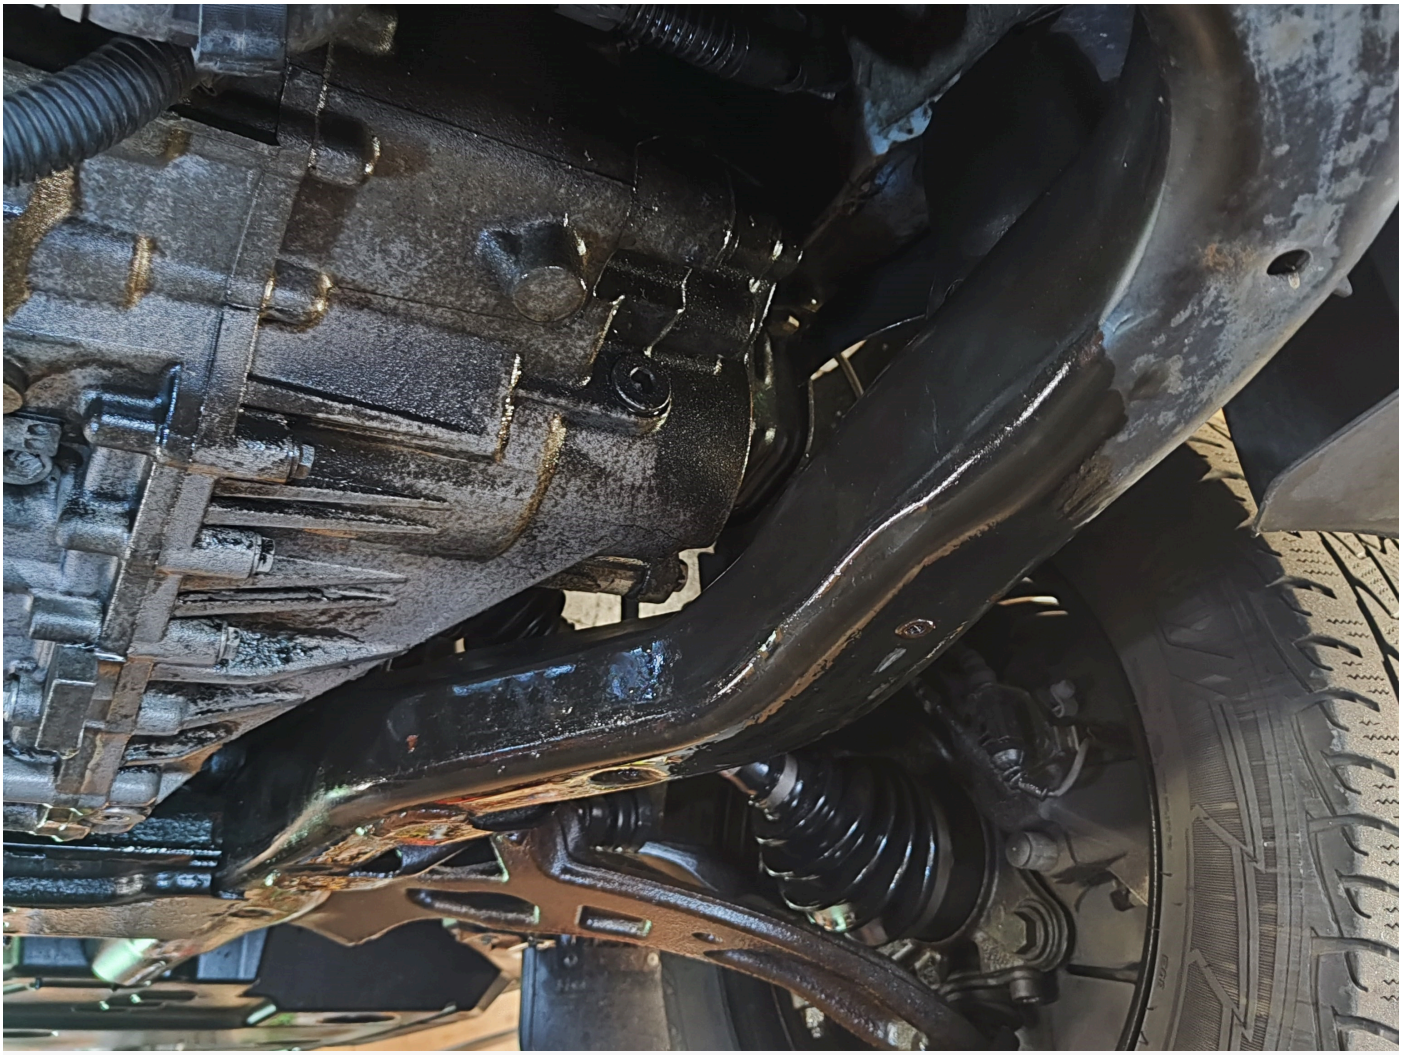
Fuel loss T6

On the vehicle mentioned above, it can happen that a strong smell of diesel suddenly becomes very noticeable. Leaking fuel may also have accumulated in the engine compartment or under the vehicle. The cause of this is not always immediately recognisable. Firstly, the fuel lines and their connections in the engine compartment should be checked. If no leak is found, the fuel filter housing may be the cause of the diesel loss.

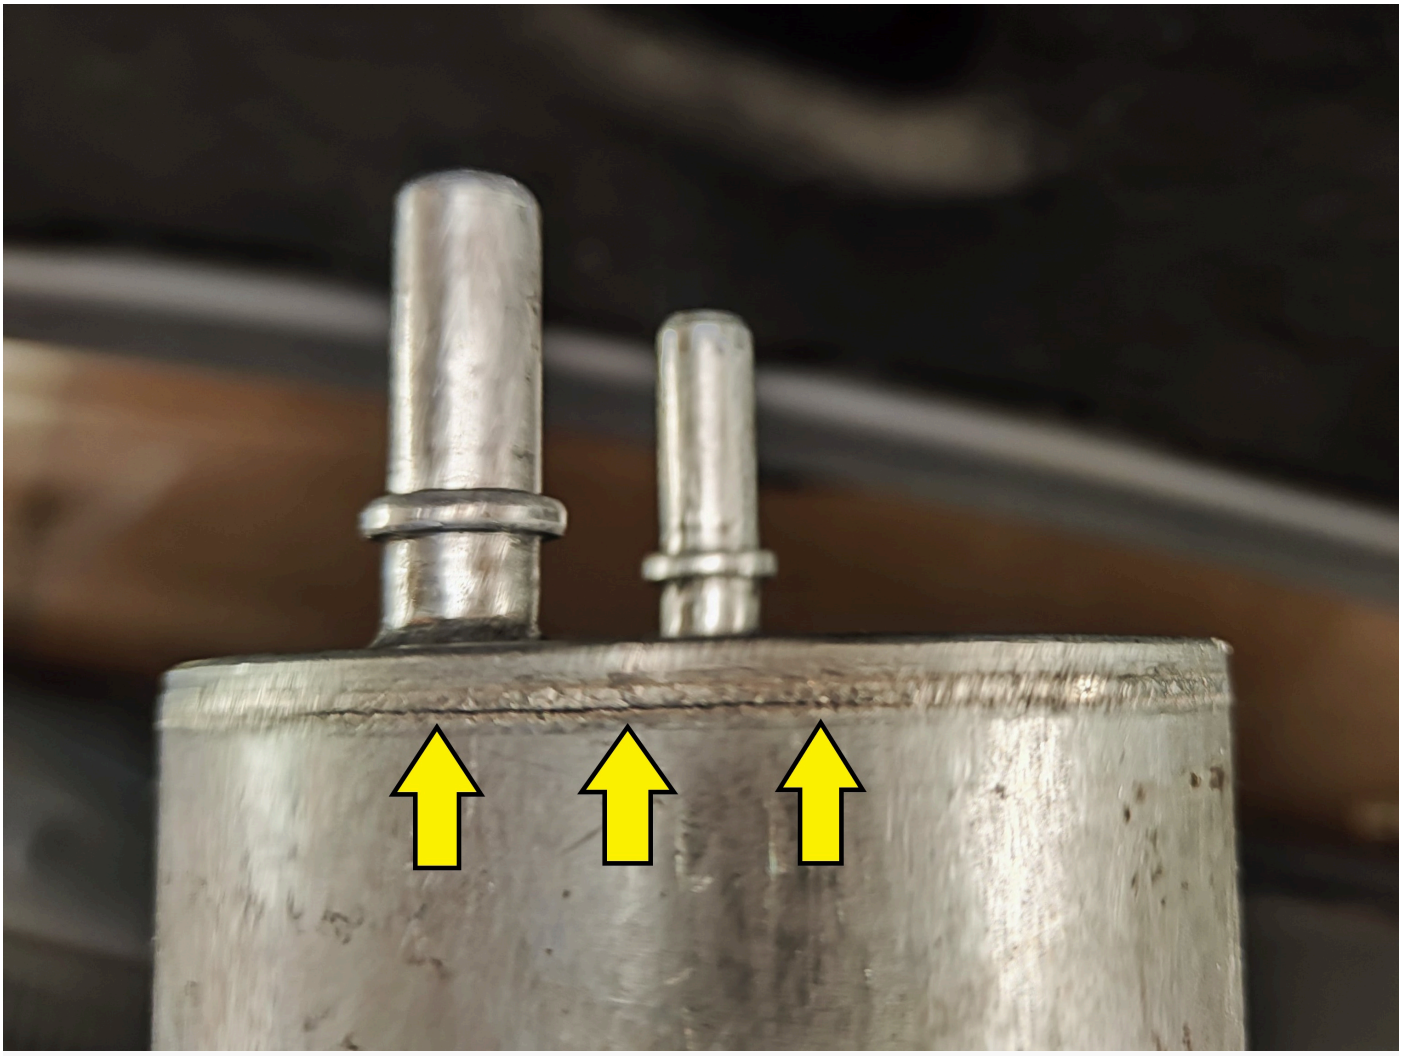
Fuel filter T6

If you now take a look at the upper area of the filter, in some cases a horizontal hairline crack can be seen, which is responsible for the leak.

In order to remedy the situation, the filter should be replaced and the fuel system bled in accordance with the vehicle manufacturer's instructions. We recommend cleaning the engine compartment as a final step of the repair.
