# **Peugeot 307 - Poor acceleration performance | HELLA**

**307 HDI**

**Engine code: 9HZ (DV6TED4)**

**Poor acceleration performance**

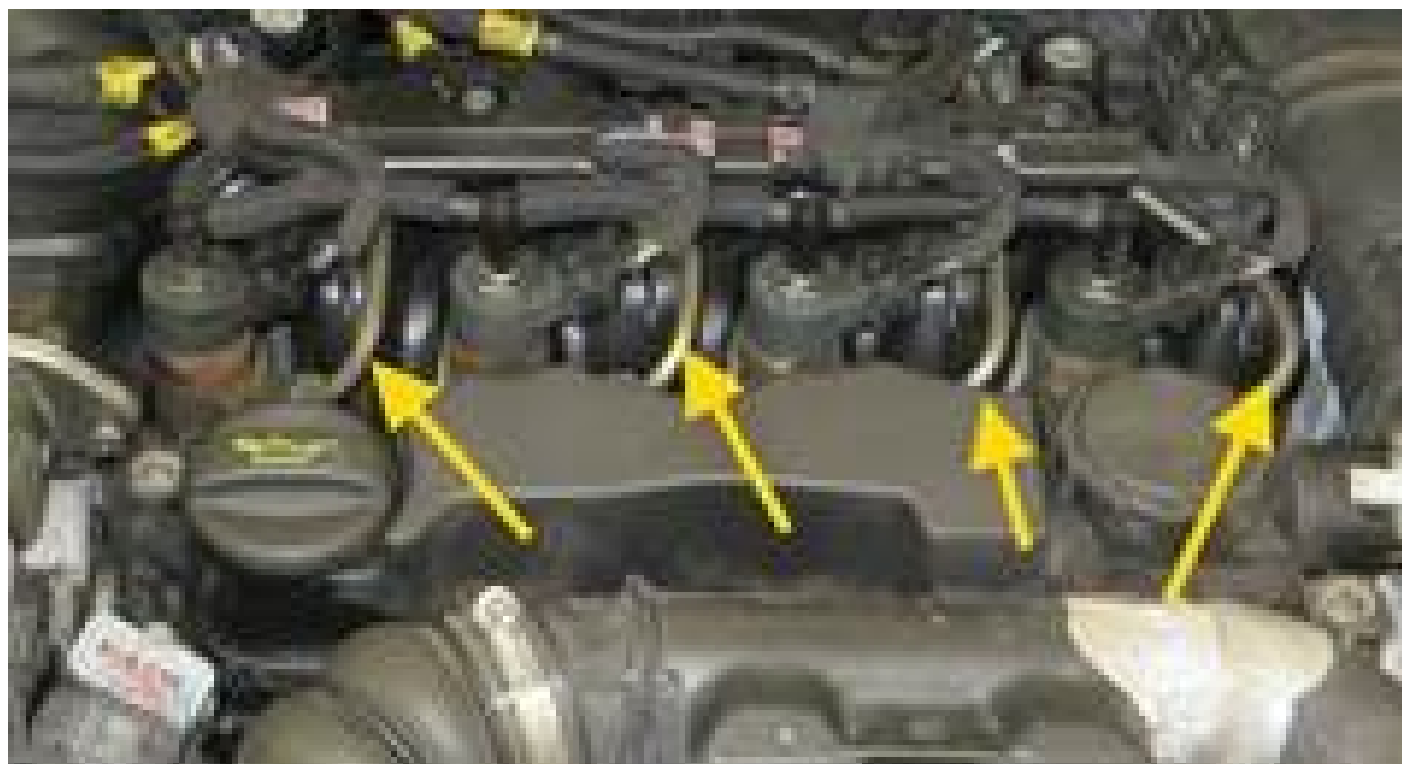
The intake manifold consists of two plastic housing halves bonded together. A leaky bonded joint (A) causes air to escape as boost pressure increases, while also making a distinctive noise. Depending on the size of the leak, the following fault entries may occur in the engine control unit.

If a leak is detected, the intake manifold must be completely replaced. It cannot be repaired. Replacing the intake manifold requires removing the high-pressure fuel lines for the injection valves (injectors).

In order to avoid leaks later, carefully remove and re-install the lines.
