# **Renault Espace-IV - Grinding noises when brake not pressed | HELLA**

**Renault Espace-IV**

**Model year 2002-2014**

**Disk brake, rear axle**

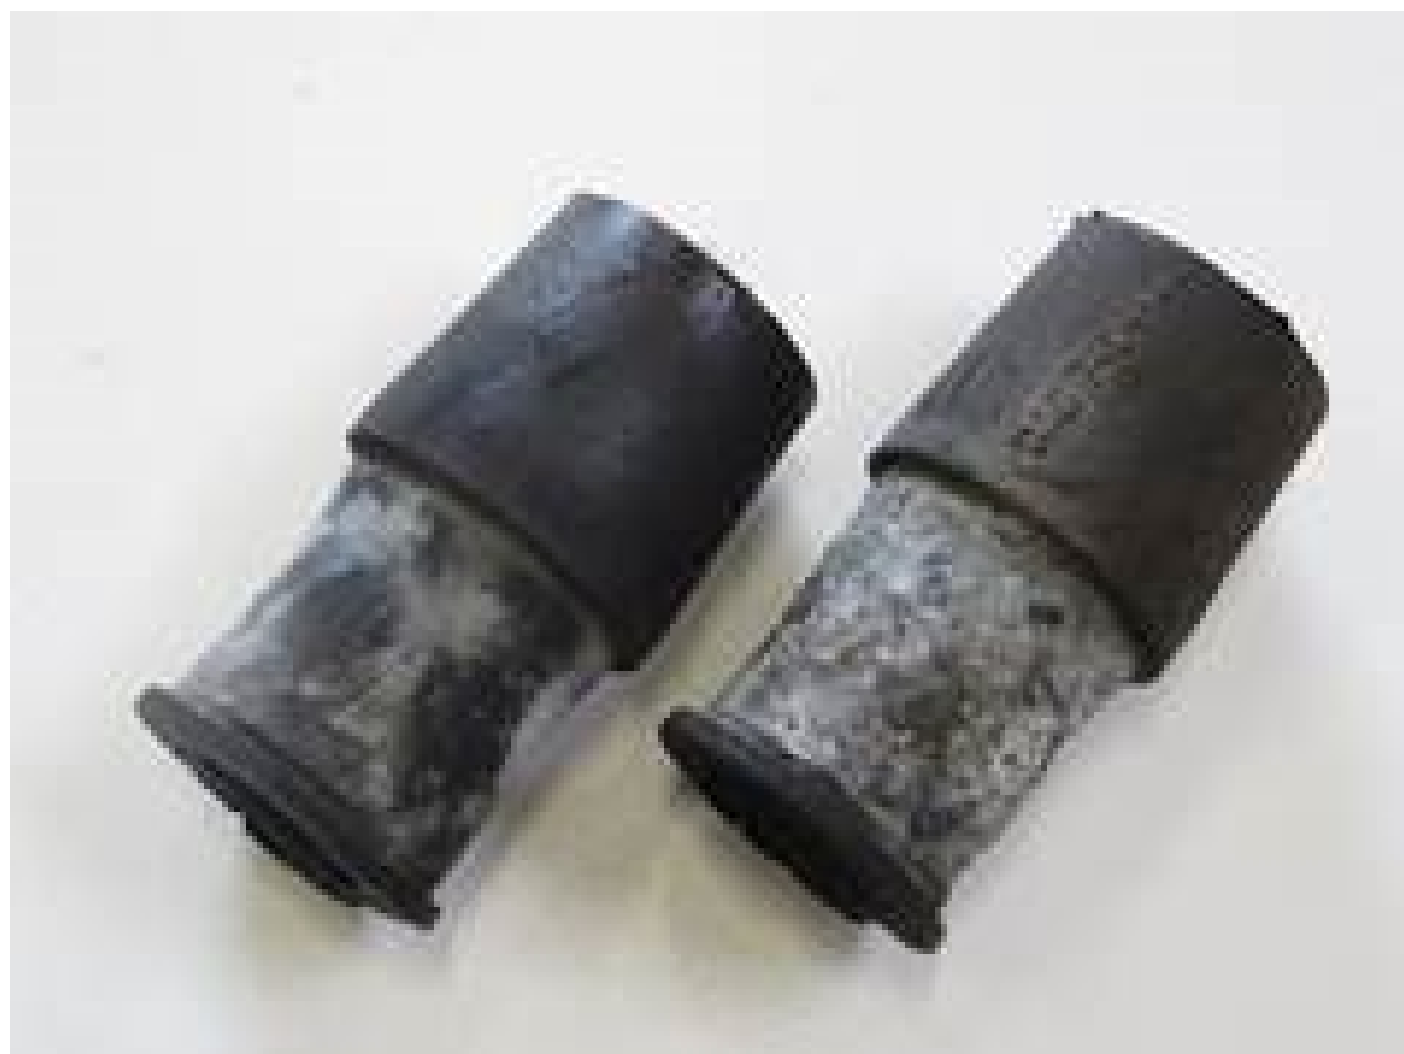
**Grinding noises when brake not pressed**

**Brake pad worn on one side**

**Heavy wear on brake disc**

If this defect is found in the vehicle models mentioned above, this may be due to a brake caliper guide becoming stiff or stuck. Heavy oxidation inside the bore holes on the aluminum housing causes the damping sleeves to sit more tightly, which in turn causes the guide bolts to jam.

Since this defect is not visible from the outside, it is essential to check that the caliper guides are not clogged while carrying out brake repairs:

- Remove the guide bolts and damping sleeves and check for damage.
- Check the bore holes for damage and refurbish if possible.

To do this, use a suitable reamer to clean out the bore hole evenly. During this repair process, the damping sleeves and, if necessary, the guide bolts need to be renewed.

If the oxidation is too heavy and it is not possible to repair the component safely, the brake caliper must be renewed.
